Corrosion on the Aluminum Endplate of the CDC

C.A. Meyer, 21 June, 2010

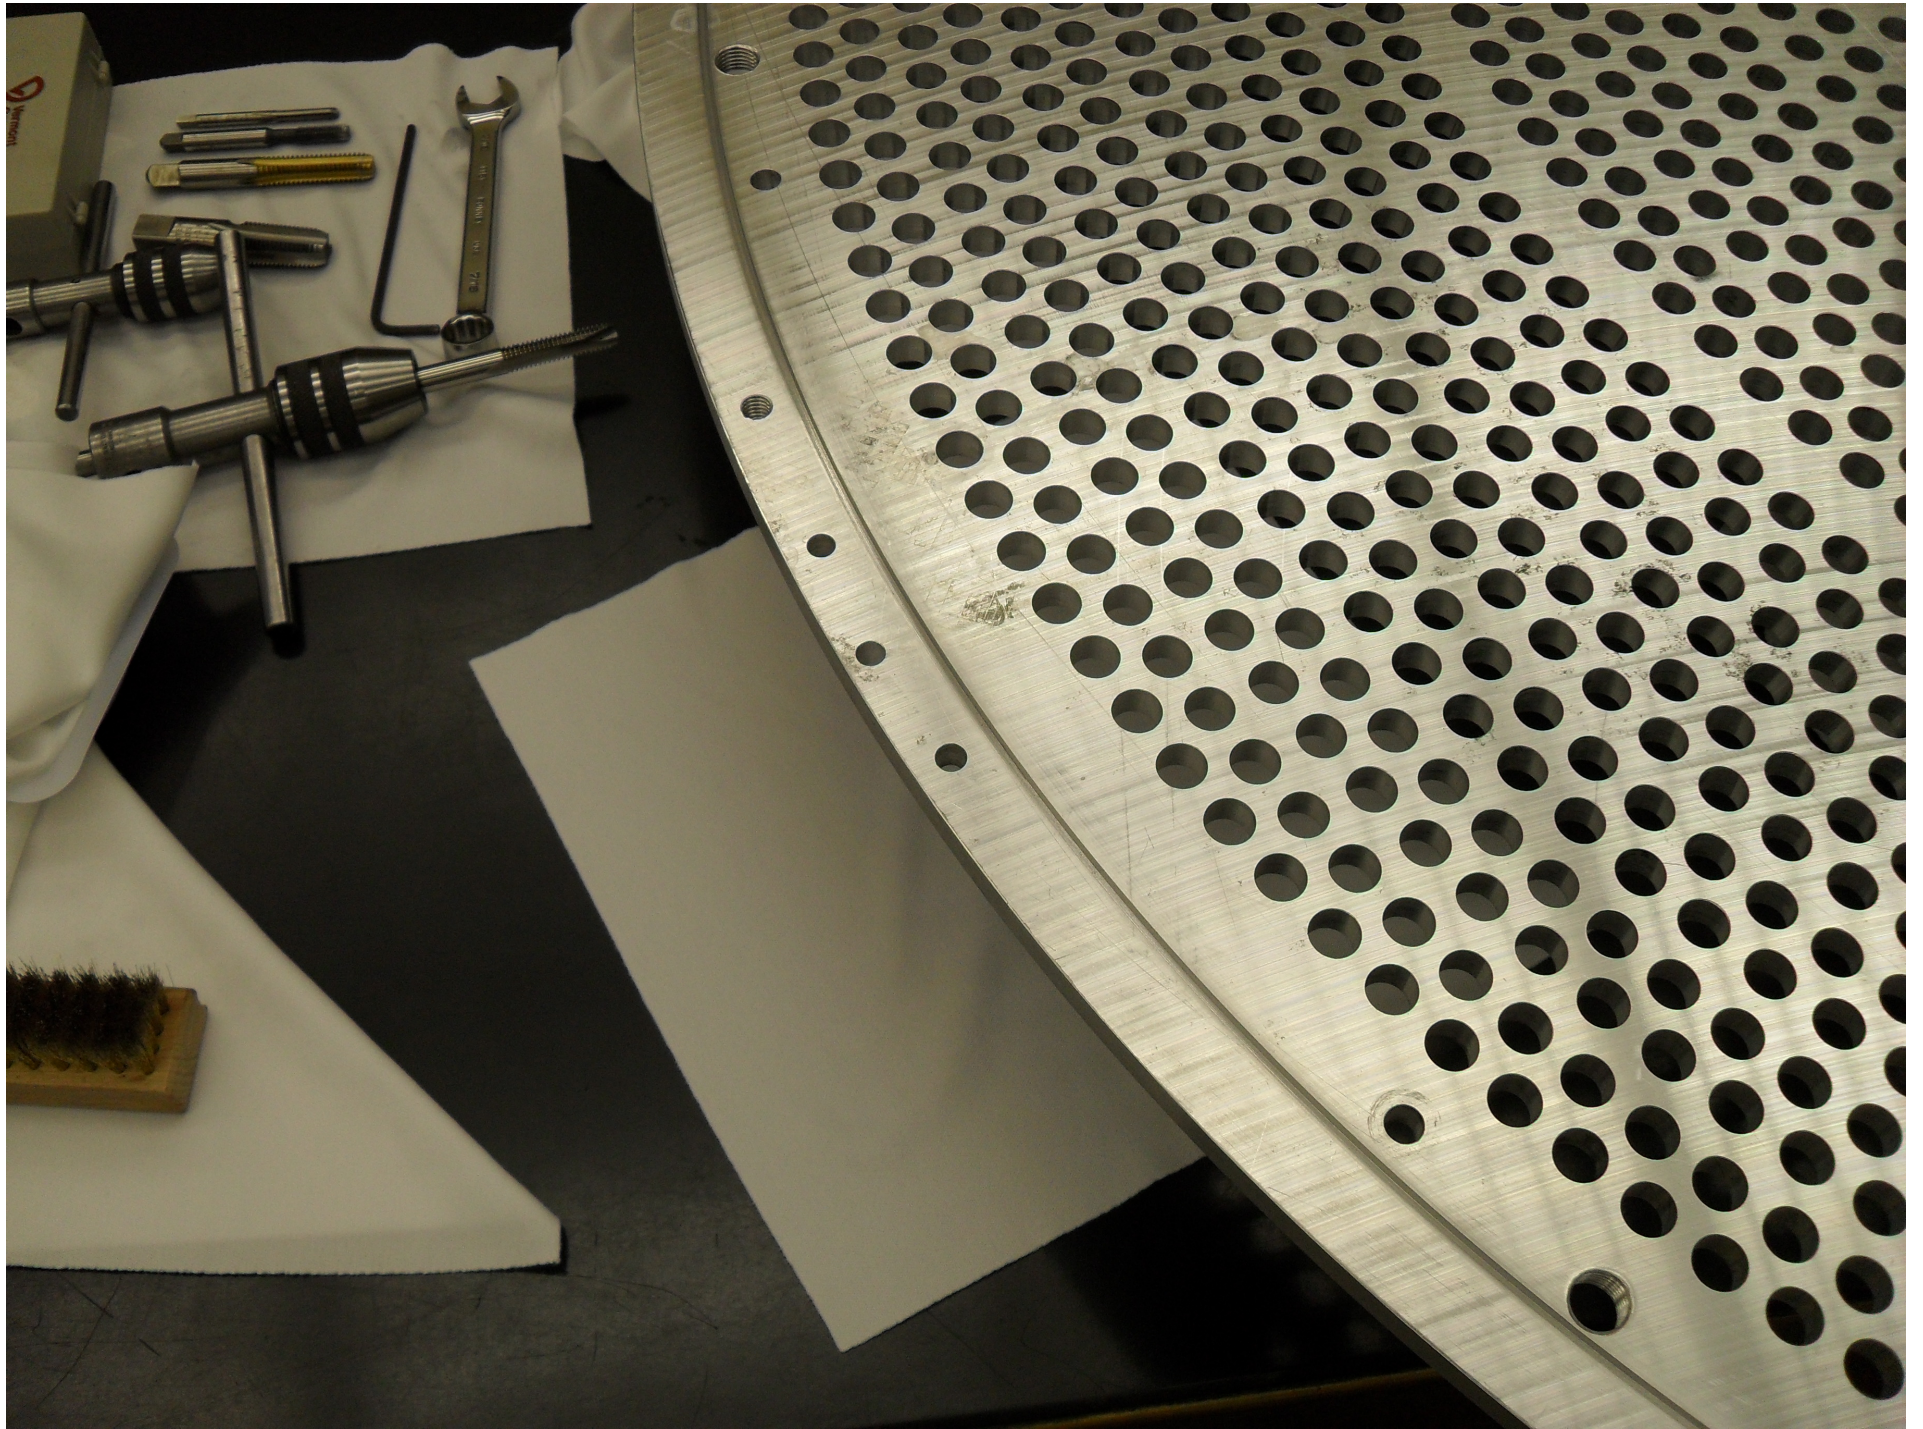
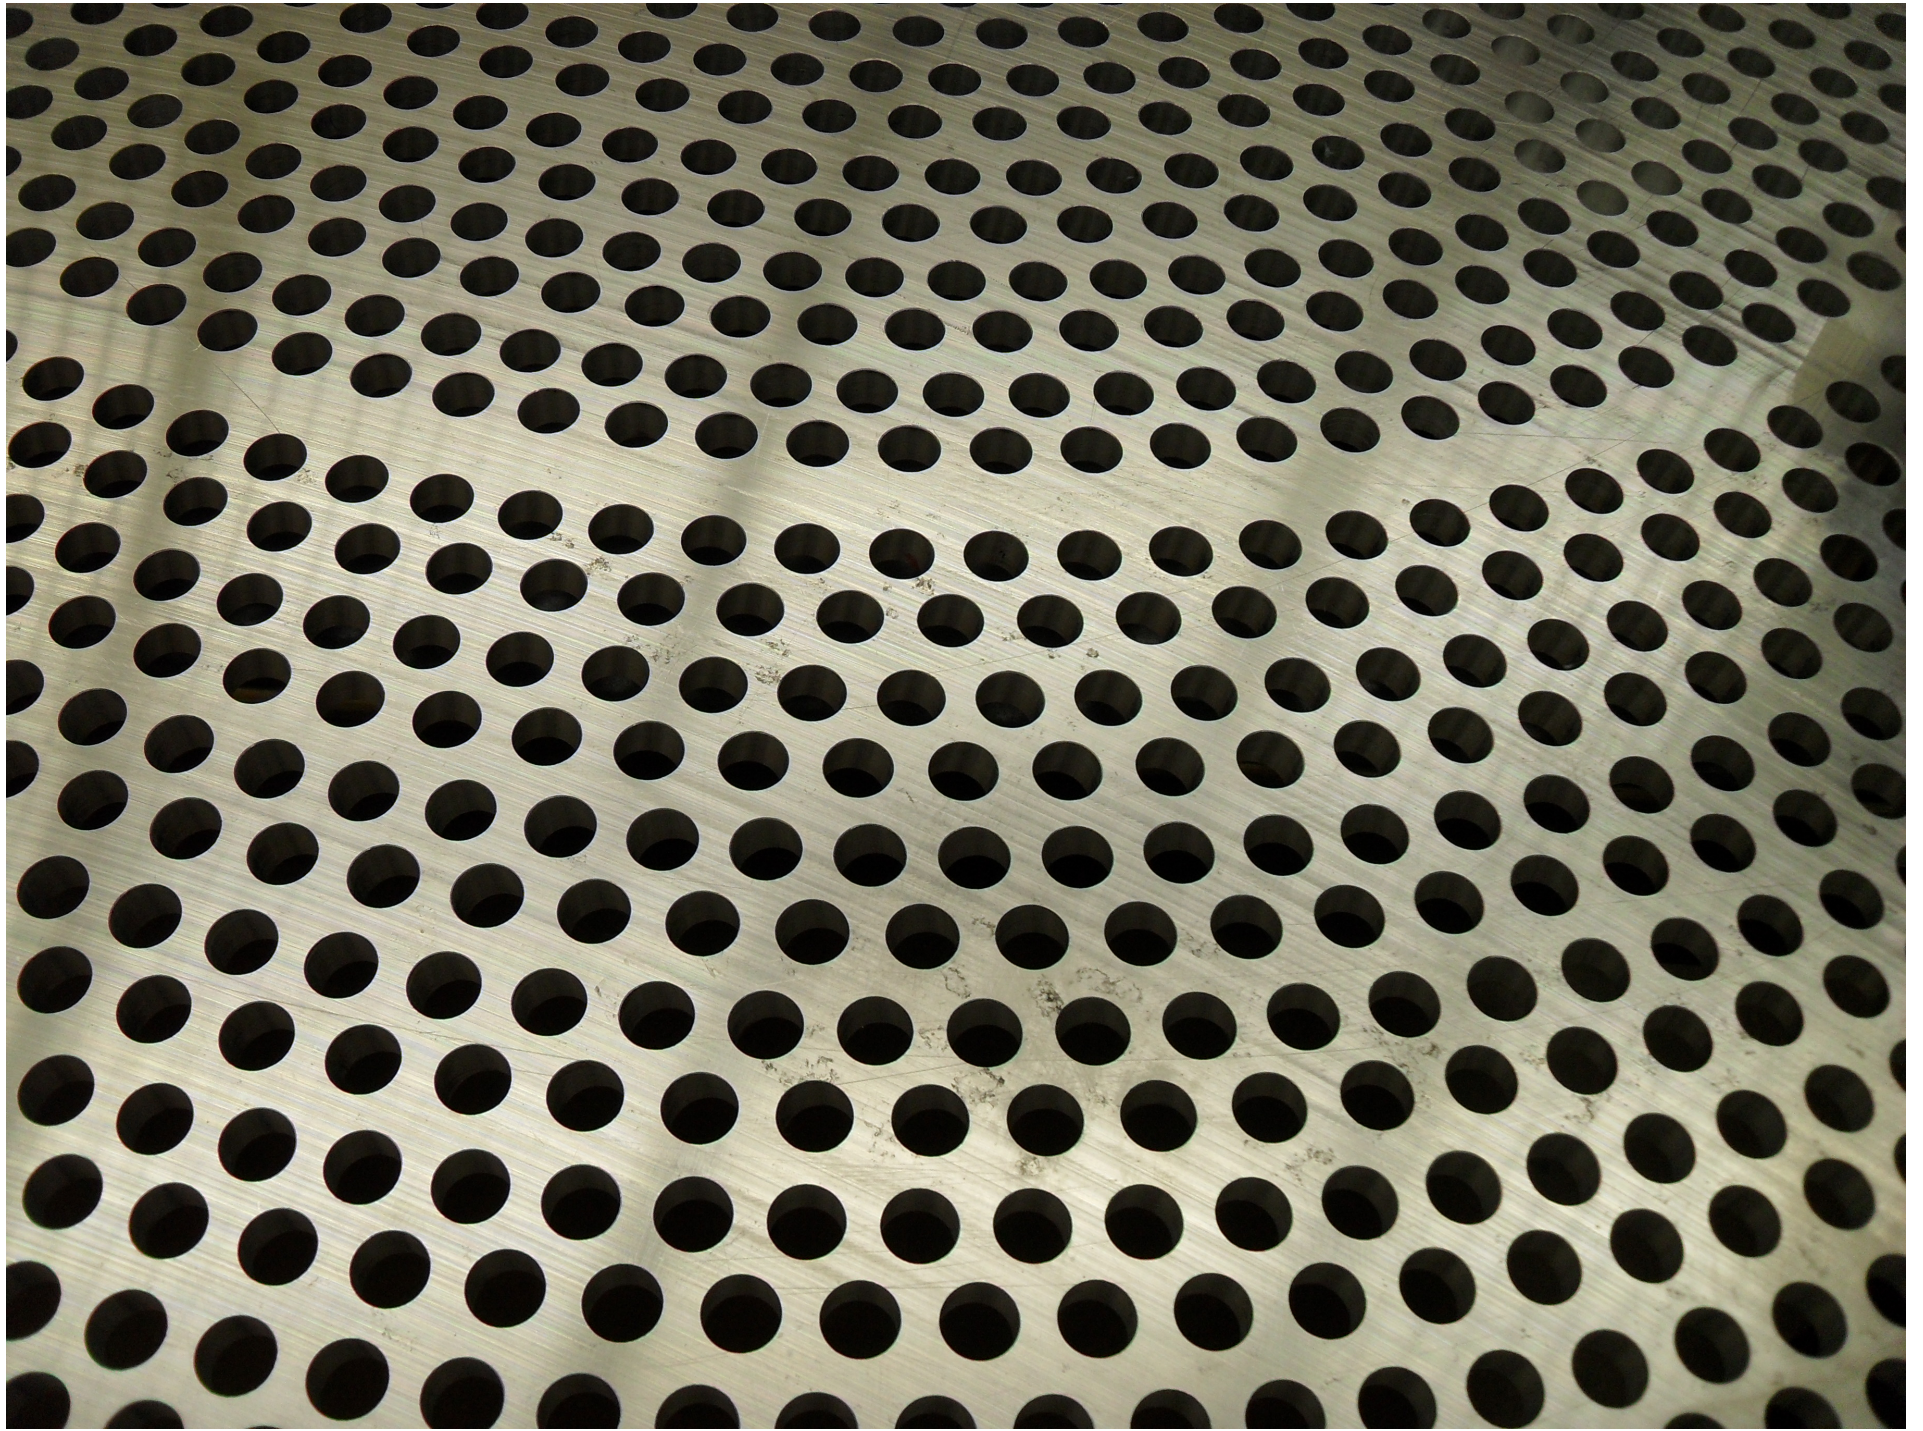
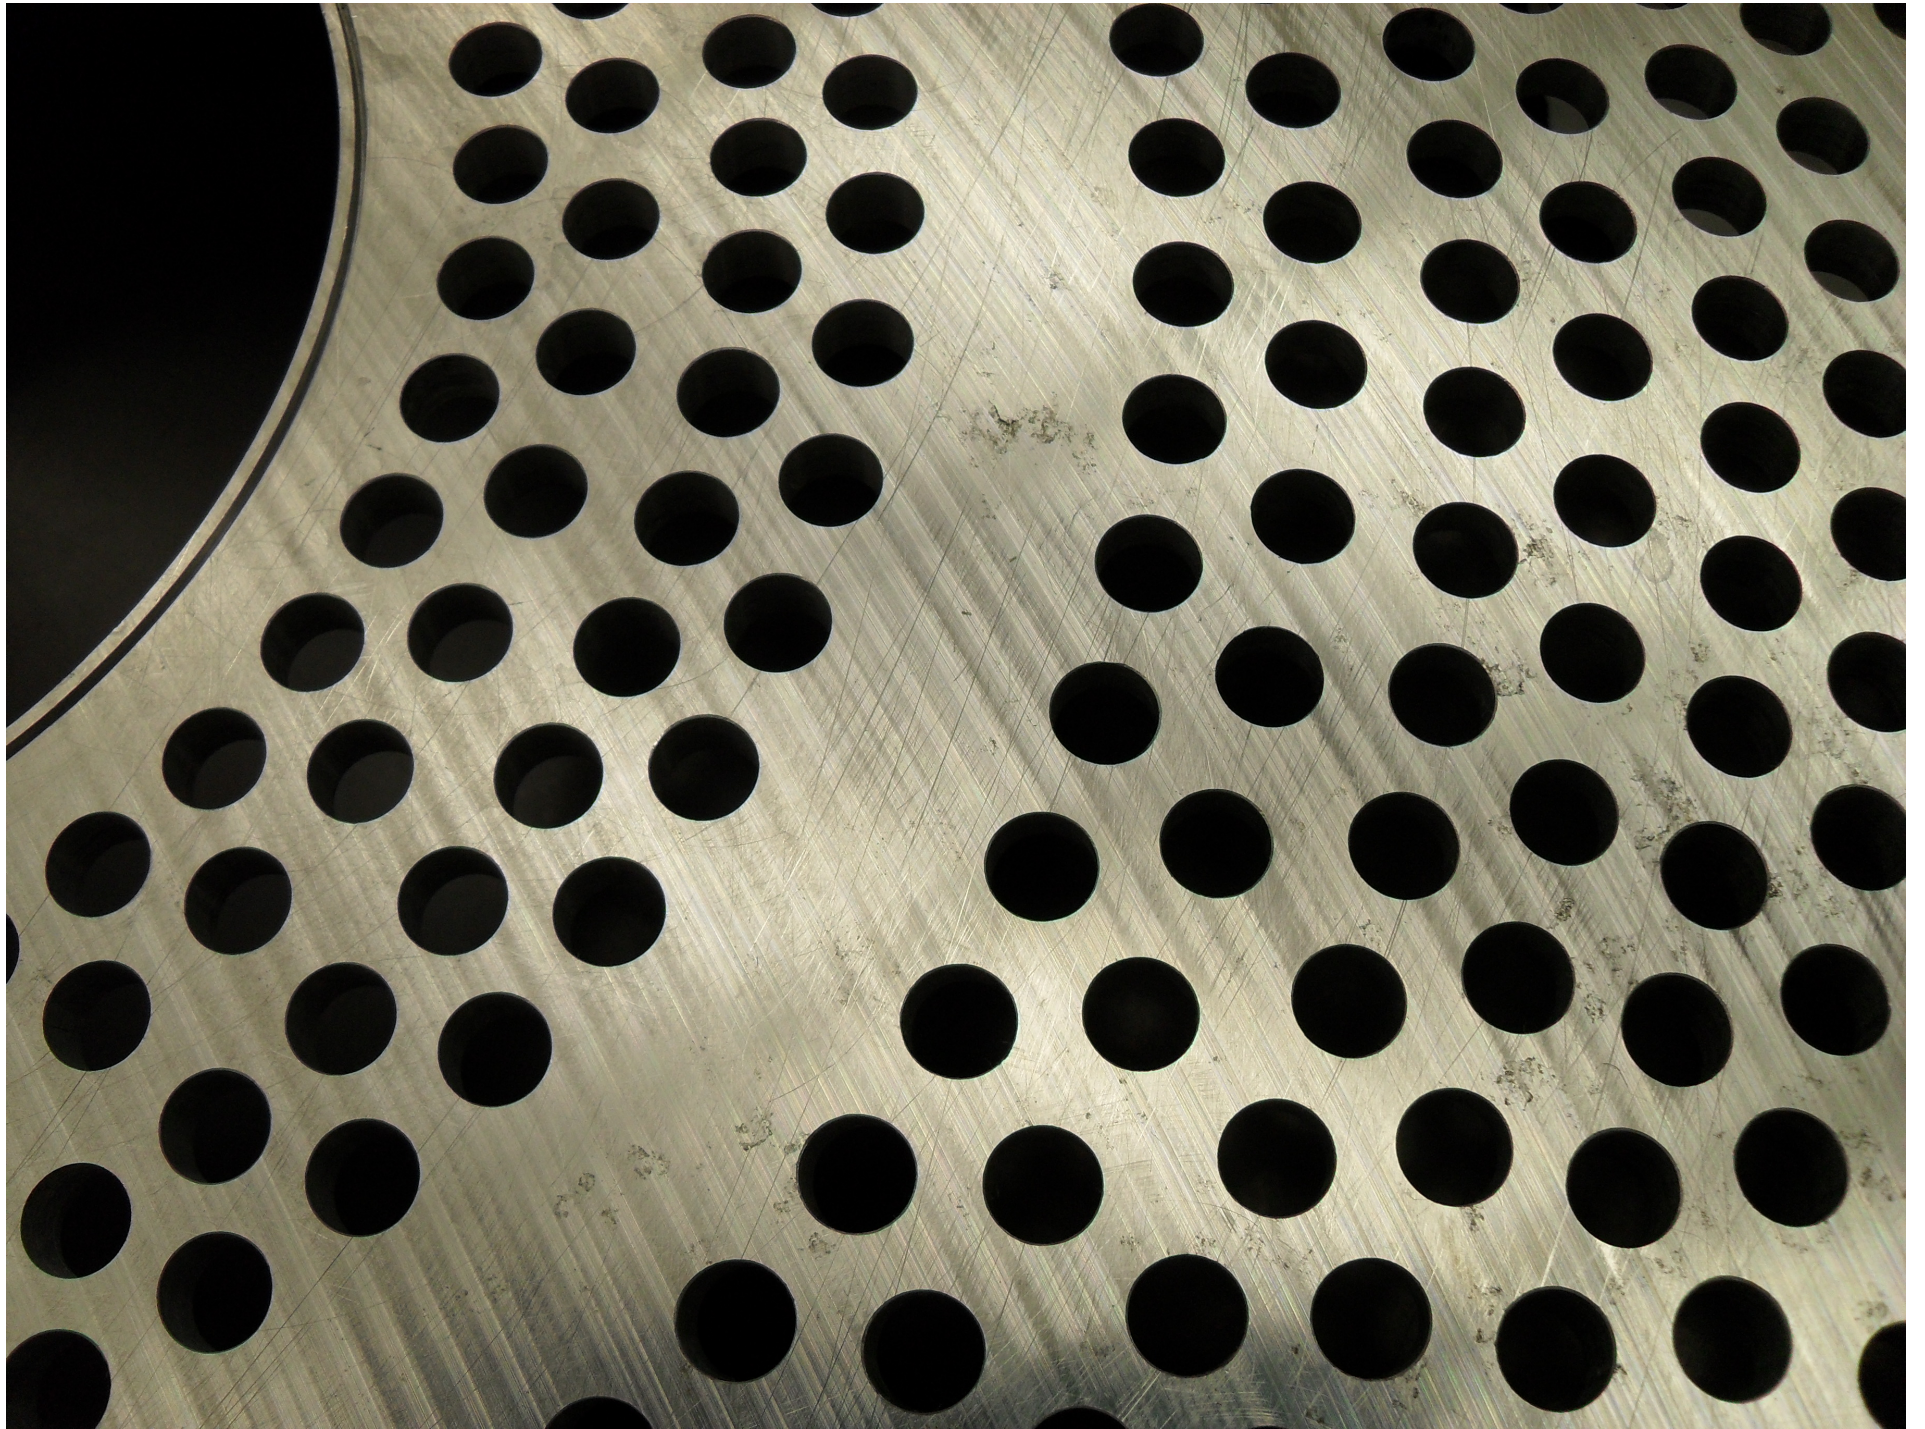
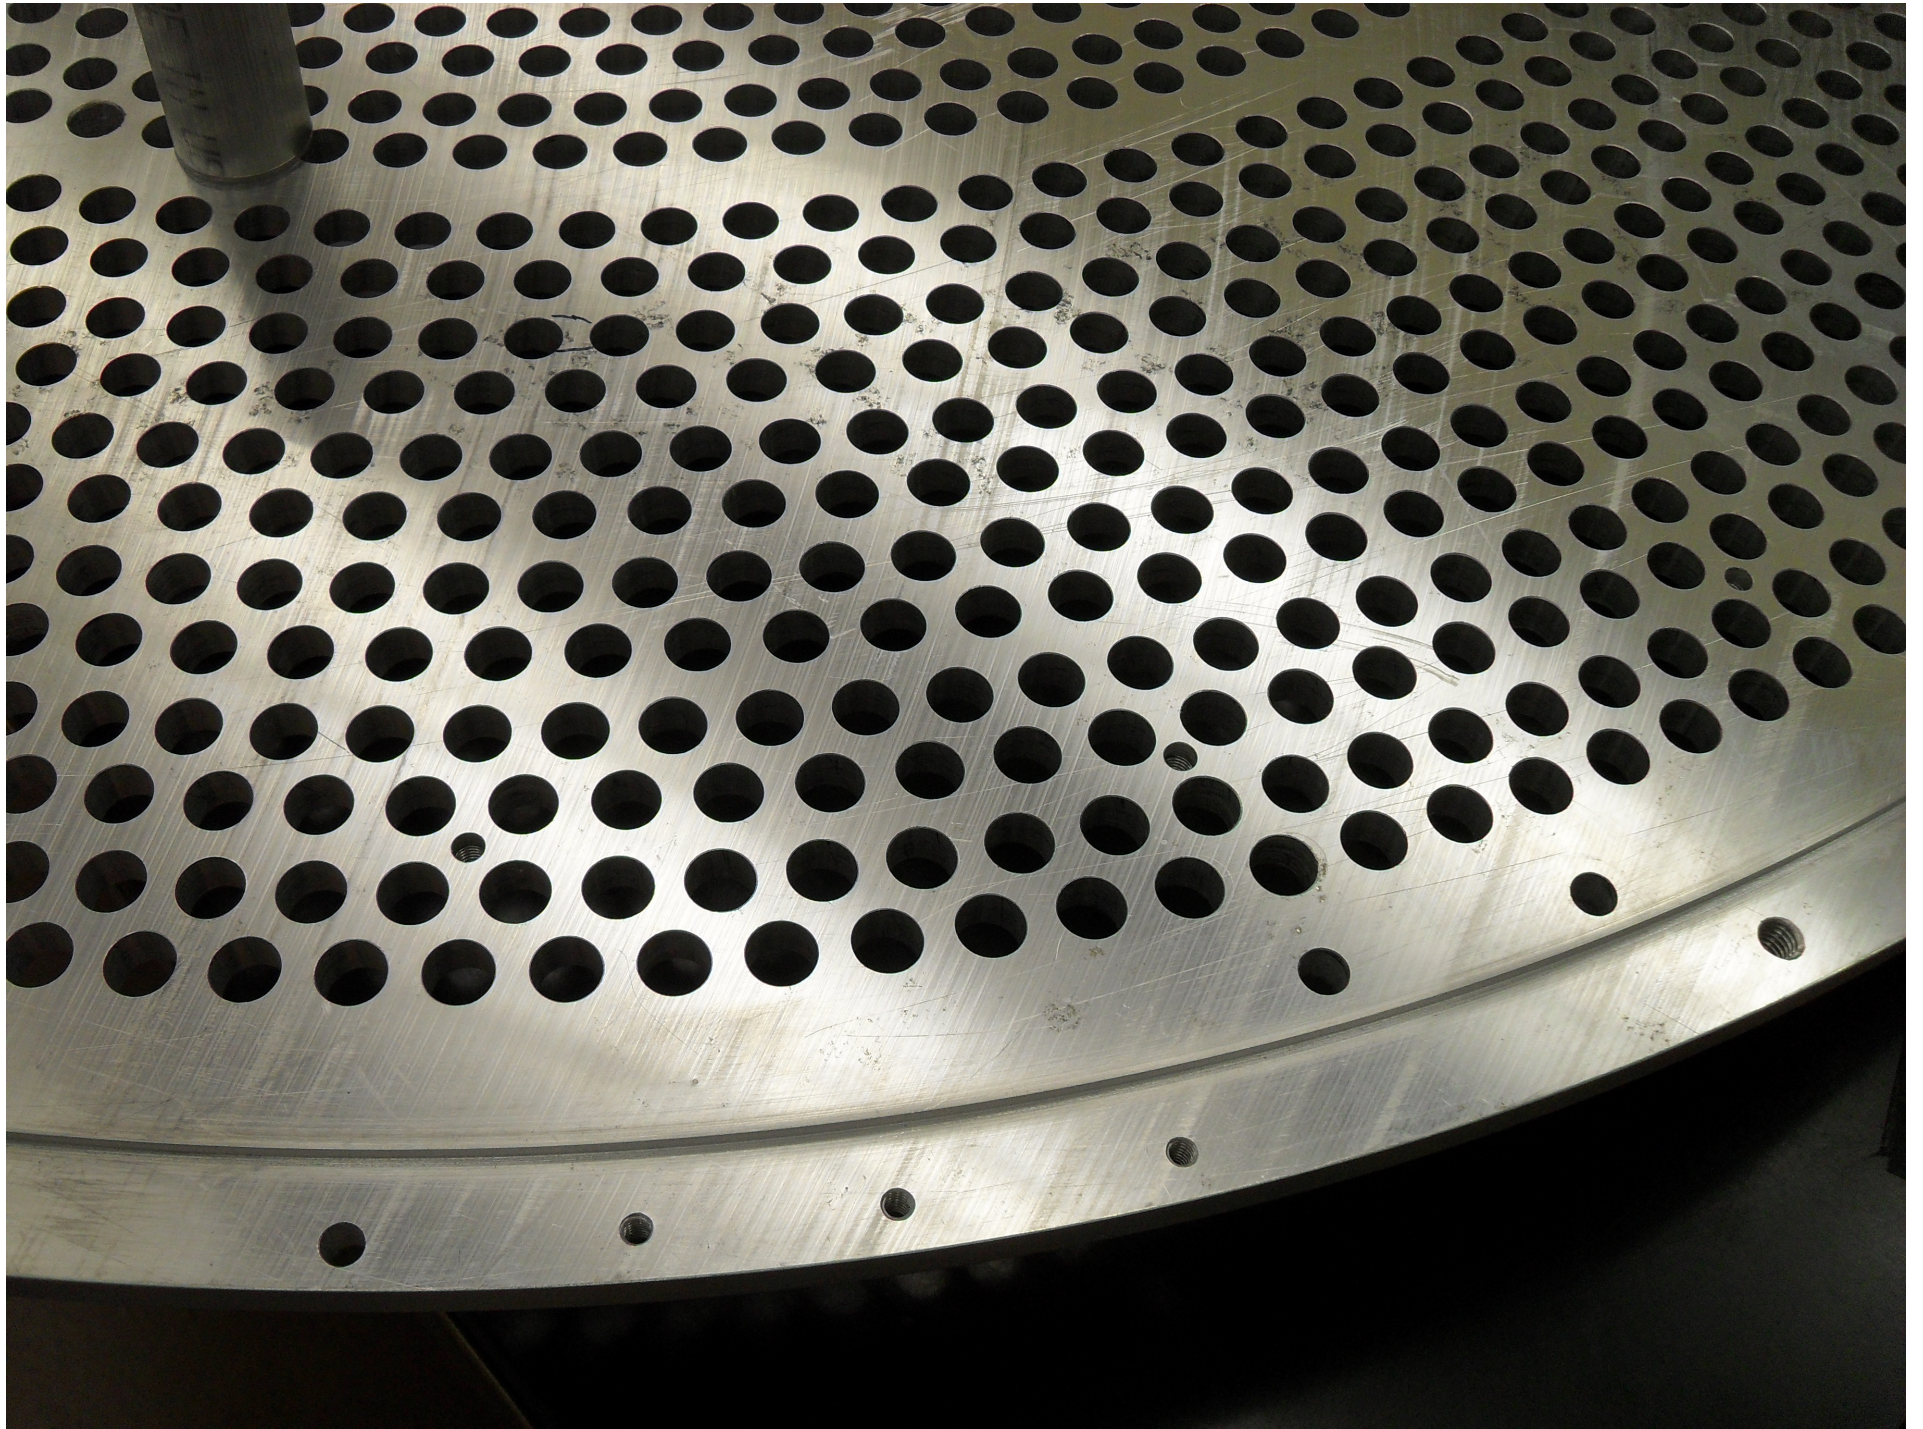
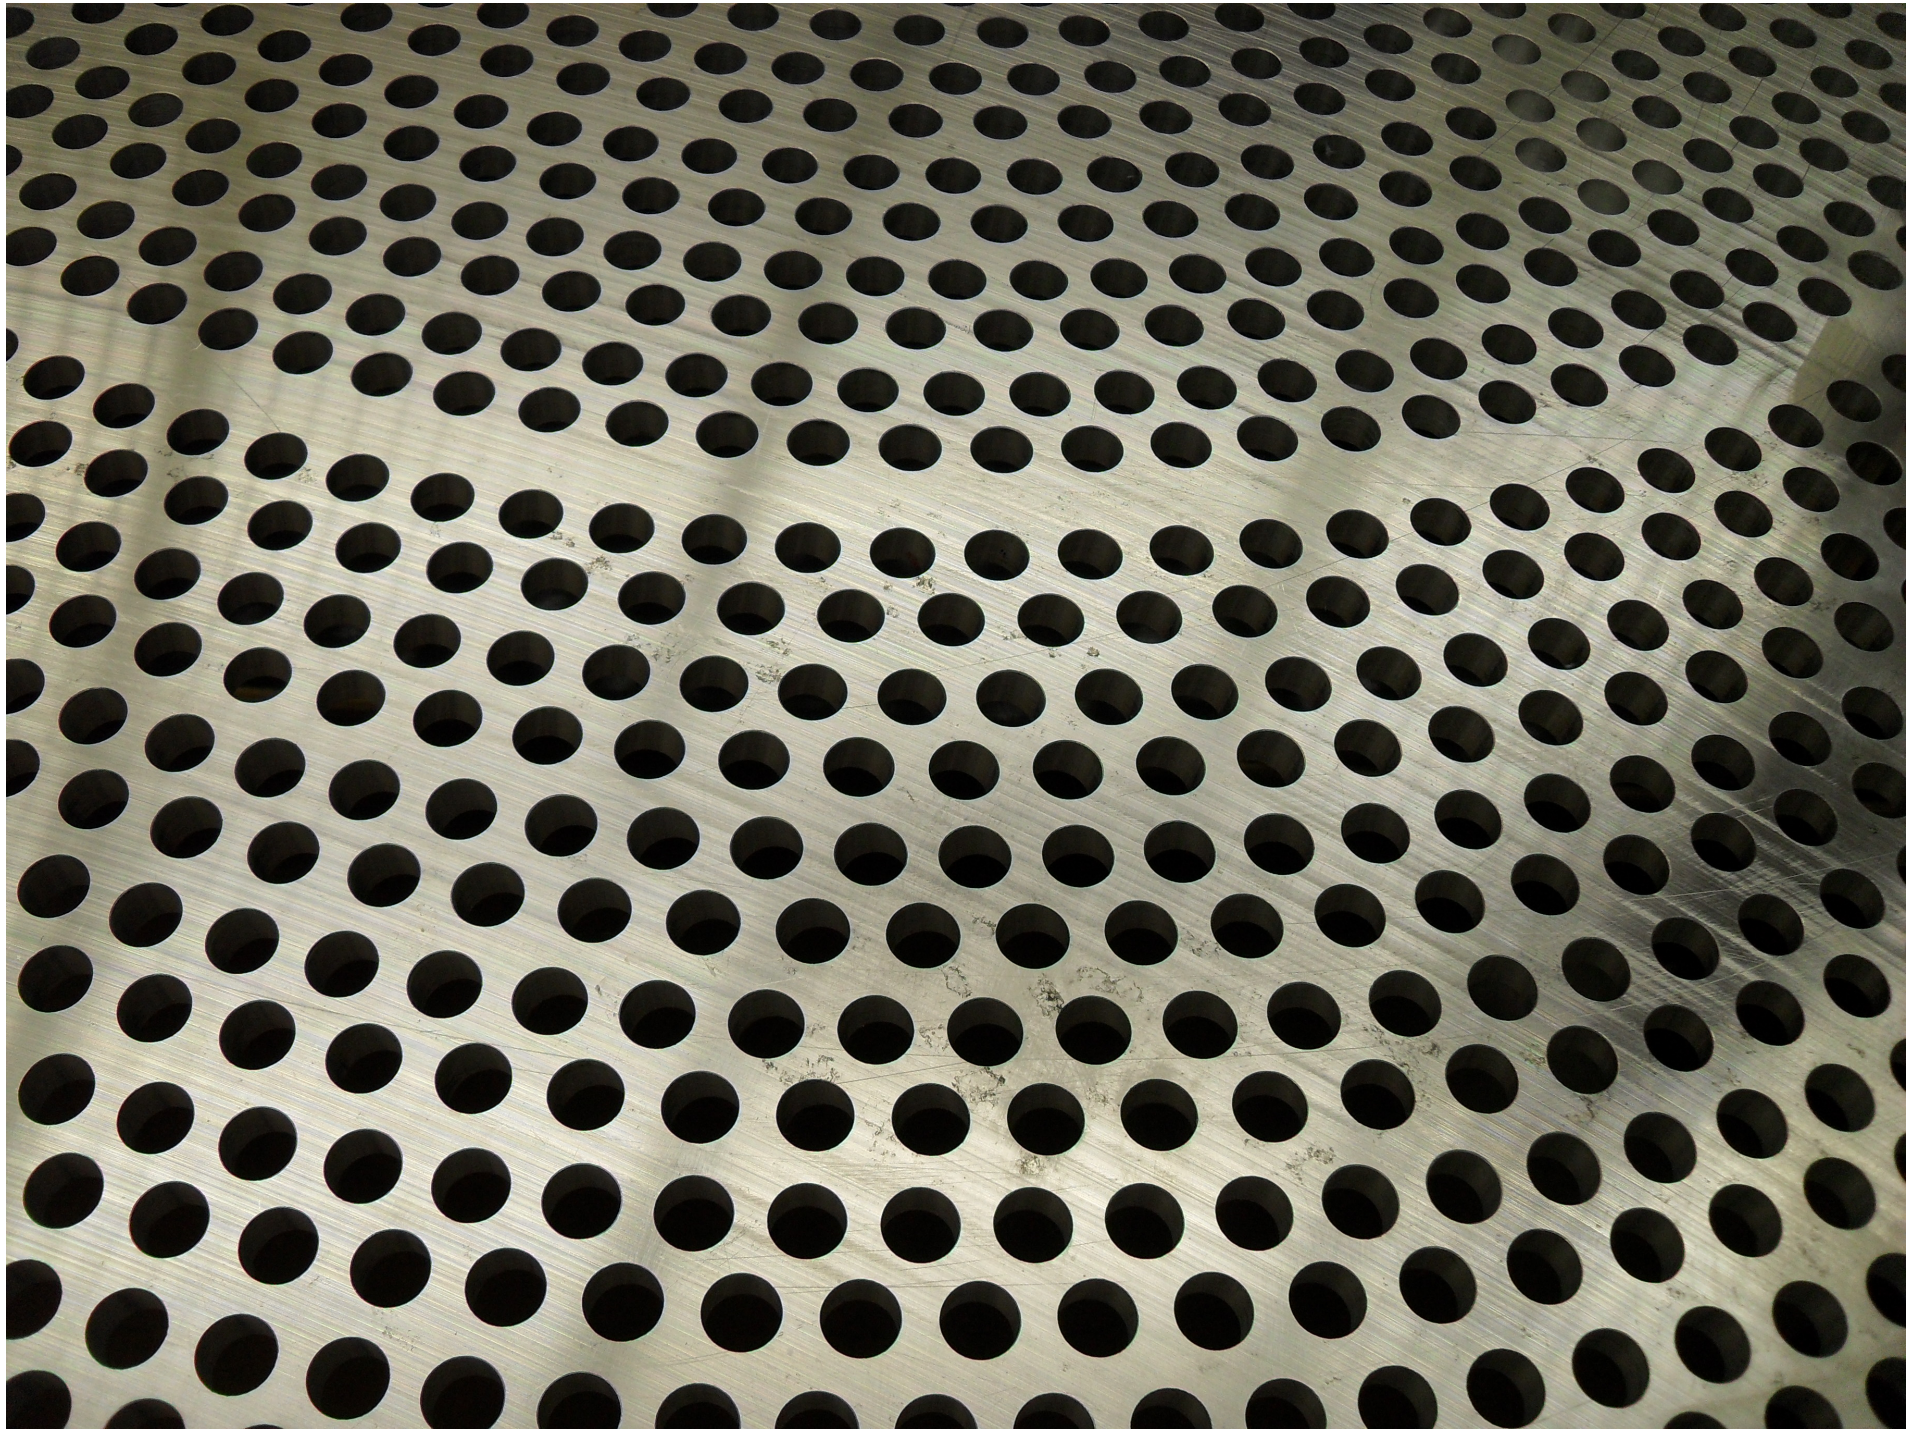
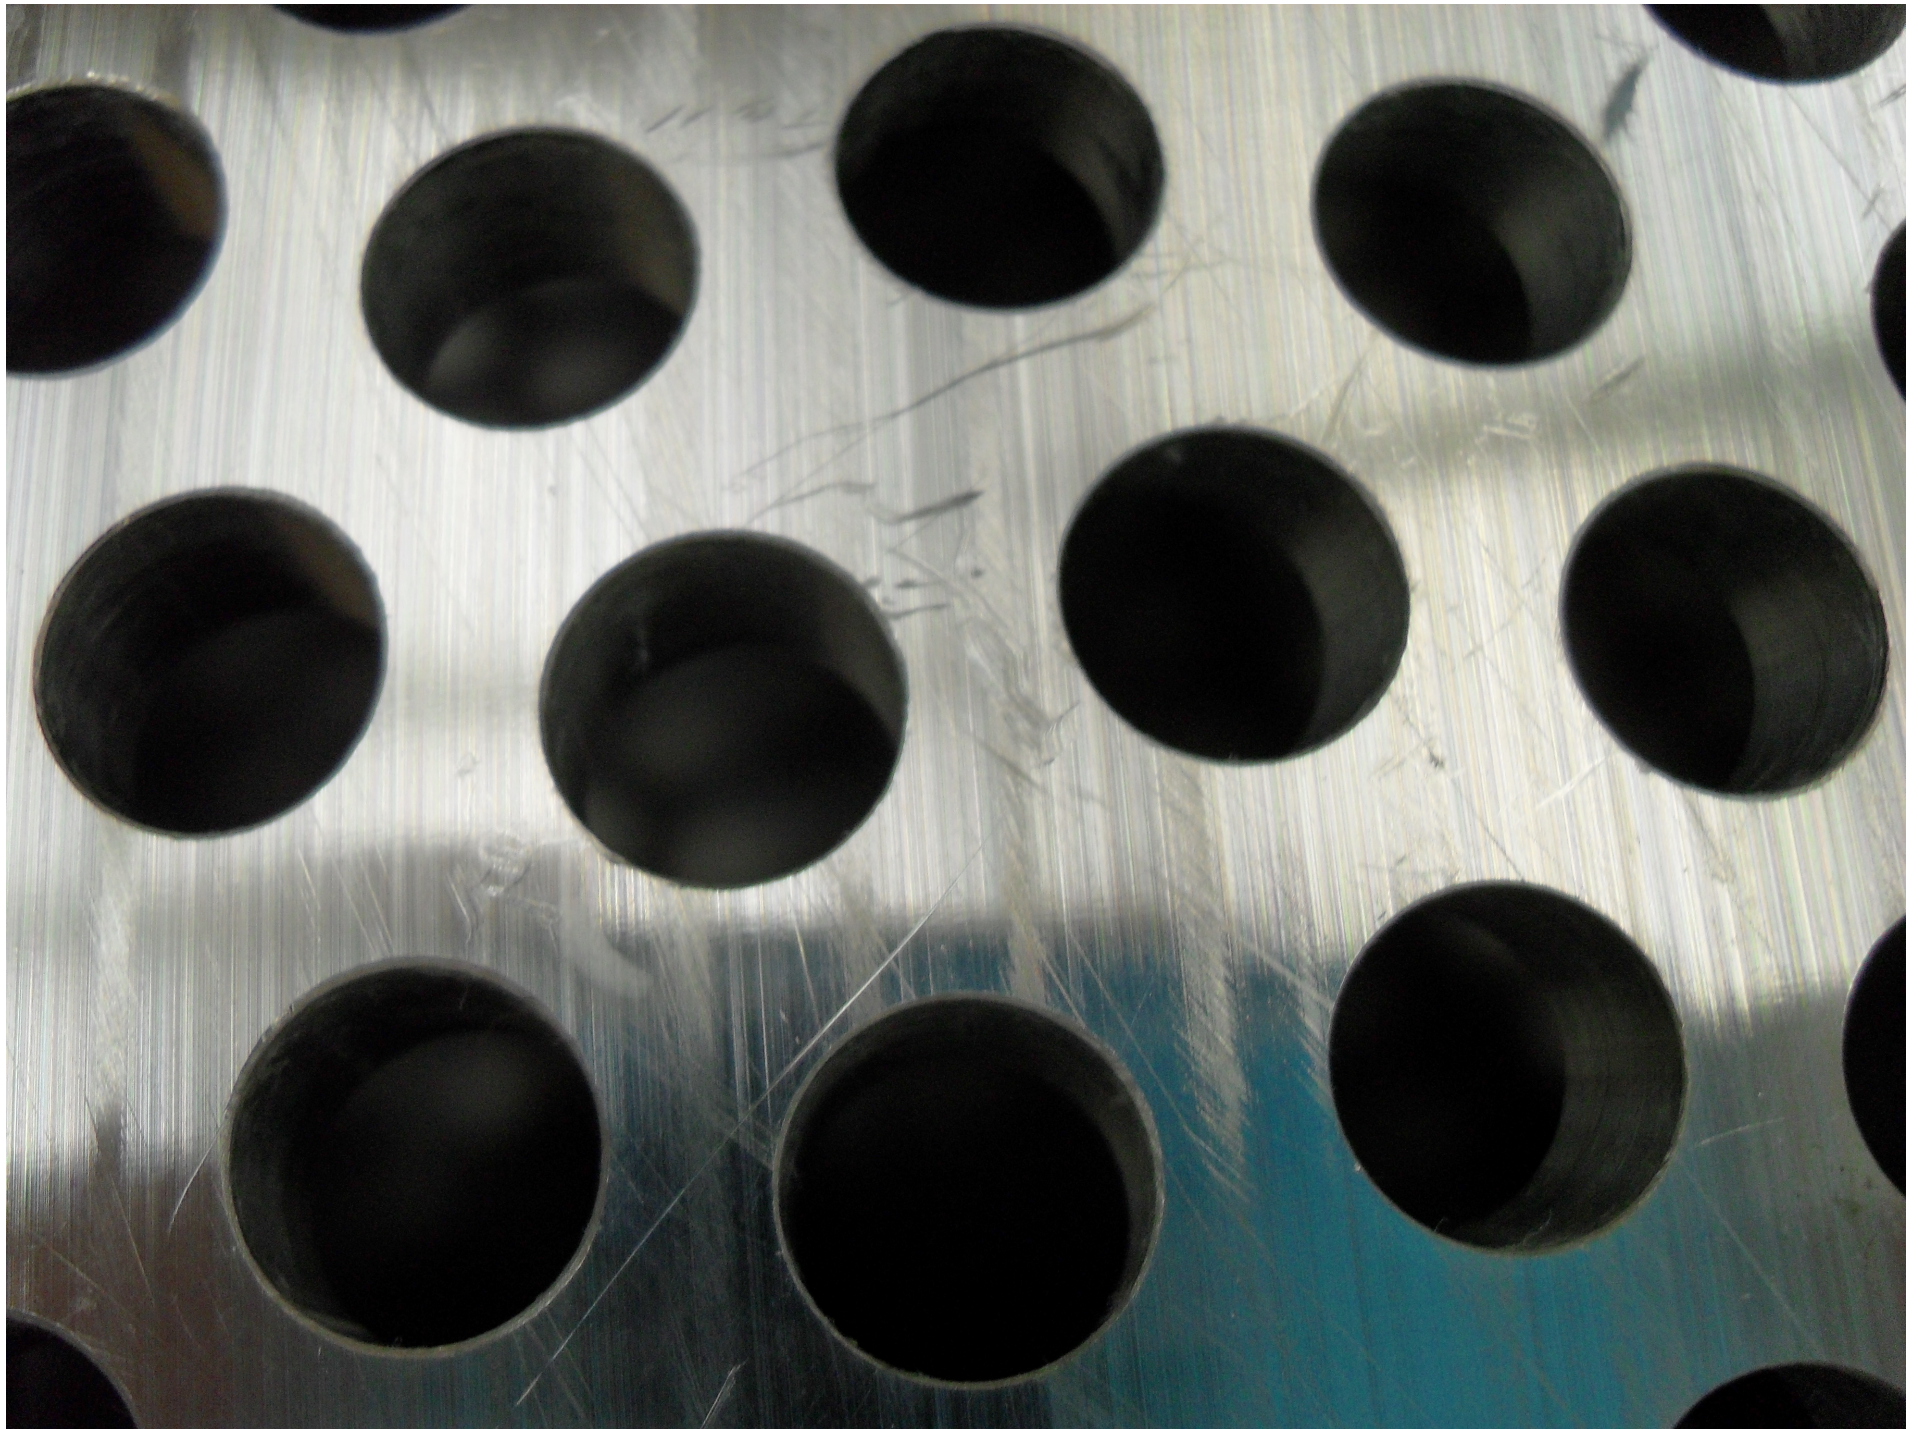
- The inside of the aluminum endplate shows a lot of scratching and corrosion that is not typical of the smooth surface of tooling plate. These extensive imperfections are not present on the outside surface of the plate.

- The imperfections appear to be the result of the plate being attached to a metal backing plate during machining. The blemishes are likely the result of the cooling fluid being in prolonged contact with the backing plate.

- The imperfections are 1-2 mils deep in the surface and do not come out with cleaning. It could be possible to grind the plate down to get rid of them, but our impression is that they will not impact the chamber performance. They are all inside the major gas volume, which is the last place the gas flows before exiting.

- The photographs in this document show the scratches and blemishes on the endplate and will serve as a reference to this issue.
- We have cleaned the plate and all the holes. We have also cleaned the blemishes to the best of our ability at CMU.
