# Hall D Wire Characterization

## Samples F5-1 & F5-2

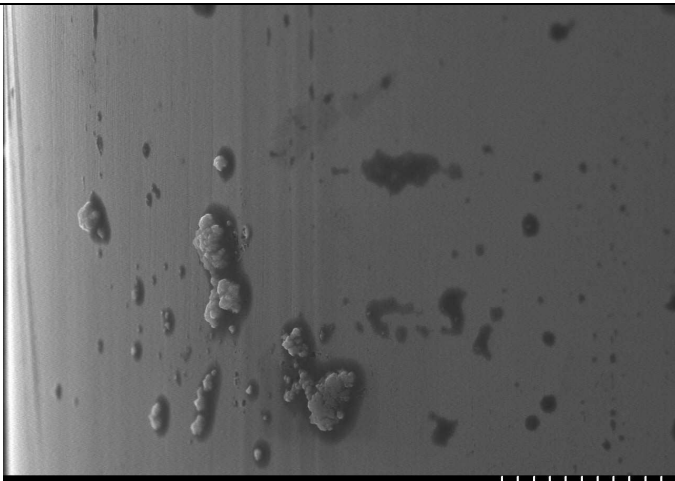
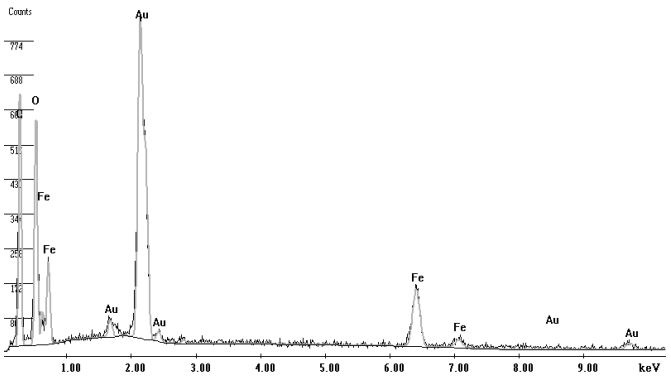
<p style="text-align: center;">F5-1A-2</p>

<p style="text-align: center;">Magnification: 6000x</p>	<p style="text-align: center;">EDS Analysis. Surface contamination (Iron oxide?)</p>
<p style="text-align: center;">F5-1A-4</p>

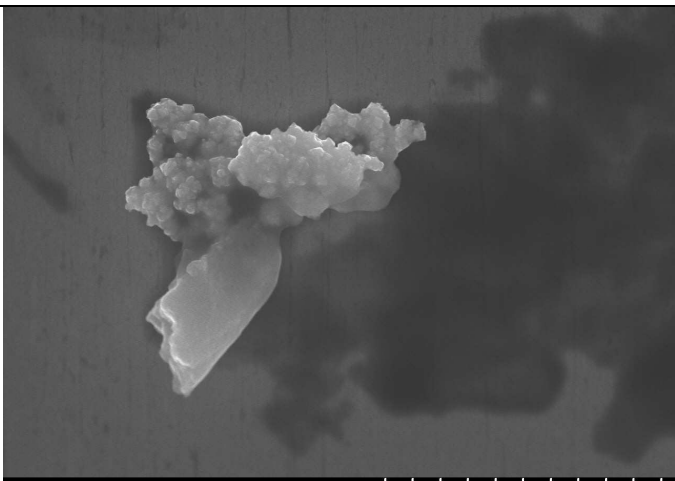
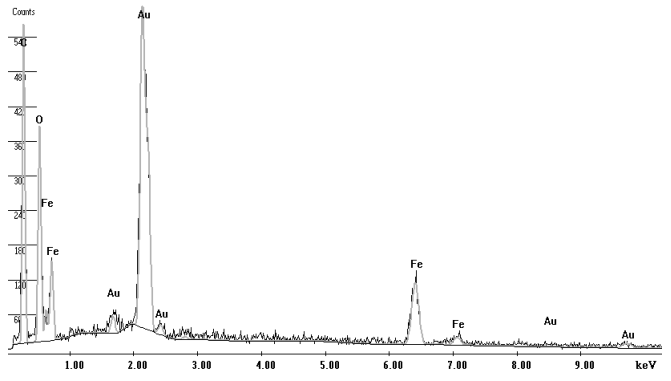
<p style="text-align: center;">Magnification: 13000x</p>	<p style="text-align: center;">EDS Analysis. Surface contamination (Iron oxide?)</p>
<p style="text-align: center;">F5-1A-7</p>

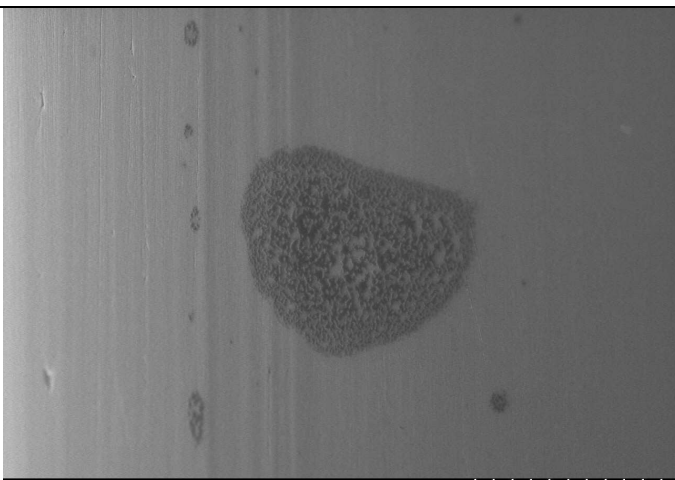
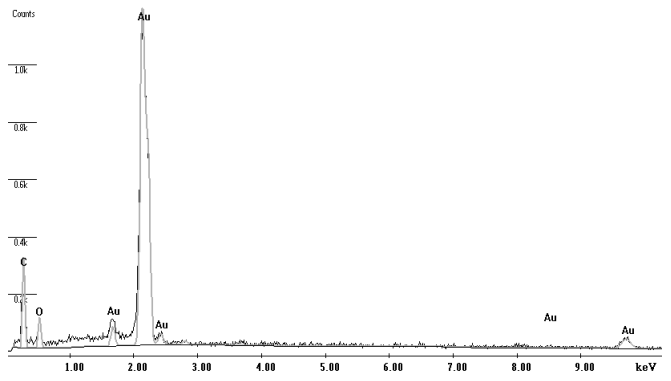
<p style="text-align: center;">Magnification: 7000x</p>	<p style="text-align: center;">EDS Analysis. Environmental surface contamination</p>

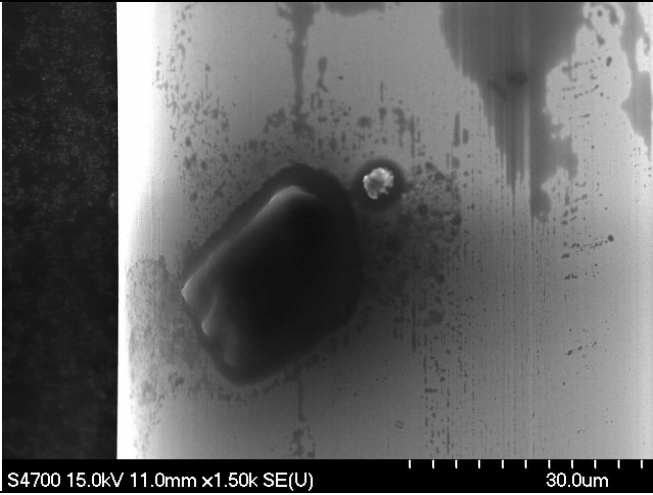
F5-1B-3 Environmental contamination

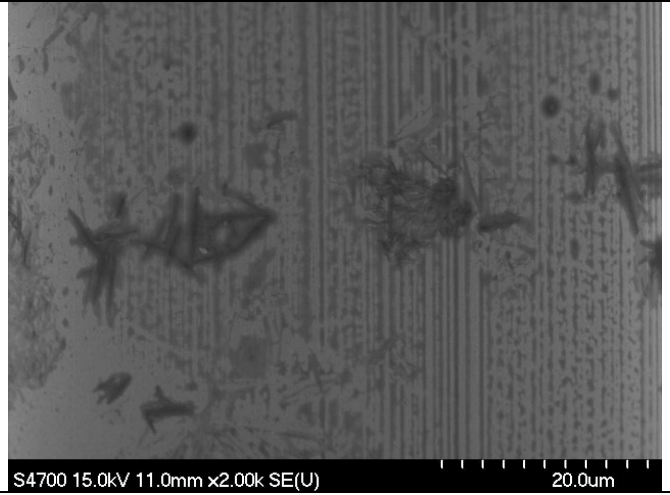
F5-1B-7 Environmental contamination

- 1) No traces of Cu within the damaged area were indicated by the EDS analysis (detection limit ~1%).
- 2) Environmental contamination as shown at pic F5-1B-7, could possibly be of bacterial origin.

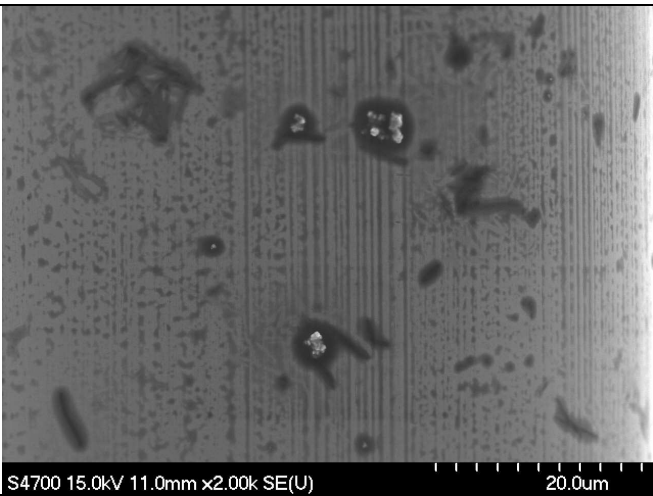
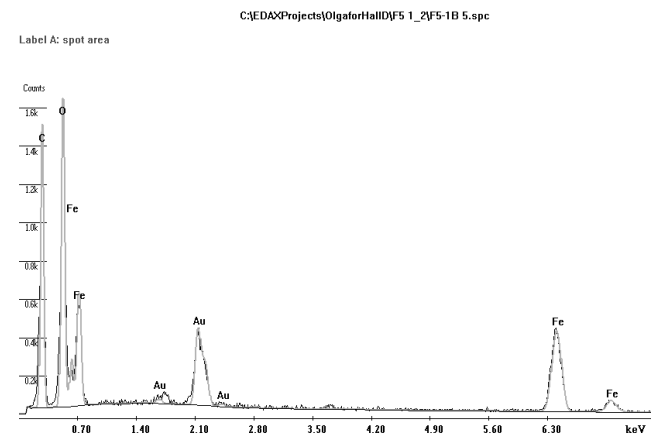
F5-1B-5

EDS Analysis. Surface contamination (Iron oxide?)

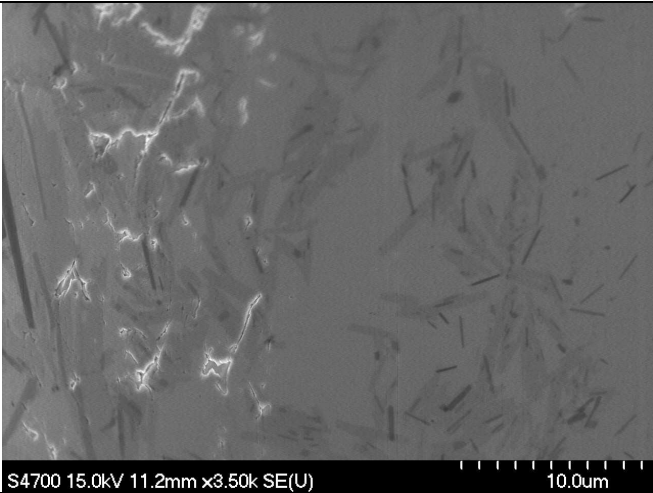
F5-1B-9 Surface damage.

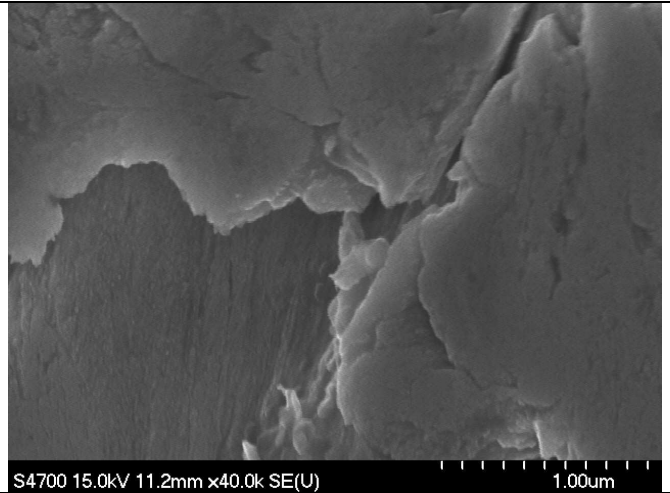
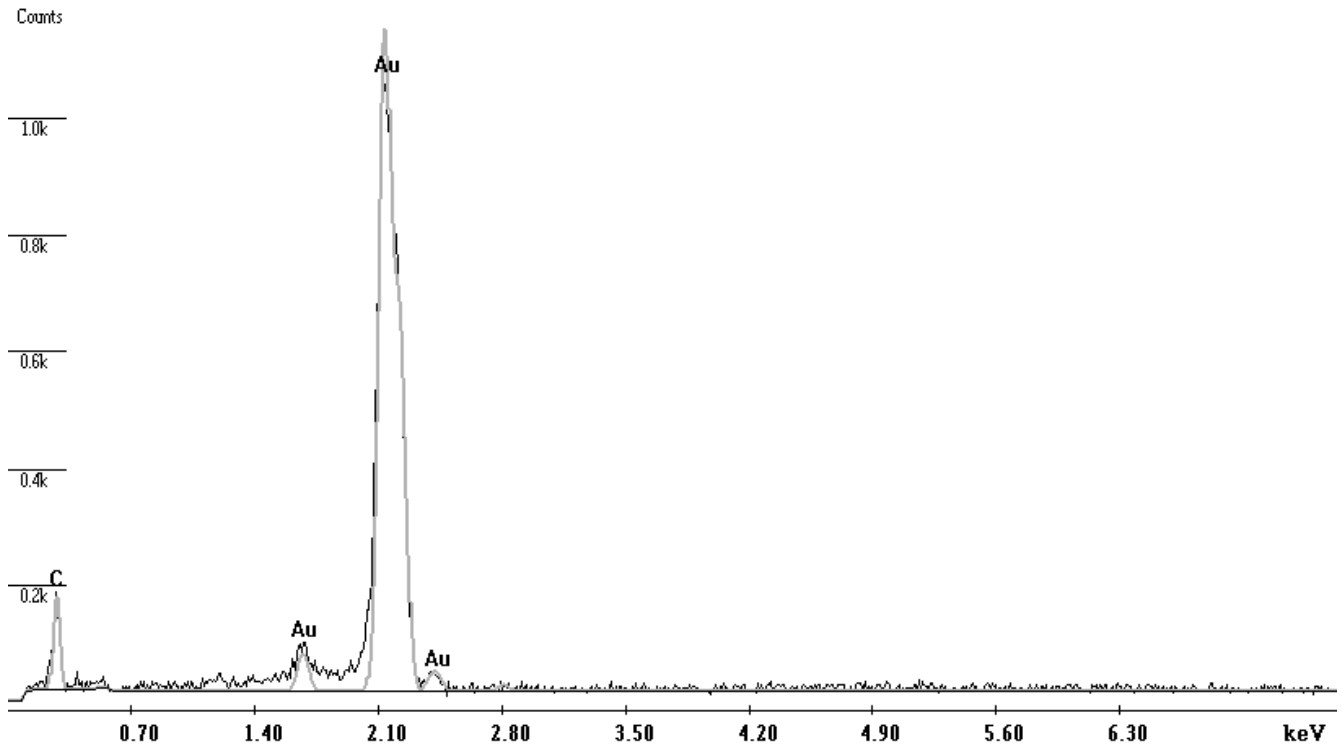
F5-1B-10 Surface damage (magnified).

## EDS analysis of damaged area.

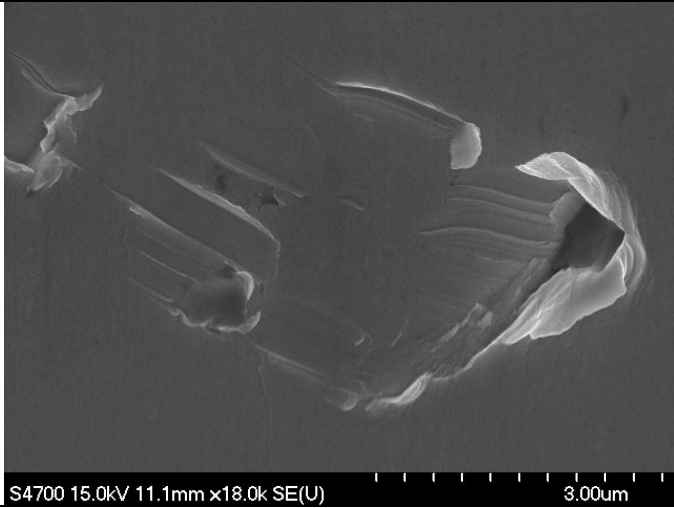
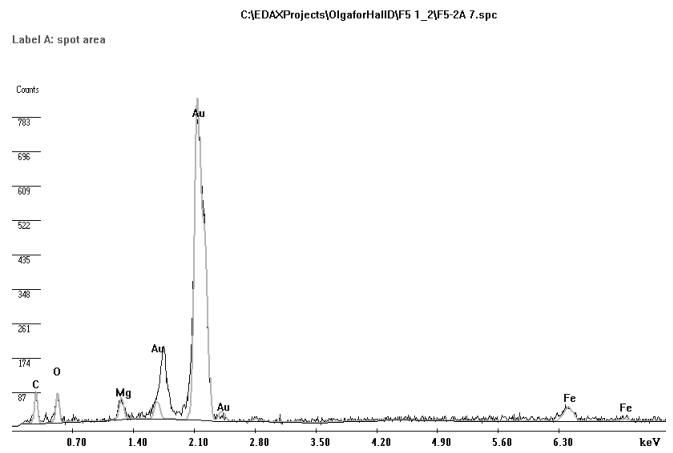
F5-2A-7 Surface damage.

EDS Analysis. Surface damage and contamination.

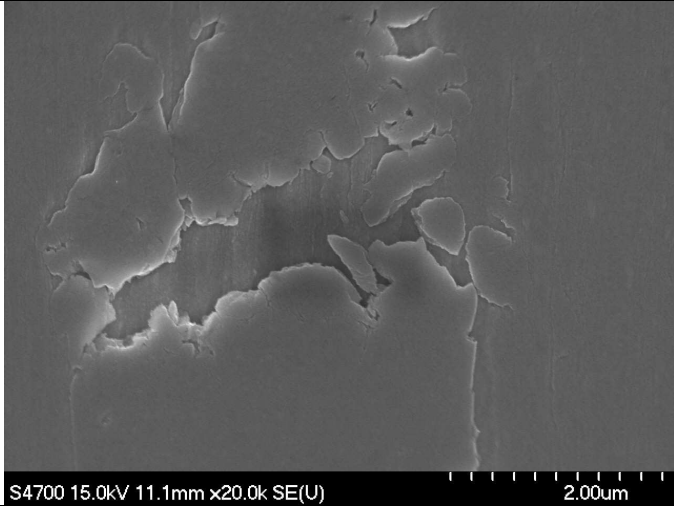
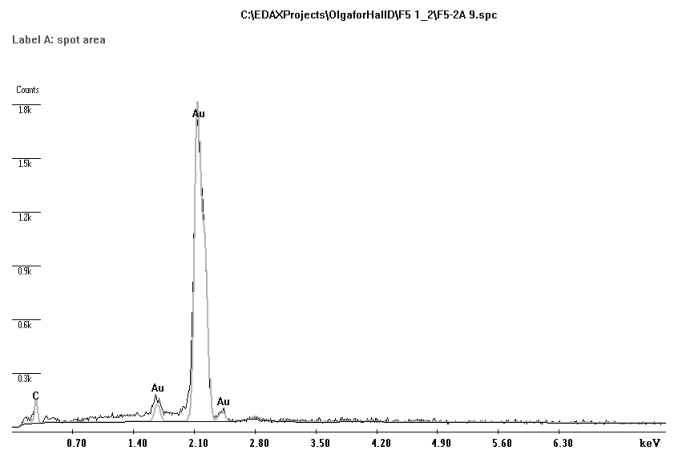
F5-2A-9 Surface damage.

EDS Analysis. Surface damage. No Cu.

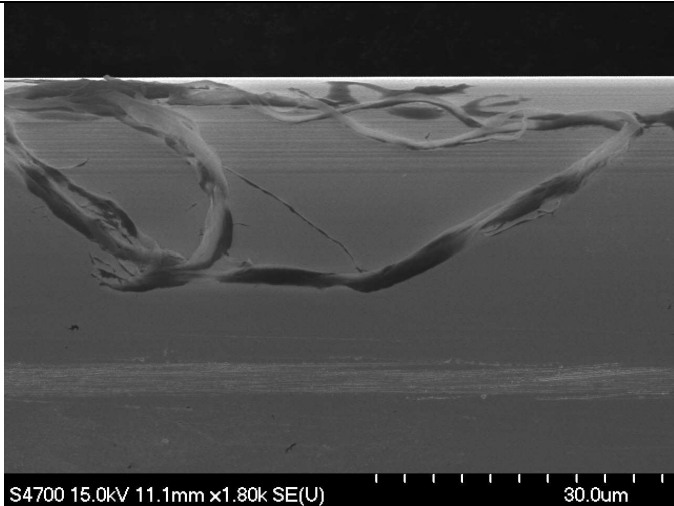
F5-2A-5 Environmental contamination.

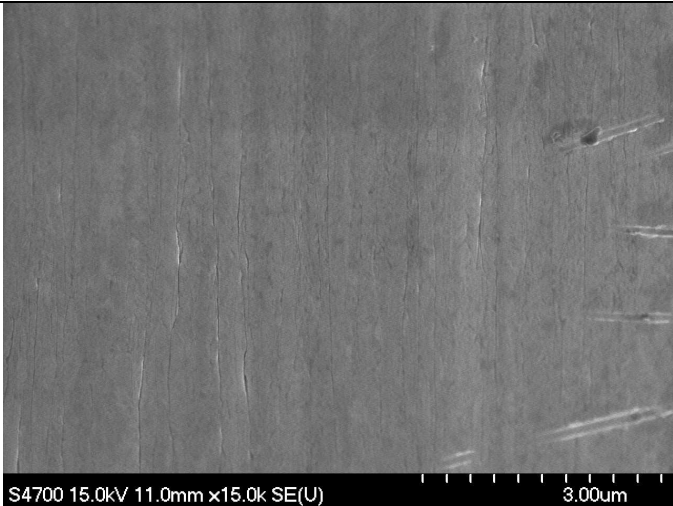
F5-2B-6 Minor surface damage..

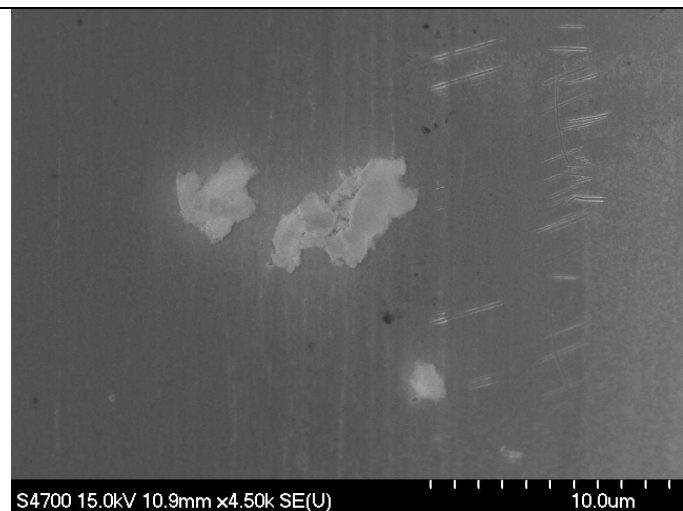
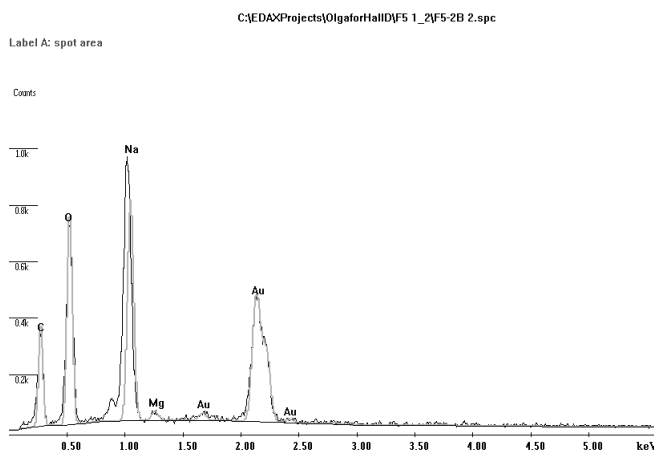
F5-2B-2 Surface contamination.

EDS Analysis. Surface contamination. (NaCl?)

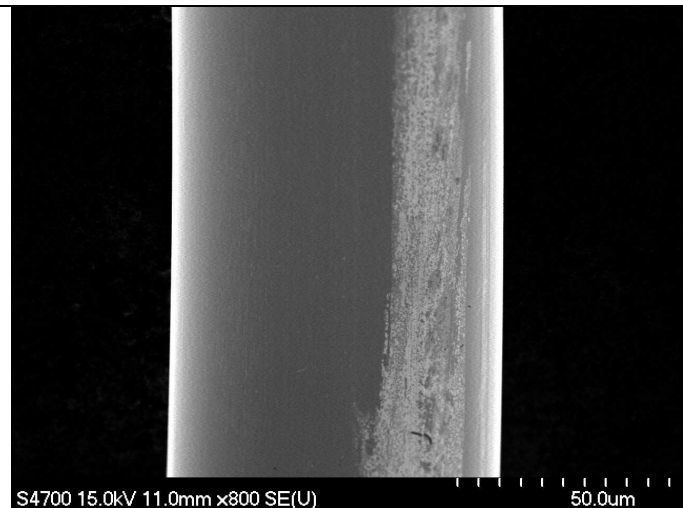
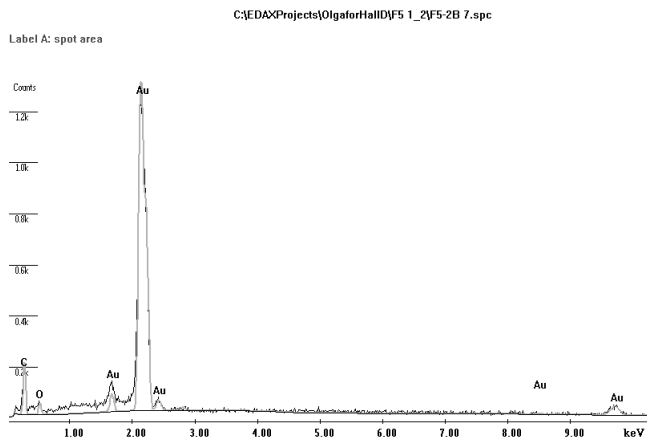
F5-2B-7 Surface contamination.

EDS Analysis. Surface contamination. Environmental.

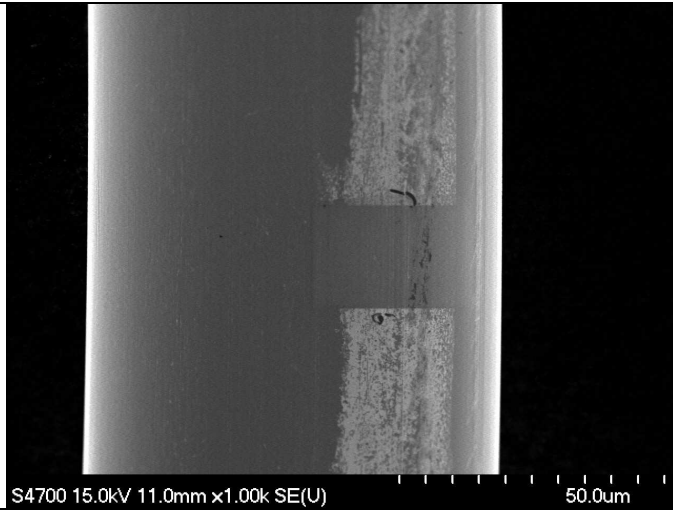
F5-2B-8 After EDS analysis.

Electron beam eliminated contamination layer o the spot of exposure during the EDS analysis.
