# Hall D Wire Characterization

## Samples F8-1 & F8-2

# Sample F8-1 A, B

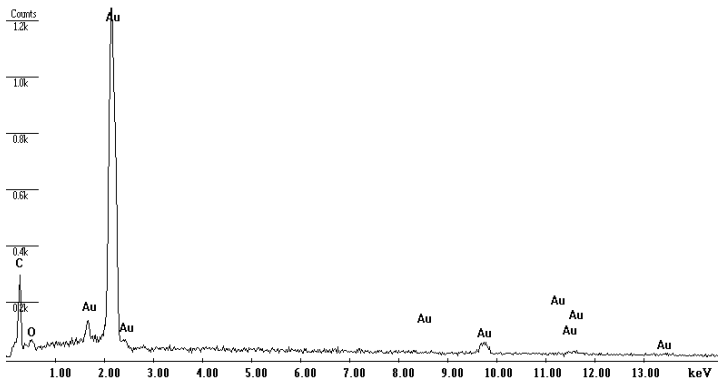
<p style="text-align: center;">EDS Analysis. Scratch. No Cu found.</p>
<p style="text-align: center;">F8-1A-4 Minor scratches.</p>	<p style="text-align: center;">F8-1A-8 Scratches and contamination.</p>

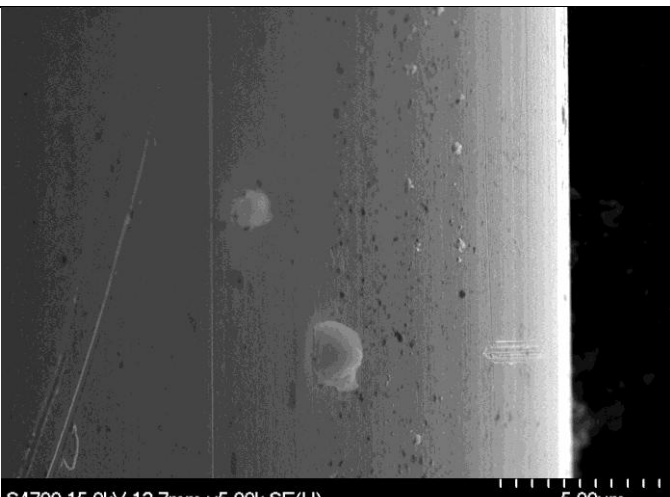
<p style="text-align: center;">Magnification: 5990x</p>	<p style="text-align: center;">F8-1B-5 Environmental contamination</p> <p style="text-align: center;">C:\EDAXProjects\OlgaforHallID\F8 1_2\F8-1b 5 typical cont.spc</p> <p>Label A: spot area</p>

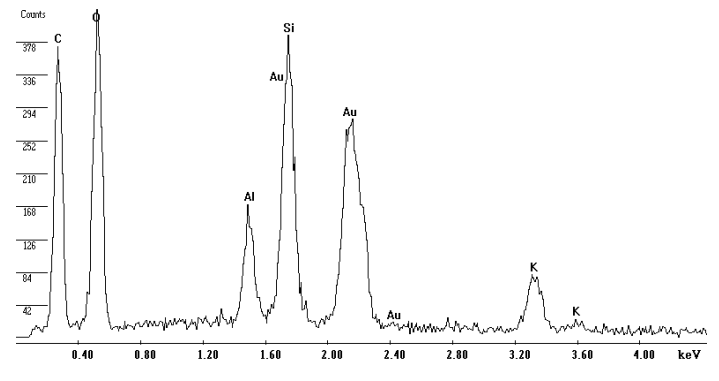
<p style="text-align: center;">EDS Analysis. Typical surface contamination</p>

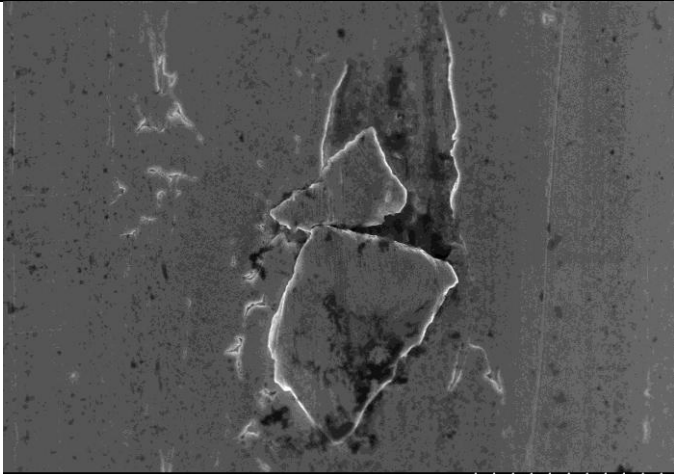
<p>F8-1B-10 Surface damage</p>

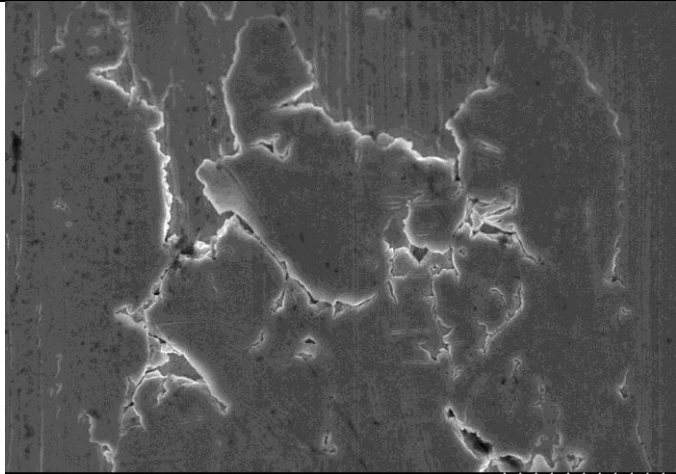
<p>S4700 15.0kV 12.6mm x3.50k SE(U) 10.0um</p>	<p>F8-1B-7 Surface damage</p>

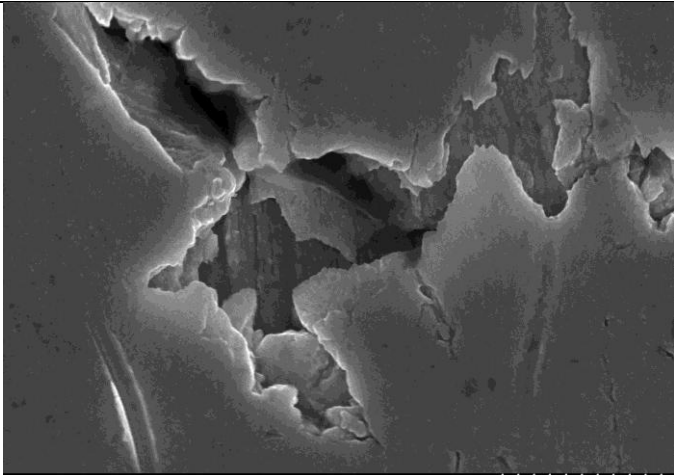
<p>S4700 15.0kV 12.6mm x6.00k SE(U) 5.00um</p>
<p>Magnification: 3500x</p>	<p>Magnification: 6000x</p>
<p>F8-1B-7 Surface damage. High mag</p>

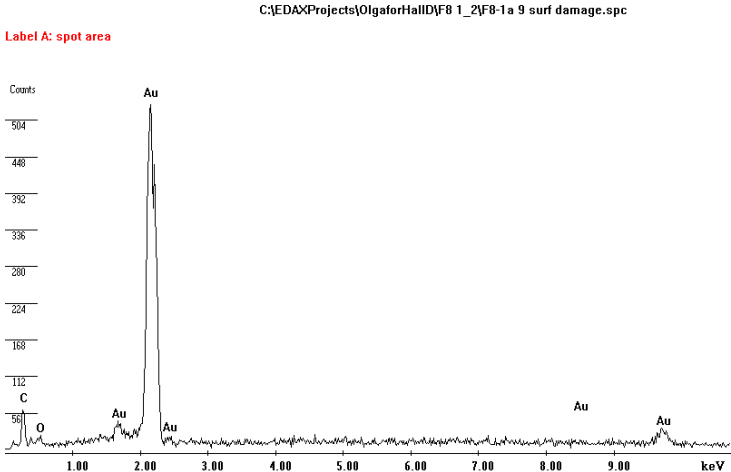
<p>C:\EDAX\Projects\OlgaforHallID\F8 1_2\F8-1a 9 surf damage.spc</p> <p>Label A: spot area</p> <p>Cents</p> <p>504</p> <p>448</p> <p>392</p> <p>336</p> <p>280</p> <p>224</p> <p>168</p> <p>112</p> <p>C</p> <p>56</p> <p>O</p> <p>Au</p> <p>Au</p> <p>Au</p> <p>Au</p> <p>Au</p> <p>keV</p>
<p>Magnification: 30000x</p>	<p>EDS Analysis. Surface damage. No Cu found.</p>

- 1) No traces of Cu within the damaged area were indicated by the EDS analysis (detection limit ~1%).

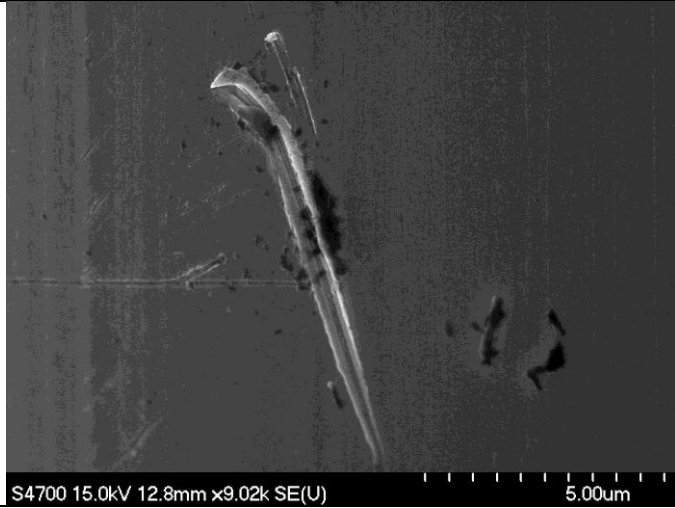
F8-2A-5 Scratch and contamination.

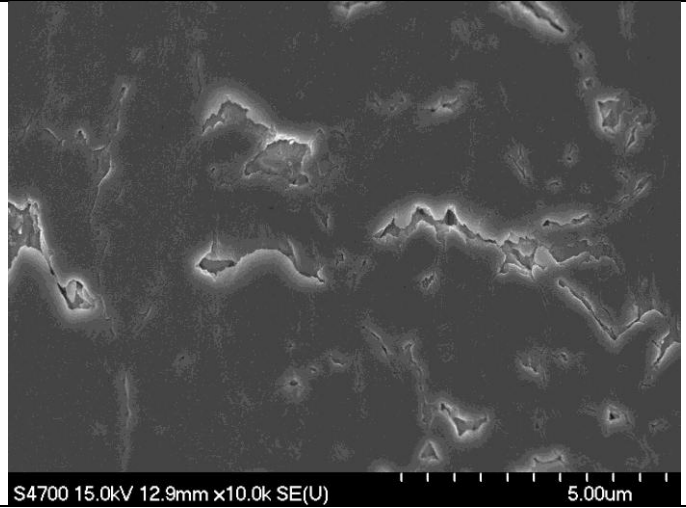
F8-2A-8 Surface damage.

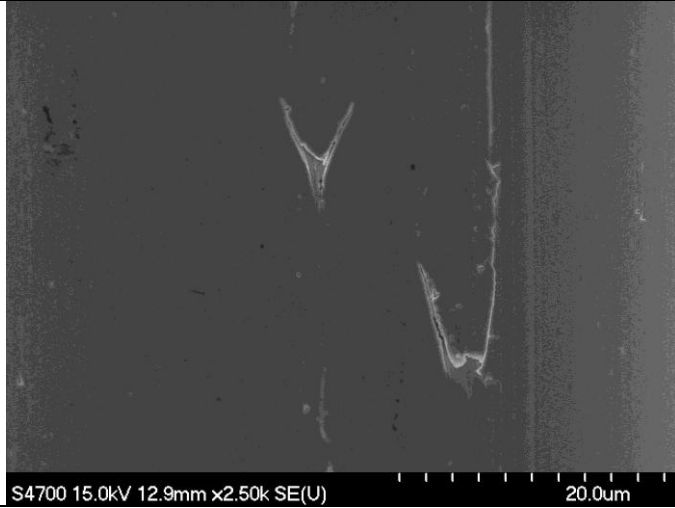
F8-2B-6 Surface damage.

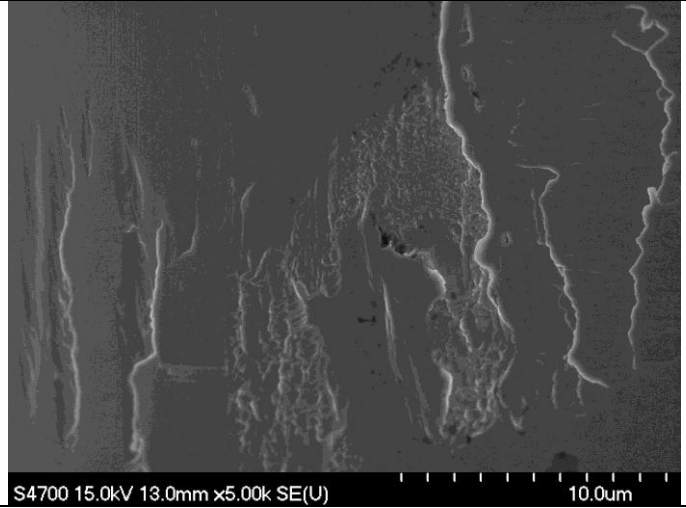
F8-2B-4 Surface damage.

EDS Analysis. Surface damage. No Cu.

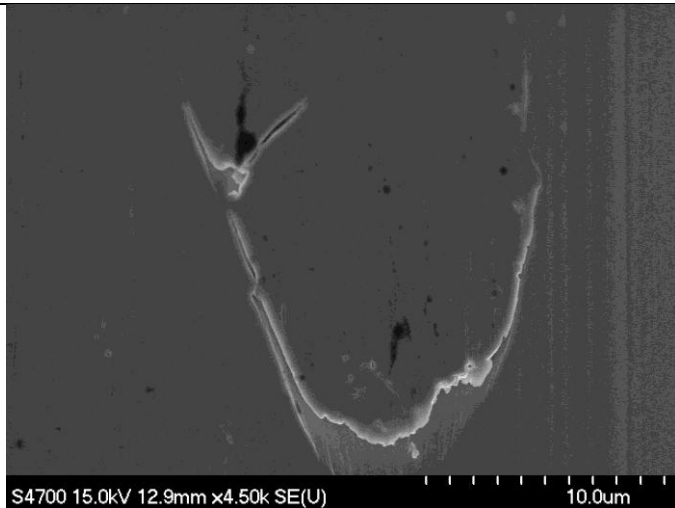
F8-2B-7 Details of surface structure.
