Hall D Wire Characterization

Samples S4-1 & S4-2

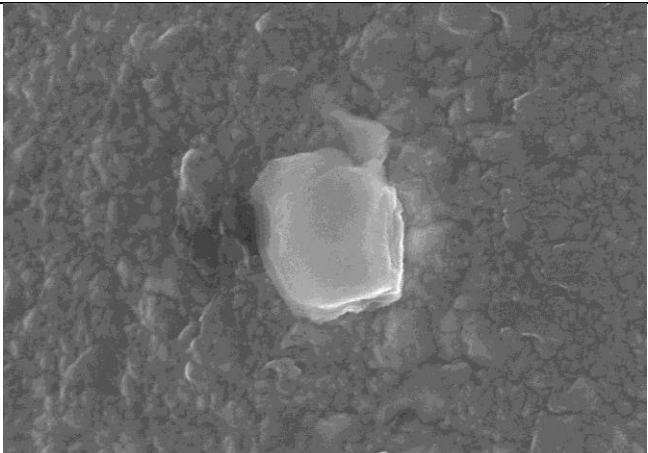
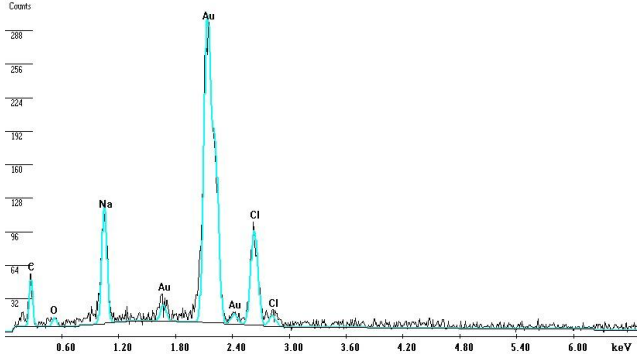
<p style="text-align: center;">S4-1A-3</p>

<p>Counts</p> <p>288 256 224 192 160 128 96 64 32 0</p> <p>0.60 1.20 1.80 2.40 3.00 3.60 4.20 4.80 5.40 6.00 keV</p>
<p style="text-align: center;">Magnification: 40000x</p>	<p style="text-align: center;">EDS Analysis. Surface contamination (NaCl?)</p>
<p style="text-align: center;">S4-1A-4 Surface damage</p>

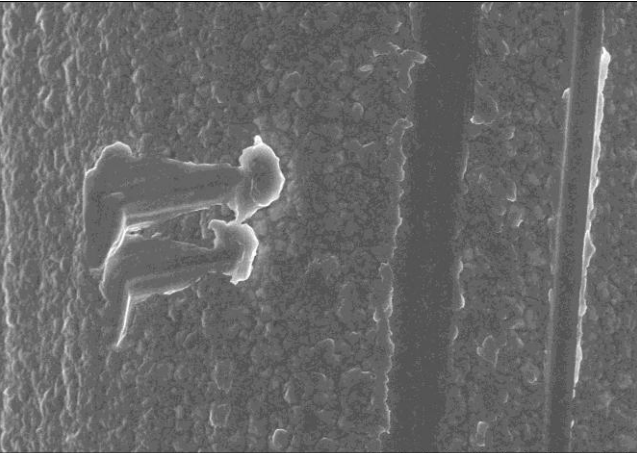
<p>S4700 15.0kV 13.1mm x8.00k SE(U) 5.00um</p>	<p style="text-align: center;">S4-1A-6 Surface damage</p>

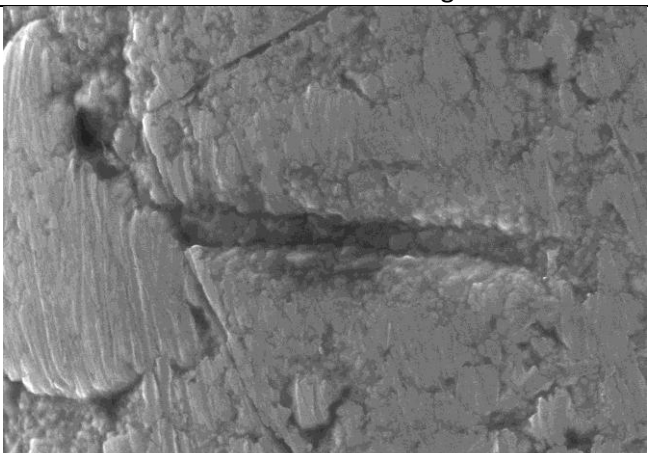
<p>S4700 15.0kV 13.2mm x10.0k SE(U) 5.00um</p>
<p style="text-align: center;">Magnification: 8000x</p>	<p style="text-align: center;">Magnification: 10000x</p>
<p style="text-align: center;">S4-1A-7 Surface damage</p>

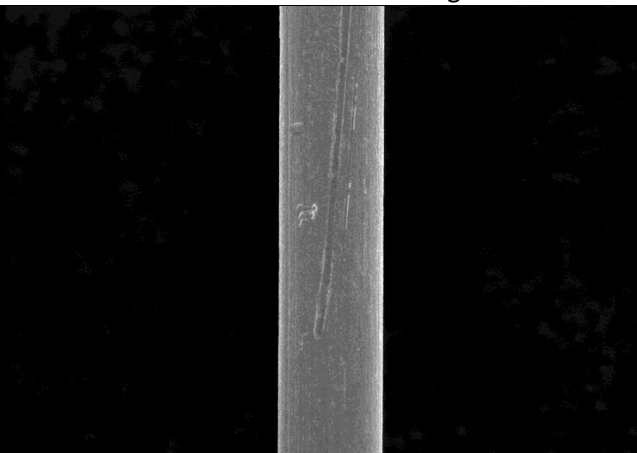
<p>S4700 15.0kV 13.4mm x25.0k SE(U) 2.00um</p>	<p style="text-align: center;">S4-1A-5 General view of damaged area</p>

Note. No **W** was indicated by EDS scan in the damaged area (detection limit ~ 1%).

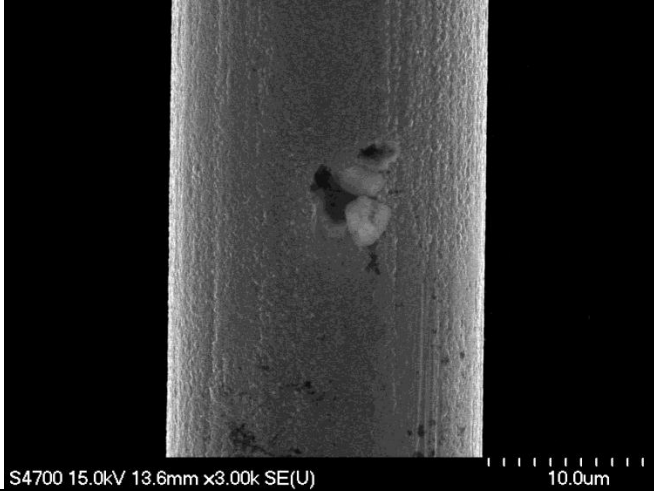
S4-1B Environmental contamination

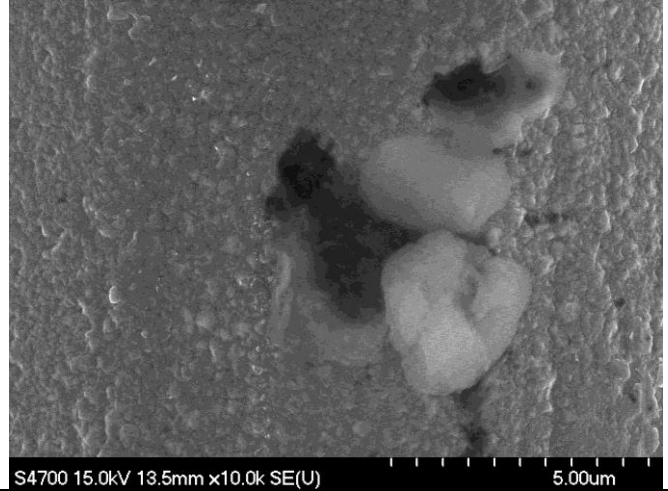
S4-1B Environmental contamination

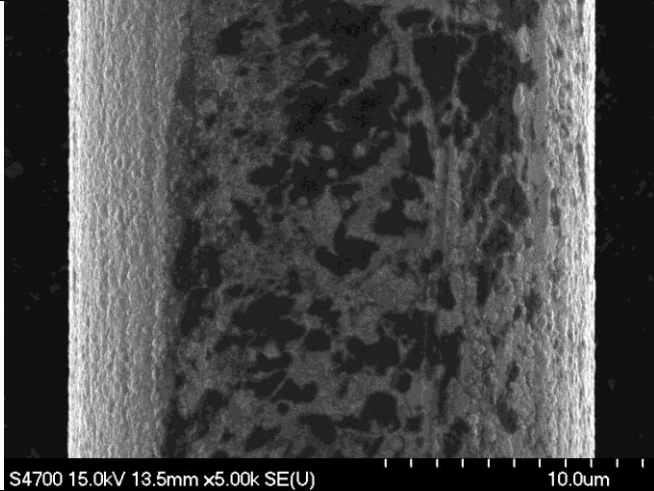
S4-1 B Black spot (carbon contamination)

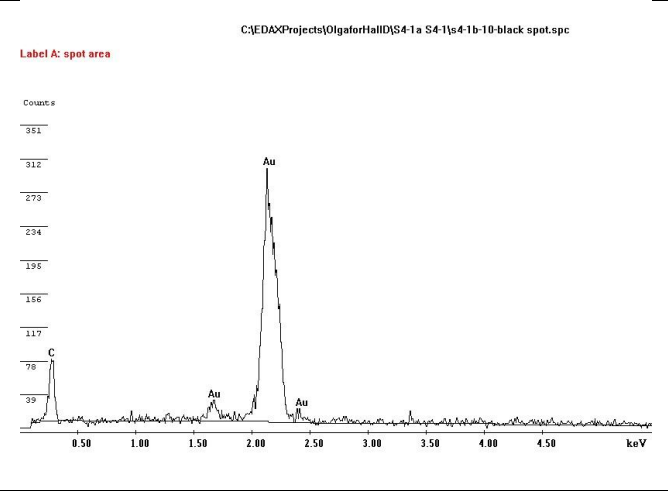
S4-1 B Black spot (carbon contamination)

EDS Analysis of black spot region (at 130Kx)

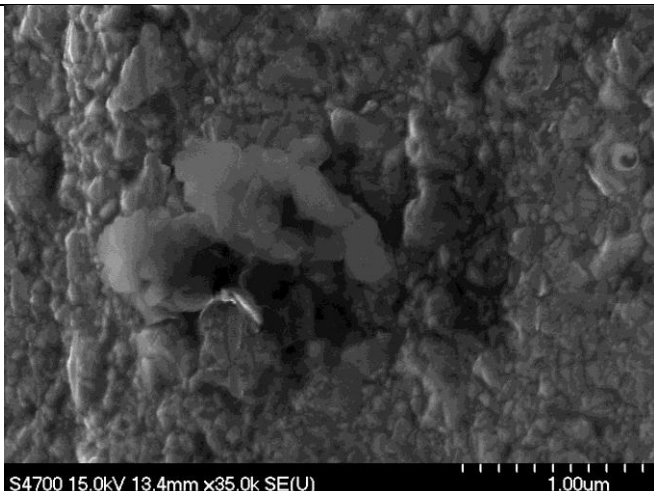
S4-1B Environmental contamination

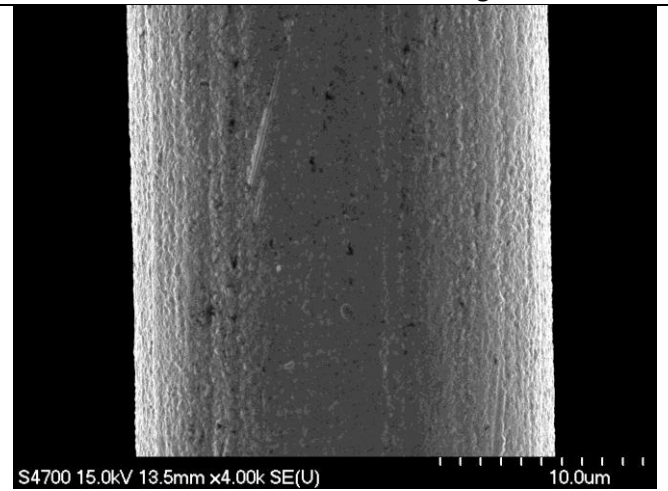
S4-1B Minor surface damage

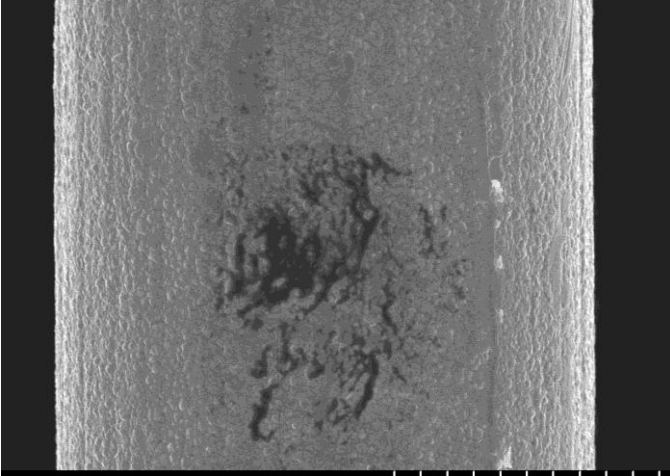
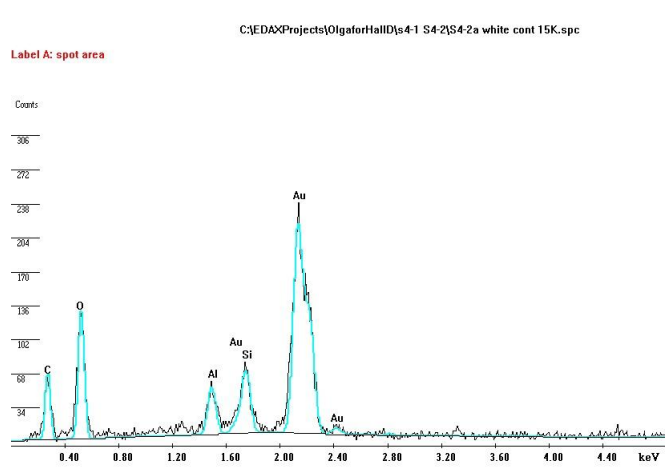
<p style="text-align: center;">S4-2A-6</p>

<p style="text-align: center;">EDS Analysis. Surface contamination (white spot)</p>
<p style="text-align: center;">S4-2A-6 Surface structure (high mag, white at low mag)</p>	<p style="text-align: center;">S4-2A-4 Flake-like contamination. Environmental.</p>

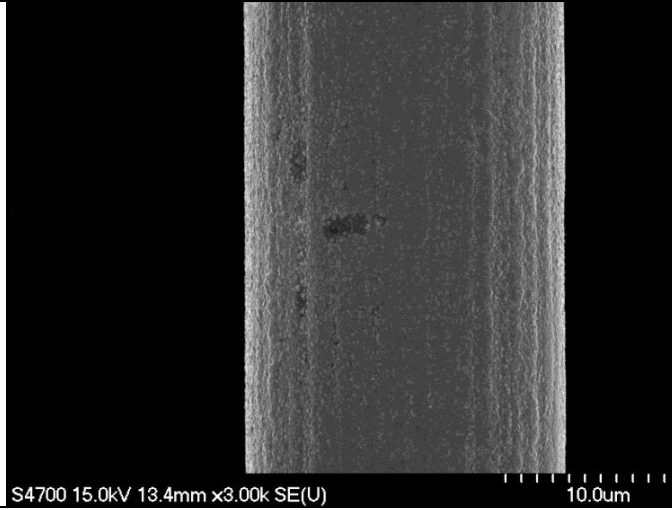
S4-2B-5 Surface imperfection

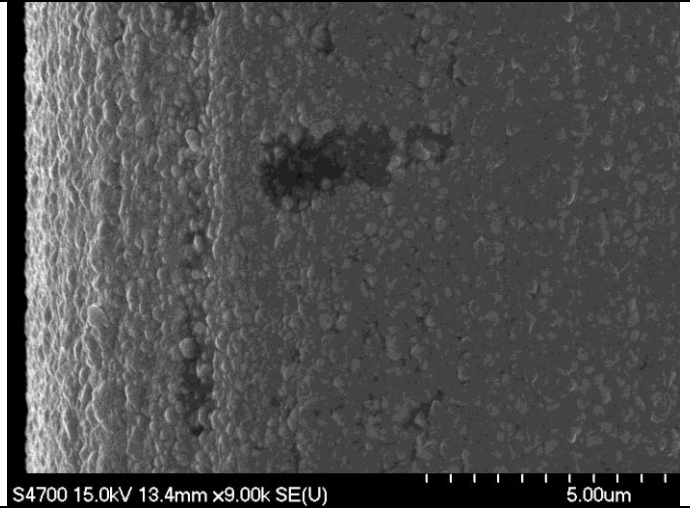
S4-2B-6 Surface imperfection: some grains of coating are sticking out

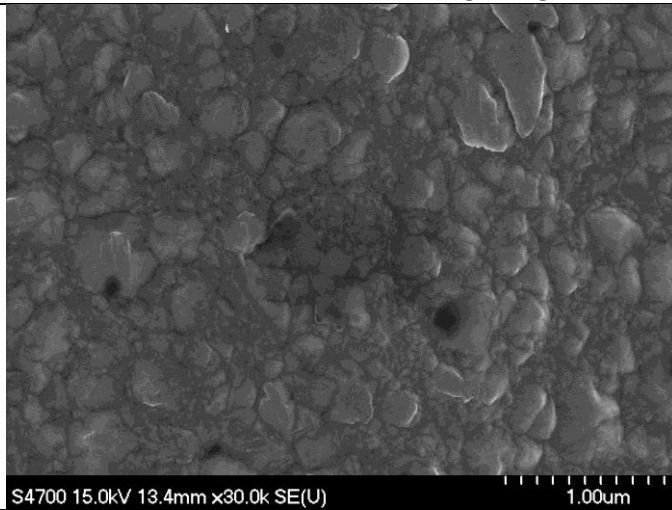
S4-2A-6 Surface structure (high mag)

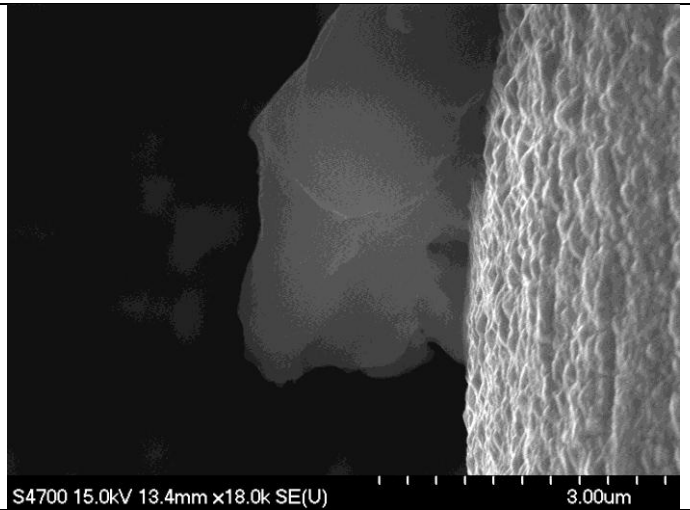
S4-2A-4 Flake-like contamination. Environmental.

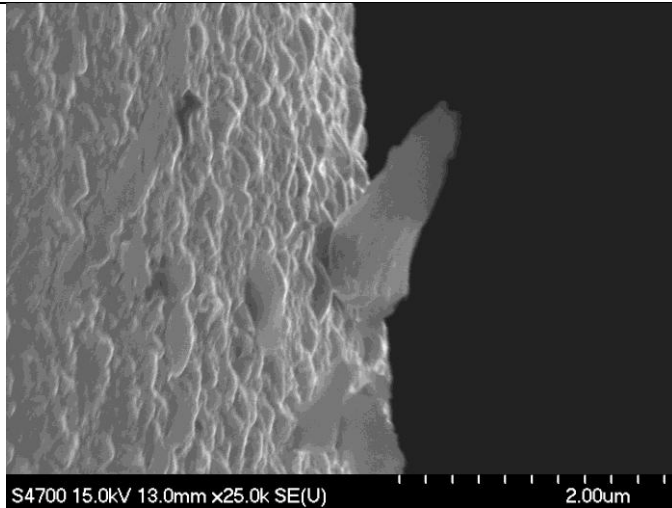
S4-2A Needle-like contamination. Environmental.

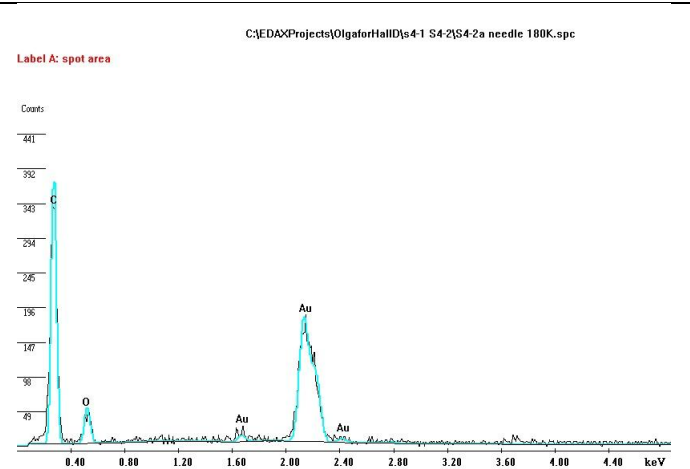
S4-2A EDS analysis of needle-like contamination

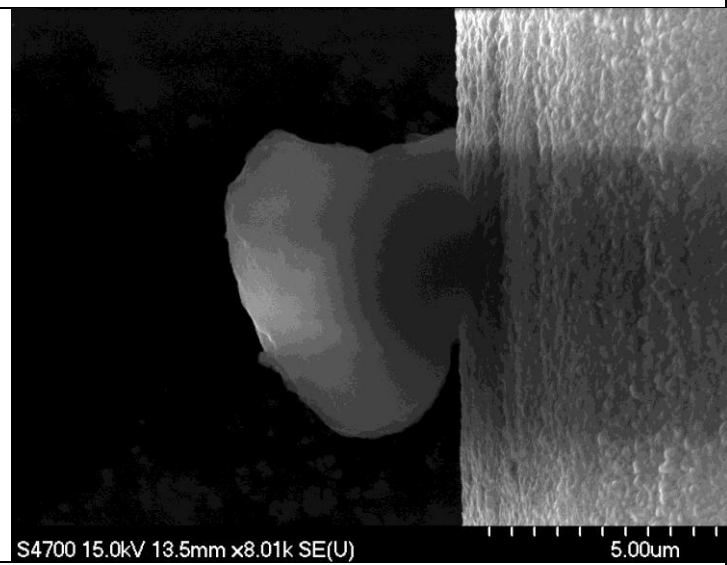
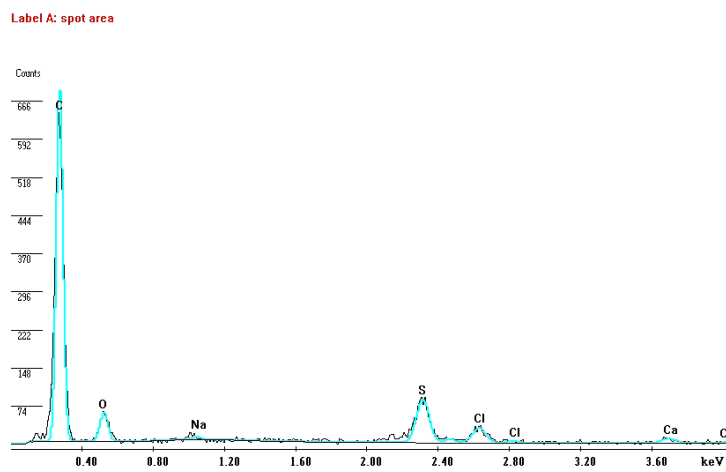
S4-2B-2 Flake-like contamination

EDS Analysis. Surface contamination (flake).
Environmental.
