80 μm Gold-coated Wire. Hall D. FE SEM & EDS Characterization Report.

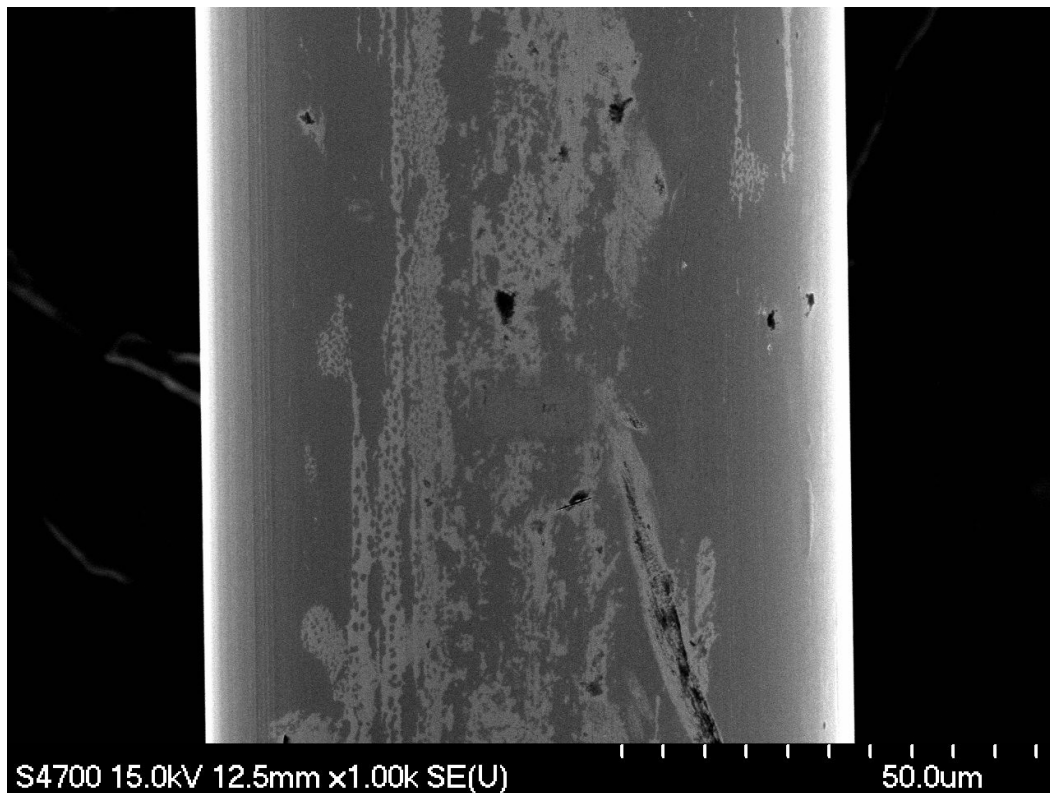
1) Pic1. Sample image at 1Kx magnification.

As observed, wire sample has some surface contamination. Partly, this contamination layer could be “burned off” by an electron beam at high magnification after prolonged exposure (see clear rectangular spot in the center of the image). Contamination layer was observed EVERYWHERE on the sample surface: some places were cleaner than others, but not a single part of wire completely contamination-free was found.

As shown below, contamination is most probably of environmental origin. Contaminated areas contained substantial amount of carbon while clean spots were practically carbon-free, as shown by the EDS analysis.

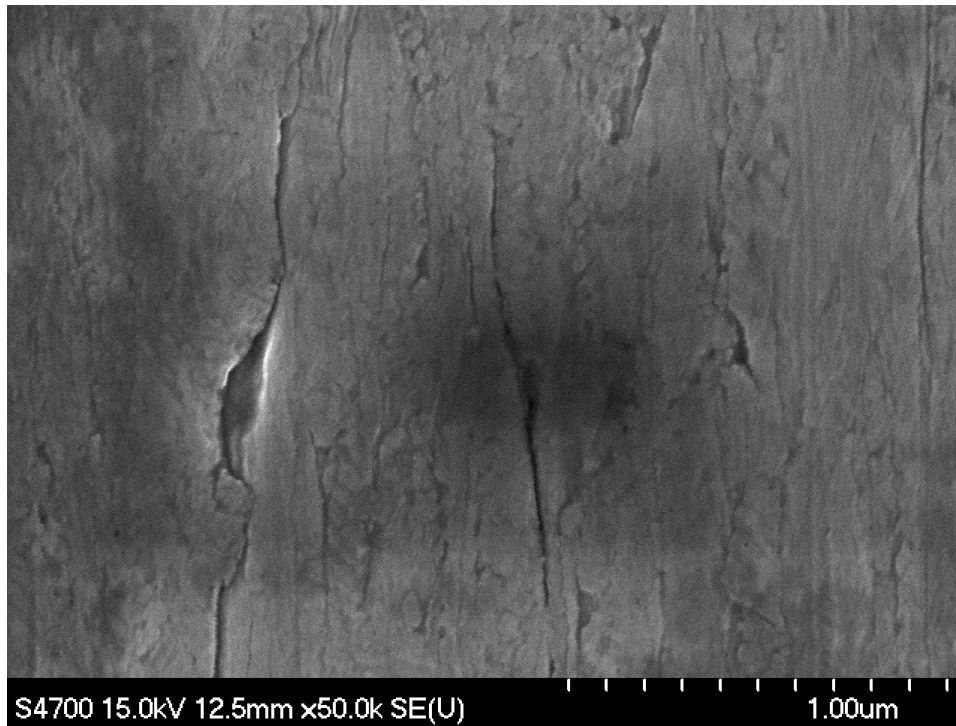
Pic2. High magnification (50Kx) image of contamination-free surface area. Surface details.

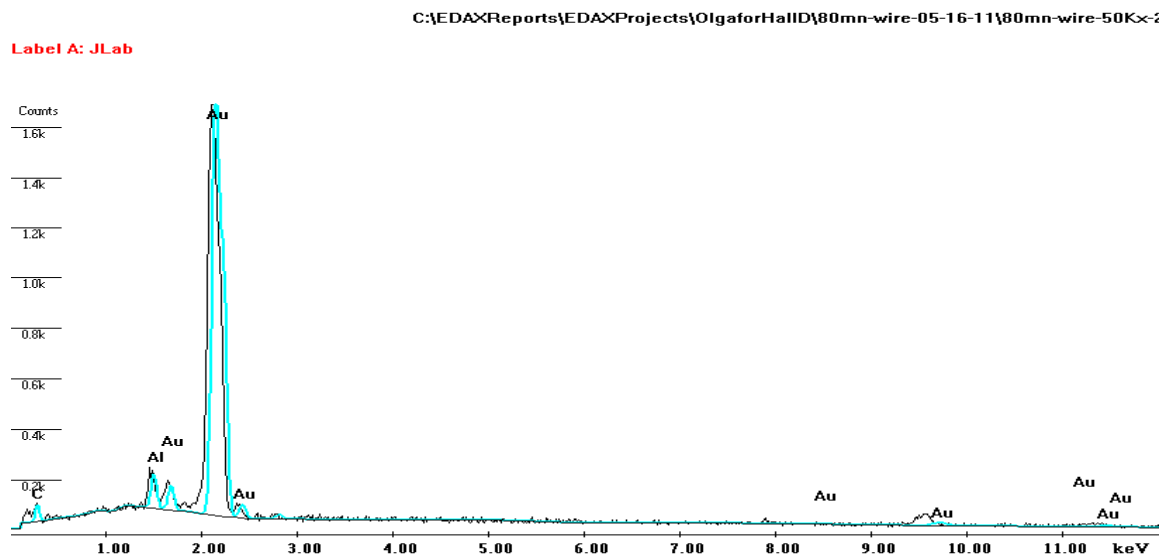
Pic3. Corresponding EDS spectrum. Carbon peak is close to noise level. Beam energy – 50KeV, filament current – 10μA.

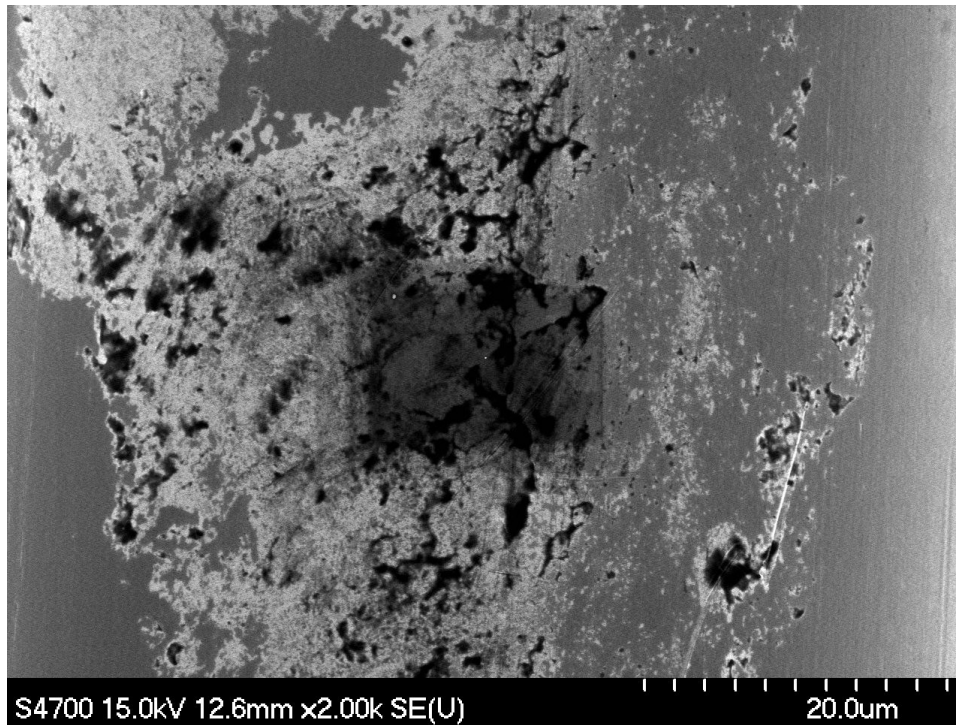
Pic4. General view of contaminated area. Magnification 2Kx. Darkened area is where EDS scan was taken.

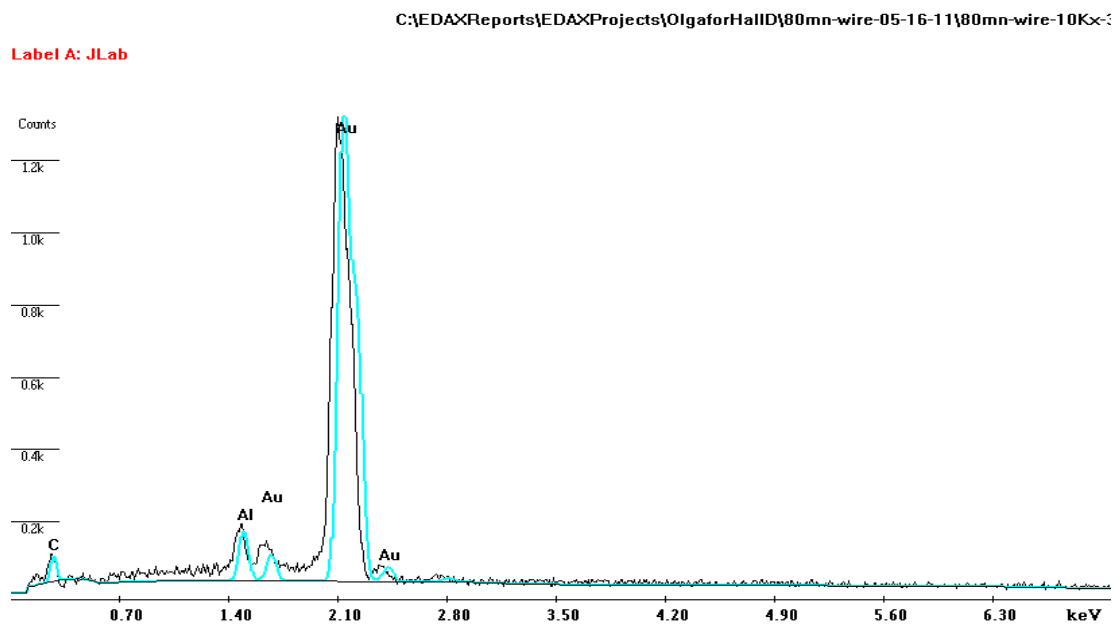
Pic5. Corresponding EDS spectrum, mag. 10Kx. Carbon peak is pronounced.

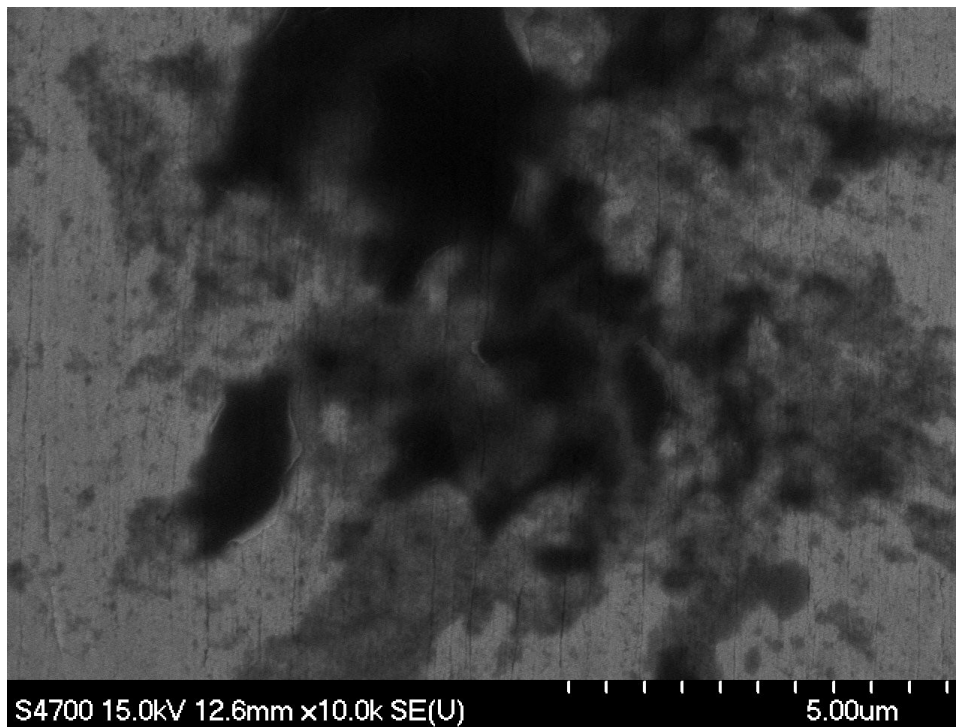
Pic6. Another contaminated area at 10Kx magnification.

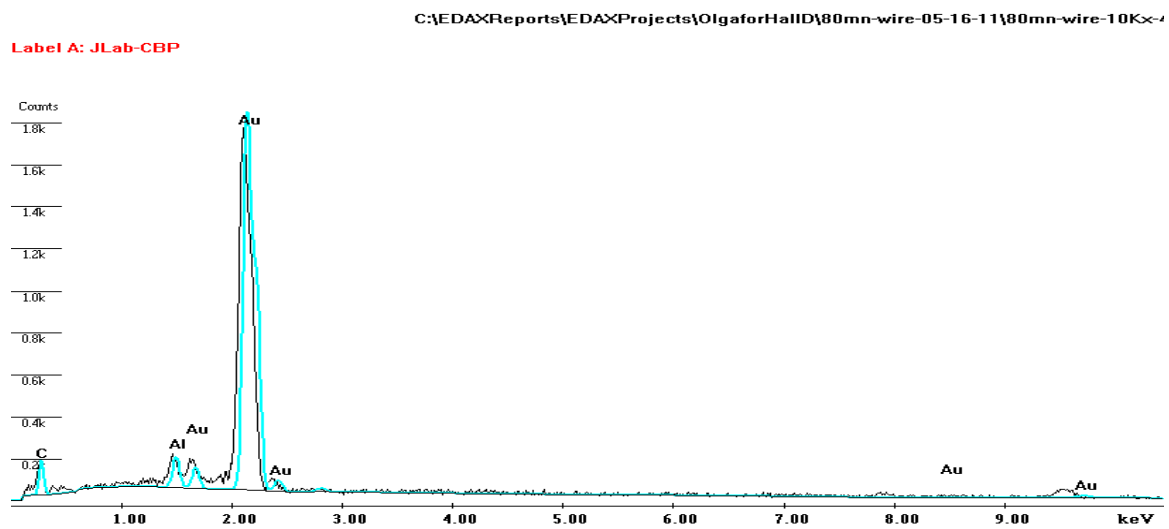
Pic7. Corresponding EDS spectrum, mag. 10Kx. Carbon peak is pronounced.

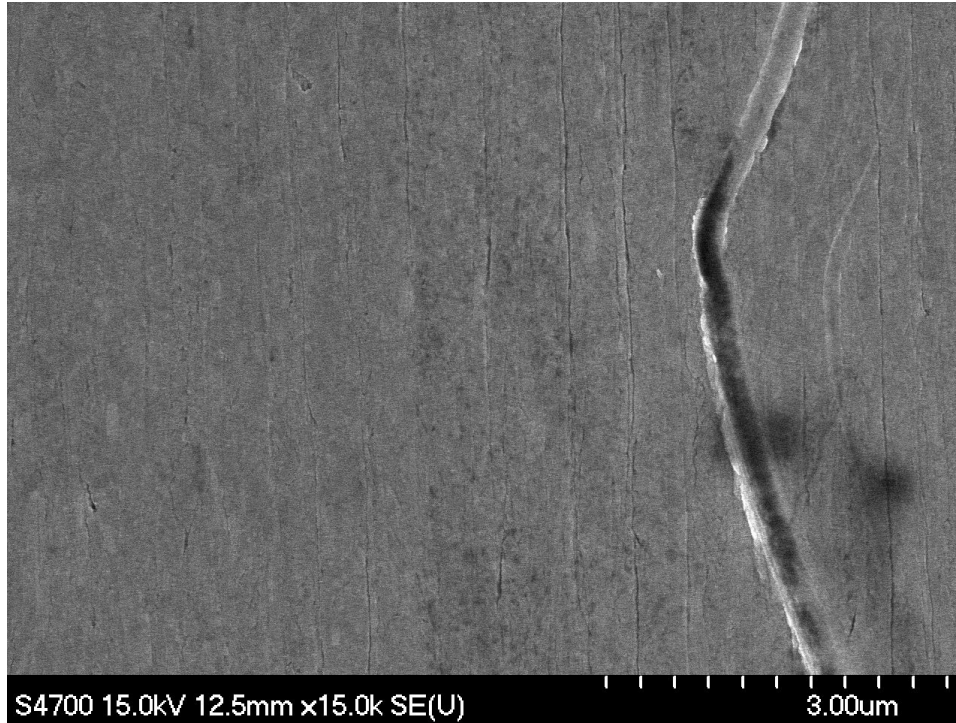
Pic8. Magnification 15Kx. Contamination-free surface area. Surface detail.

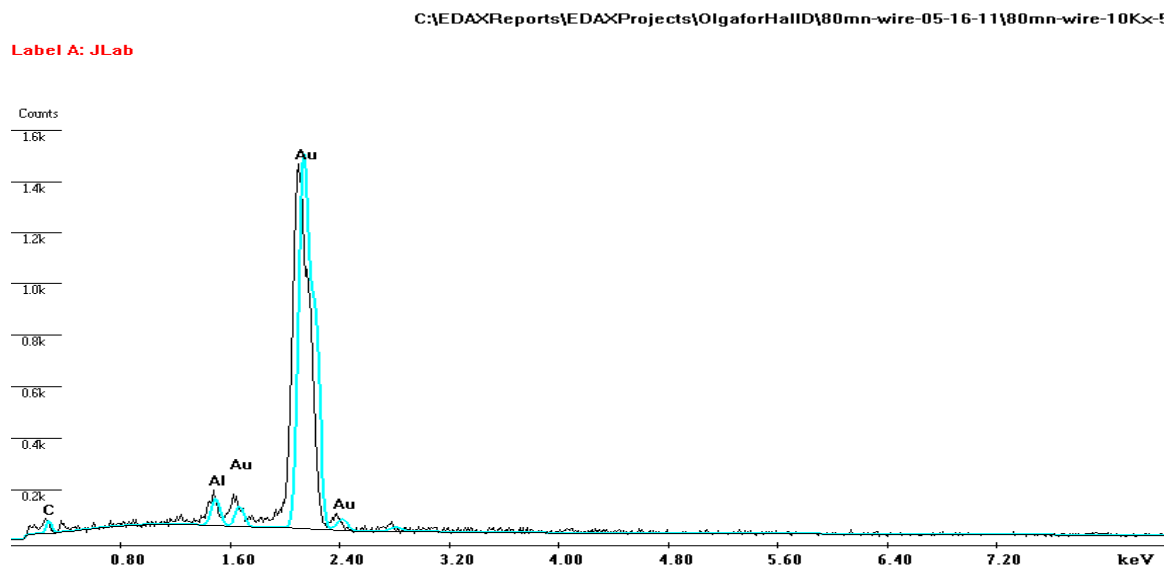
Pic9. Corresponding EDS spectrum, mag. 10Kx. Carbon peak is at noise level.

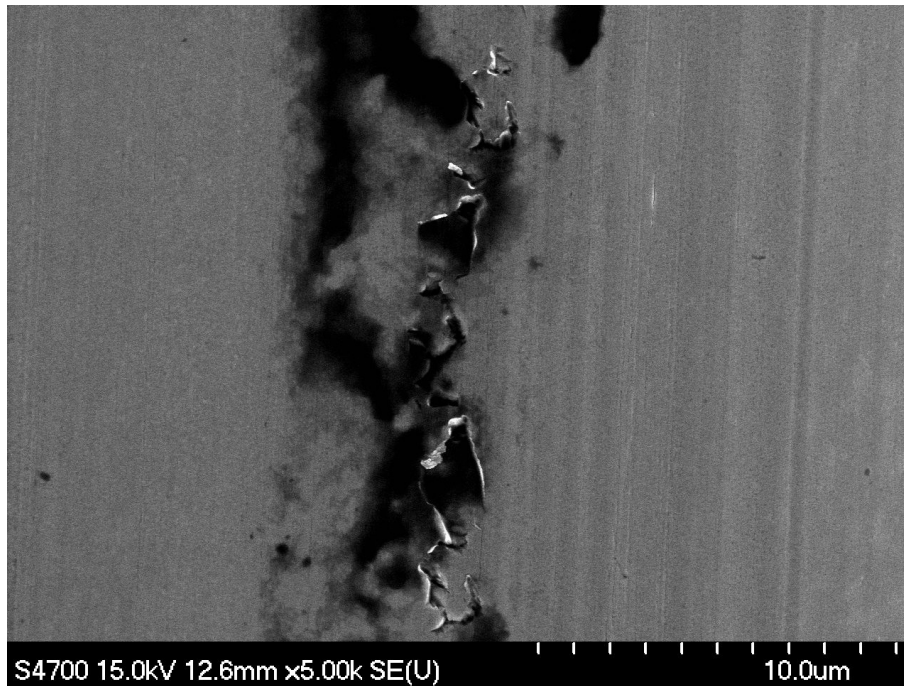
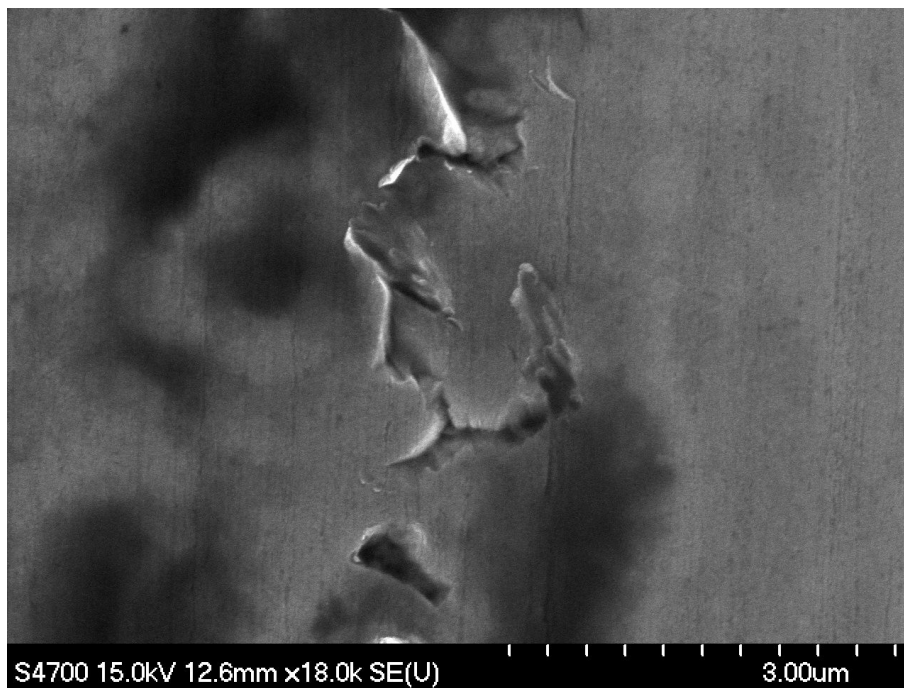
Pic10, pic11. Detailed view of some contaminated areas.

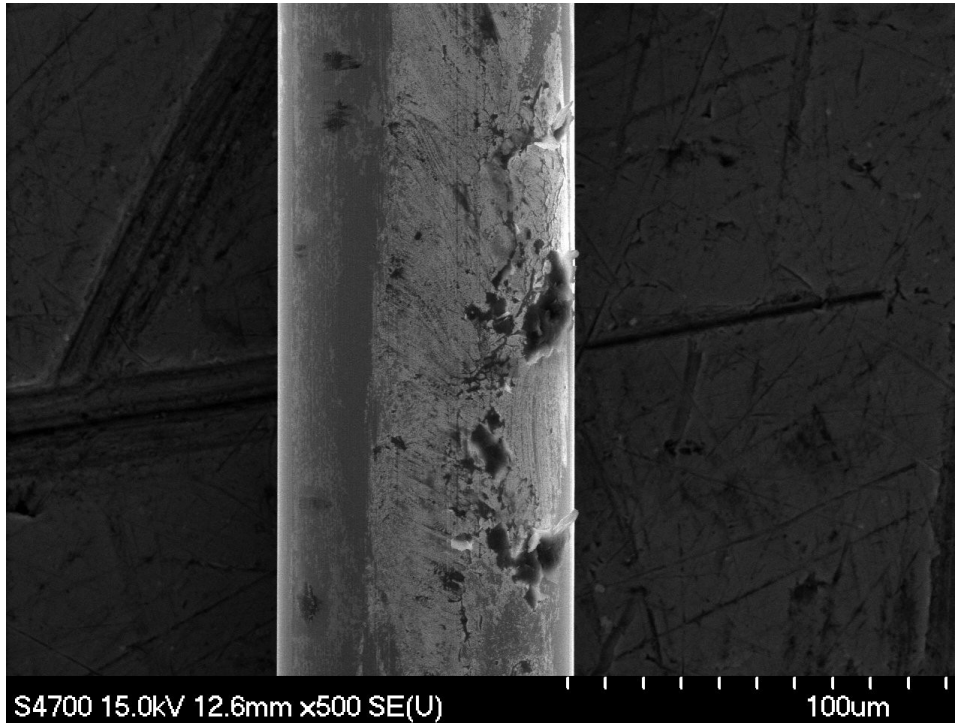
Pic12. General view of contamination on wire at low magnification (500x).

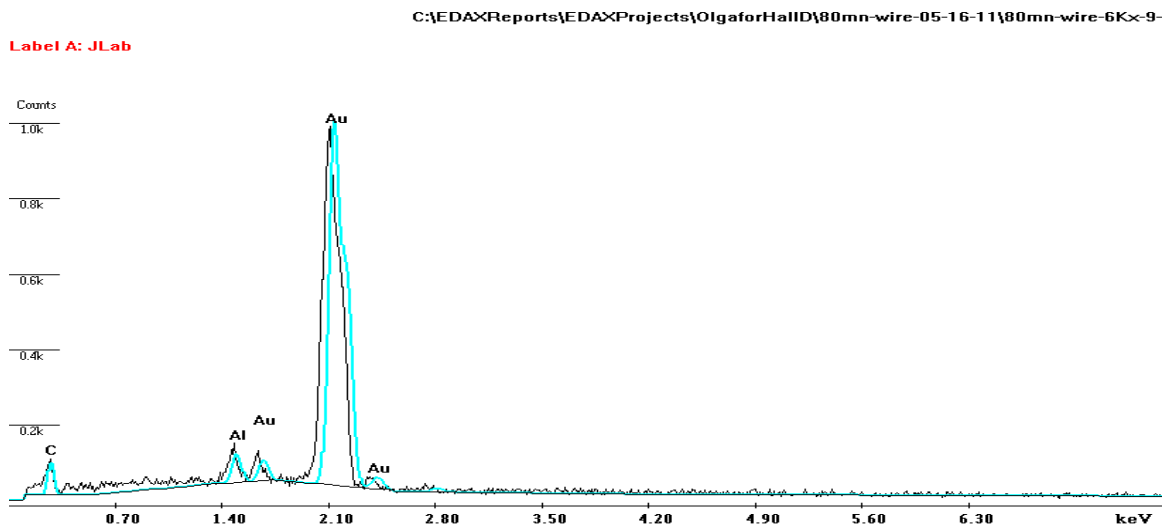
Pic13. EDS spectrum of contaminated part of the surface , mag. 10Kx. Carbon peak is pronounced.
