Department of Energy
Thomas Jefferson Site Office
12000 Jefferson Avenue
Newport News, Virginia 23606

March 19, 2008

**Final Report
Rigging and Material Handling Surveillance
at the
Thomas Jefferson National Accelerator Facility
January 2008**

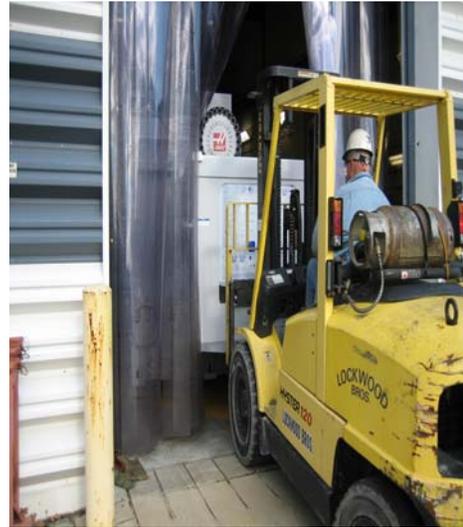
In conjunction with the milling machine lift at Building 90, the subcontractors transported to the site a company-owned forklift (Hyster 120). The forklift was used to push the milling machine into position in conjunction with industrial rollers. There was no evidence that a pre-shift (or post-delivery) inspection had been conducted by the subcontractor as required by 29 CFR 1910.178 (q) (7). The SOTR intervened to have the subcontractor install a more substantial fuel tank restraint, as a single bungee cord (orange-elastic strap) was initially being used as the propane tank restraint. The substitution of a substandard restraint (elastic strap versus factory metal strap) by the subcontractor is a violation of the OSHA standard for powered industrial trucks, 29 CFR 1910.178 (q) (6). **(FIND-P2-001)**

Figure 1. Lockwood Forklift

FIND-P2-001	The substitution of a substandard restraint (elastic strap versus factory metal strap) by the subcontractor is a violation of the OSHA standard for powered industrial trucks (29 CFR 1910.178 (q) (6)).
FIND-P2-002	Records being maintained for crane hook monthly inspections do not document the status of the crane hook in accordance with 29 CFR 1910.180 (d)(6) for mobile cranes.
FIND-P2-003	The e-mail process used by the Laboratory to satisfy monthly wire rope inspection records for overhead cranes does not meet the requirements of an inspector's signed and dated record of the specific wire rope being certified 29 CFR 1910.179.(m)(1).
FIND-P2-004	Modification of an overhead crane was not adequately tested (inspected) to ensure safety device functionality (missing audible or visual warning signal), per 29 CFR 1910.179 (k)(1)(i)(d), and 29 CFR 1910.179 (i).
FIND-P3-001	The records on file with the Lab's procurement office do not include evidence of crane inspector qualifications as specified in the subcontractor's Blanket Order Agreement.

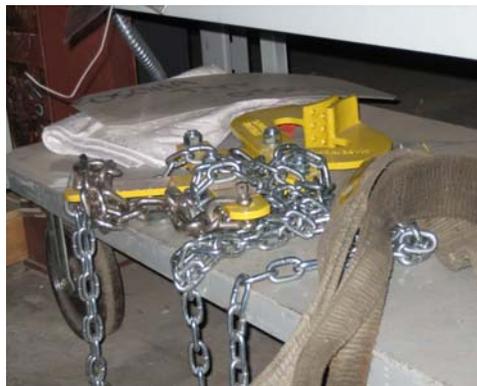
lighting, and storage rack loading appeared to be adequate. The rigging hardware being used at this location was reportedly limited to horizontal material pulling. This rigging hardware includes some nylon slings, with abrasions consistent with dragging items across the floor, and is subject to shock loading, since loads moved horizontally are not freely suspended.

Rigging used for towing applications at the Blue Crab Warehouse are not uniquely identified/distinguished from other hardware, as to prevent future use for overhead lift applications. Rigging articles that are used for horizontal pulling (dragging material) are subjected to shock loading conditions which are a cause for disqualifying rigging equipment for use in overhead lifts (DOE-STD-1090-2007, 11.3.5.3 and 12.2.8). **(FIND-P3-003)**

Figure 2. Tow Straps and Slings Stored at Blue Crab Warehouse

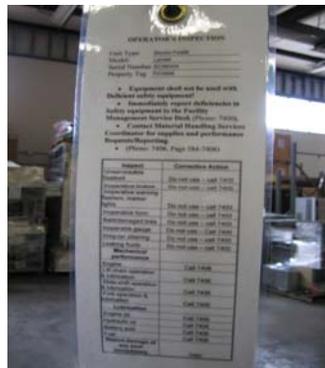
The pre-use inspection checklist for forklifts used at Blue Crab and elsewhere at the Laboratory are not consistent or comprehensive relative to the make and model specific pre-use inspection criteria from the manufacturer; as such, some elements of the equipment operation may be overlooked during the pre-use review. The Laboratory's ES&H Manual, Appendix 6145-T-1, likewise includes the instruction to "... use the appropriate operator daily checklist." **(FIND-P3-004)**

Figure 4. JLab Forklift Inspection Generic Checklist

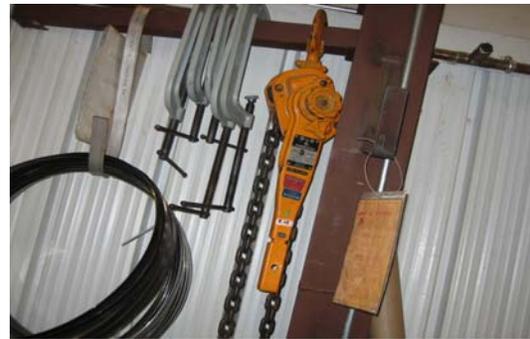
The subcontractor responsible for conducting crane and lifting equipment inspections does not use the same inspection stickers across the Lab. In some cases the stickers indicate the due date for the next annual inspection, whereas other equipment was labeled with the date the inspection was performed. This condition can create confusion among the user groups if they do not pay very close attention to the wording on these small stickers. **(FIND-P3-007)**

Figure 6. Inspection Sticker Example

FIND-P3-007	The subcontractor responsible for conducting crane and lifting equipment inspections did not use the same inspection stickers across the Lab.
FIND-P3-008	Annual crane and hoist inspection records contain notes highlighted by the inspector for equipment conditions that warrant “monitoring”. These notes are not being shared with the cognizant building managers or crane operators.
FIND-P3-009	Several half-inch rigging shackles were available for use in the Building 90 machine shop tool crib without manufacturer’s markings preventing traceability to a recognized standard, as required in Chapter 3410 of the Laboratory’s ES&H Manual.
FIND-P3-010	The manufacturer’s capacity markings were obliterated on a forklift boom attachment stored outdoors adjacent to Building 8, and equipment of this type should be included within an inspection program.
FIND-P3-011	A worker whose forklift training had expired several months ago was able to use his pass code to access the keys to a forklift that were contained inside an electronic lock-box.

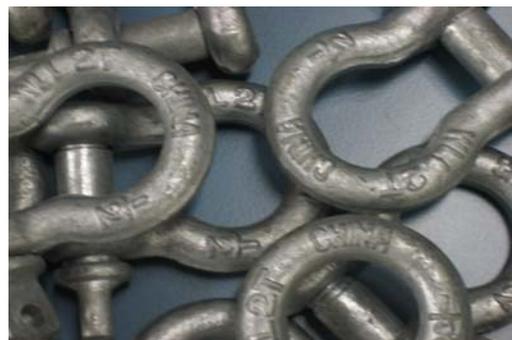
During the interview with the Supervisor of the South Machine Shop in Building 90, several half-inch rigging shackles were identified in the tool crib and available for use. These shackles were without manufacturer marks (forge marking were limited to "China" and the Working Load Limit), preventing traceability to a recognized standard as required in Chapter 3410 of the Laboratory’s ES&H Manual.

FIND-P3-009)

Figure 7. Half-Inch Rigging Shackles Located in Building 90

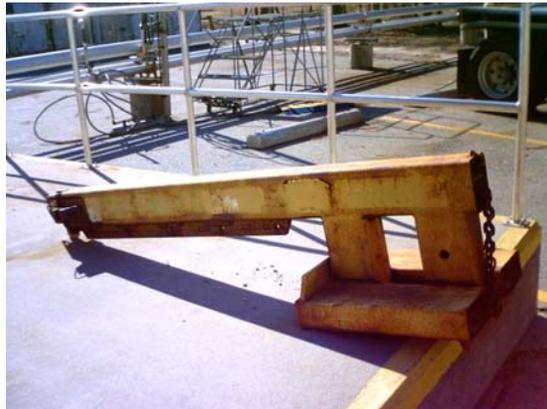
During a visit to the field, a forklift boom attachment was observed being stored outdoors adjacent to Building 8 (CHL). The combination of rust and previous paint application has obliterated the manufacturer's capacity markings and user instructions. This type of material handling equipment should be included within an inspection program. **(FIND-P3-010)**

Figure 8. Forklift Boom Attachment

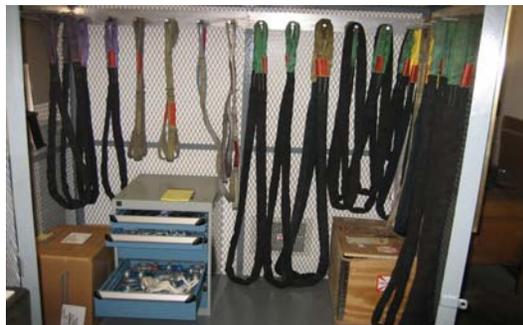
Through the course of visiting several locations where rigging equipment was available for use, the storage practices of rigging hardware were considered exemplary in most instances. **(PRO-002)**

Figure 9. Rigging Hardware Storage
