Torus

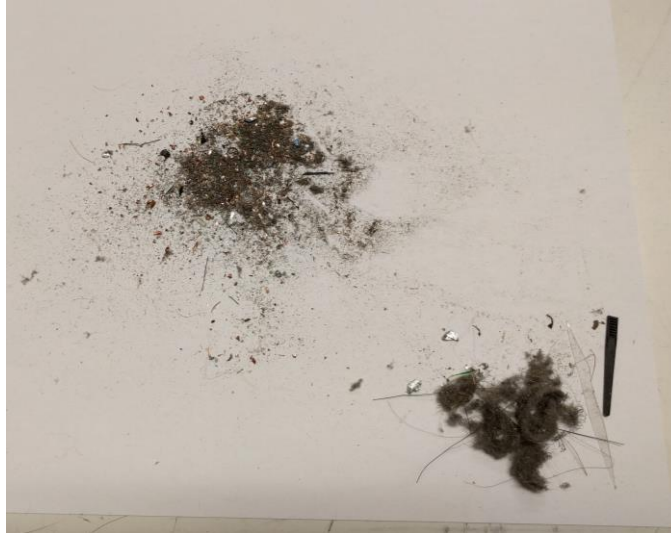
- MPS internal faults investigated after Fast dump on the Torus and cross bars circuits were burned.
 - * Found metallic debris inside, most likely from machining work.
 - * Inside of MPS cleaned and debris collected.

Debris found in MPS.

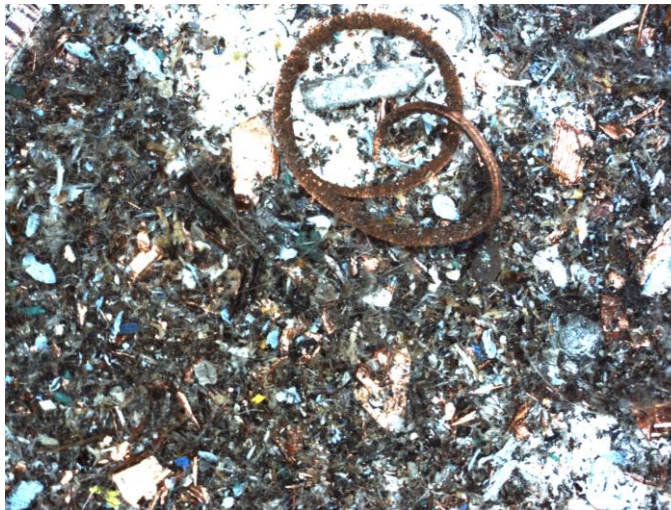
Debris found in MPS; long copper coil is ~6 mm in diameter.
