Analysis of Hall B Solenoid Load Cells' Readings during Fast Dumps

Physics Division, Thomas Jefferson National Accelerator Facility, Newport News, VA 23606

January 10, 2019

As of October 23, 2018, the Hall B Solenoid has had 19 fast dumps, prompting an investigation into whether the loads on structural components of the Solenoid changed as a result of these fast dumps. This note discusses the results of the investigation.

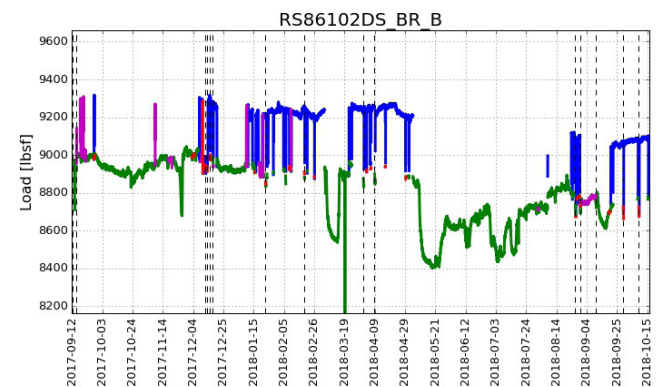
FIG. 2. Plot for radial load cell RS86102DS_BR_B showing coloring for Hall B Magnets System's different states. Vertical dashed lines indicate Solenoid fast dumps. Breaks in plot are a side effect of masking used to color plots.

cell values and the power state of the Hall B Torus. When Torus is powered and is at full field, all load cells read ~400 lbsf greater than when Torus is not powered. This difference in readings is expected because the Solenoid is within the field of the Torus.

2. There does not appear to be an overall trend in the load cell values due to the fast dumps. However, the load cell values changed over three different periods. From September 2017 to mid-July 2018, there was a decreasing trend in load cell values. During Summer 2018, there was a large change in all load cell readings, most likely due to the Solenoid warming to and remaining at 80 K for an extended period of time. From mid-August 2018 to present, there was a slight increasing trend in radial load cell values and a slight decreasing trend in axial load cell values. It has been determined that the changes in load cell readings and their trends are not significant and should not be concerning.

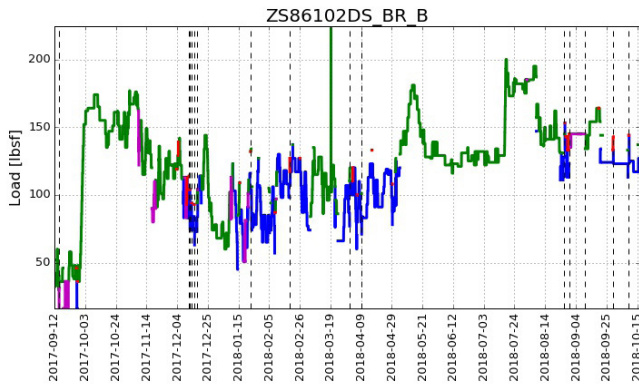
FIG. 3. Plot for axial load cell ZS86102DS_BR_B showing coloring for Hall B Magnets System’s different states. Vertical dashed lines indicate Solenoid fast dumps. Breaks in plot are a side effect of masking used to color plots.

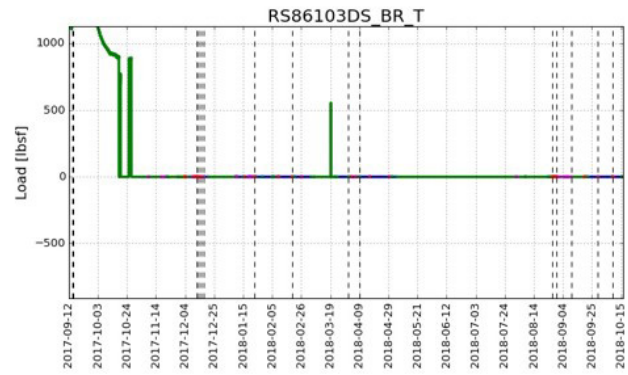
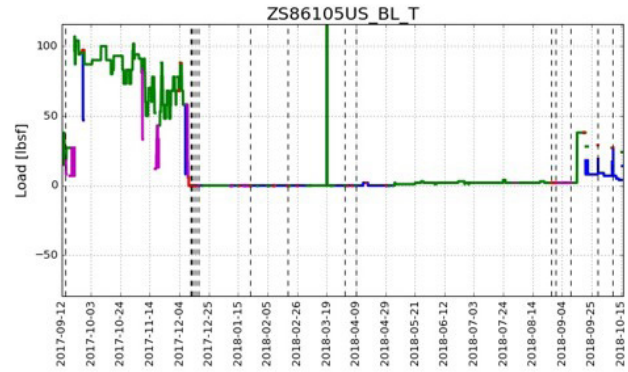
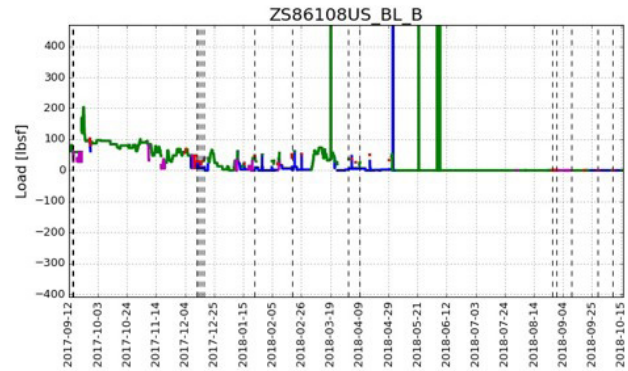
3. There are three load cells that read 0 lbsf for extended periods of time: RS86103DS_BR_T since the end of October 2017; ZS86105US_BL_T from mid-December 2017 to April 2018 and has since read very low values; and ZS86108US_BL_B since mid-June 2018. Fig. 4 shows these three load cells. It is uncertain what causes this, or if the three load cells should be repaired.

FIG. 4. Plots for load cells RS86103DS_BR_T (top), ZS86105US_BL_T (middle), and ZS86108US_BL_B (bottom) showing that they have read 0 lbsf for extended periods of time.
