Nitrogen Supply Outage to the RICH Detector: Consequences and Resulting Actions

Physics Division, Thomas Jefferson National Accelerator Facility, Newport News, VA 23606

July 19, 2019

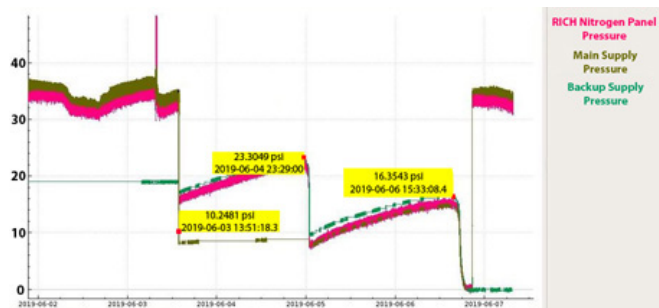
Figure 1 shows the pressure drop on 2019-06-03 at 13:51, from the normal ~35 psi to ~20 psi, the backup system's supply pressure, indicating nitrogen loss in the main supply line.

After about 34 hours, on 2019-06-04 at 23:29, there is another pressure drop from 20 psi to 10 psi, indicating that the first stage of the backup system had run out of nitrogen and that the backup system had switched to the second stage.

FIG. 1. Pressure drop on June 3 indicates the gas system switching to the backup system. June 5 pressure drop shows that the backup system switched to the second bank of nitrogen cylinders.

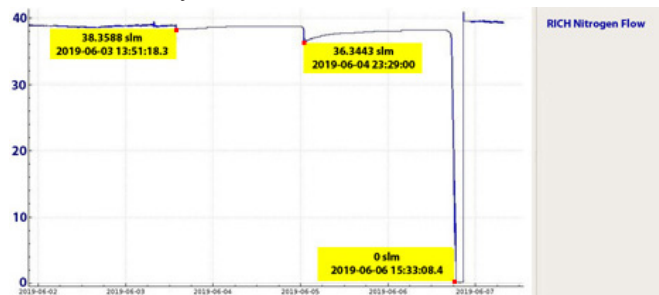
After about another 40 hours, on 2019-06-06 at 15:33 all pressures, Fig. 1, and flow, Fig. 2, dropped to zero, at which time the alarm system alerted Hall B staff.

FIG. 2. Labels (left to right) indicate nitrogen flow reduction, due to valve closing, backup system's first stage runs out of nitrogen, and eventually second stage runs out of nitrogen. Zero nitrogen flowed to RICH on 2019-06-06 at 15:33.

- To prevent inadvertent closing of the main nitrogen supply line valve, an administrative lock-out has been placed on the valve, which will be relocated to a secure location.

- To alert staff about changes in nitrogen flow, software alarms have been developed and implemented. The main nitrogen supply line pressure alarm will alert staff if the pressure drops below 20 psi for more than a minute; the backup system's supply pressure alarm will alert staff if the pressure drops below 10 psi for more than a minute.

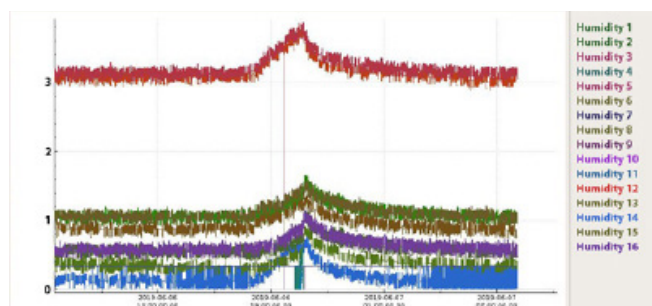
System inspection revealed the closed valve, which was reopened about two hours after nitrogen flow had stopped, Fig. 2. During this period, the detector's relative humidity rose by ~0.5%, Fig. 3. After about twelve hours from restoration of nitrogen flow back to 40-slm, humidity sensors readings returned to their normal values.

FIG. 3. RICH detector interior relative humidity readings before, during, and after the June 6, 2019 nitrogen outage. Except for sensor 12's 3% RH reading, due to its location behind the spherical mirrors where there is little nitrogen movement, all sensors normally read less than 1% RH. The spike in the relative humidity is due to nitrogen flow outage.
