Hall B Magnets Issues – Engineering Run

Detector Support Group

01/17/2018

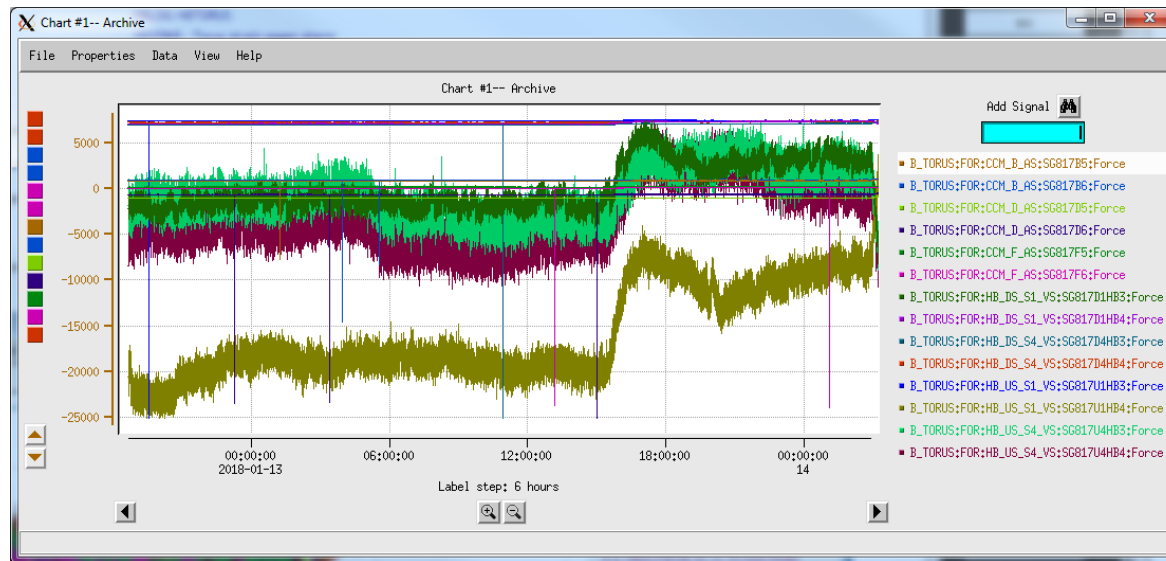
Torus – Strain gauges issues

- On 01/13/2018 alarms raised for the CCM strain gages
 - Torus strain gauges are not interlocked only monitored
- Support strain gages indicated higher than the alarm levels.
- Solution: Reset alarms to not alarm and raised alarm limits.
