Hall B Magnet Issues Engineering Run - Week 2

Detector Support Group

January 24, 2018

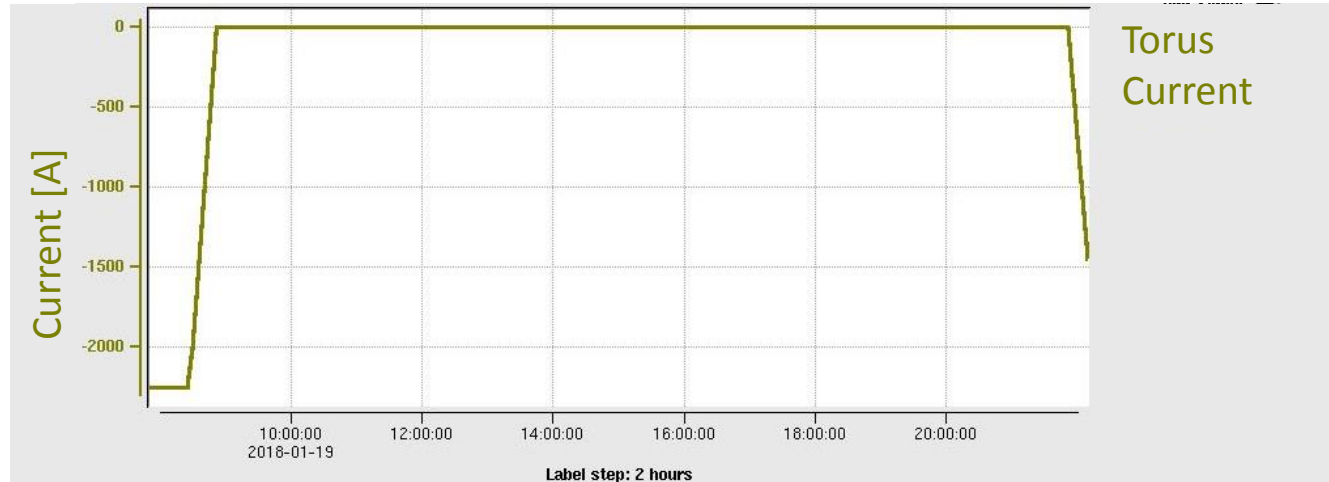
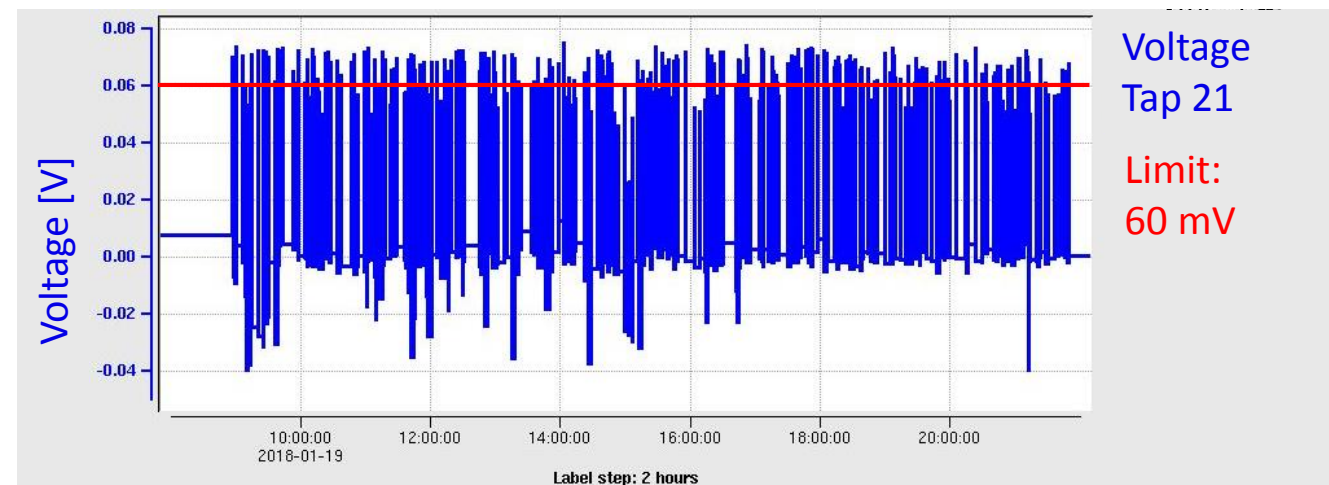
VT21 and Torus Current on January 19, 2018

Torus Cryo Sum Interlock Trip on January 19, 2018

- Torus was already at 0 [A] due to an earlier planned ramp to 0 [A].
- Voltage Tap 21 (VT21) monitoring voltage across vapor-cooled lead B (VCL B) went above 60 [mV] threshold for longer than 650 [ms].
- VT21 was noisy as soon as Torus current reached 0 [A] due to floating ground of its power supply.
- Solution: conditions for current coded into interlock.
 - Controlled ramp down will only be triggered when VT21 is over-threshold if absolute current is greater than 10 [A].

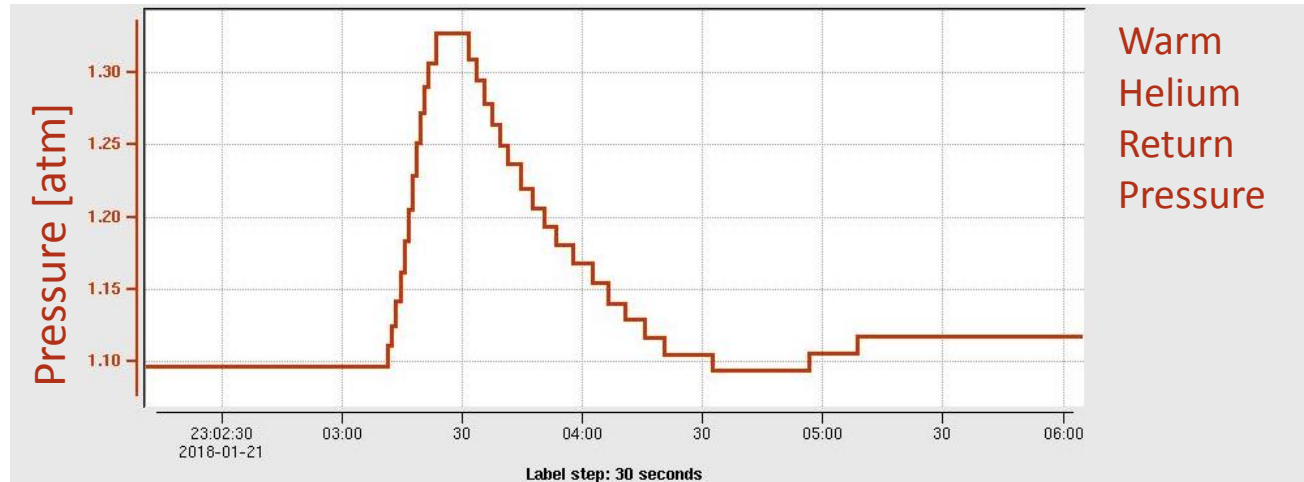
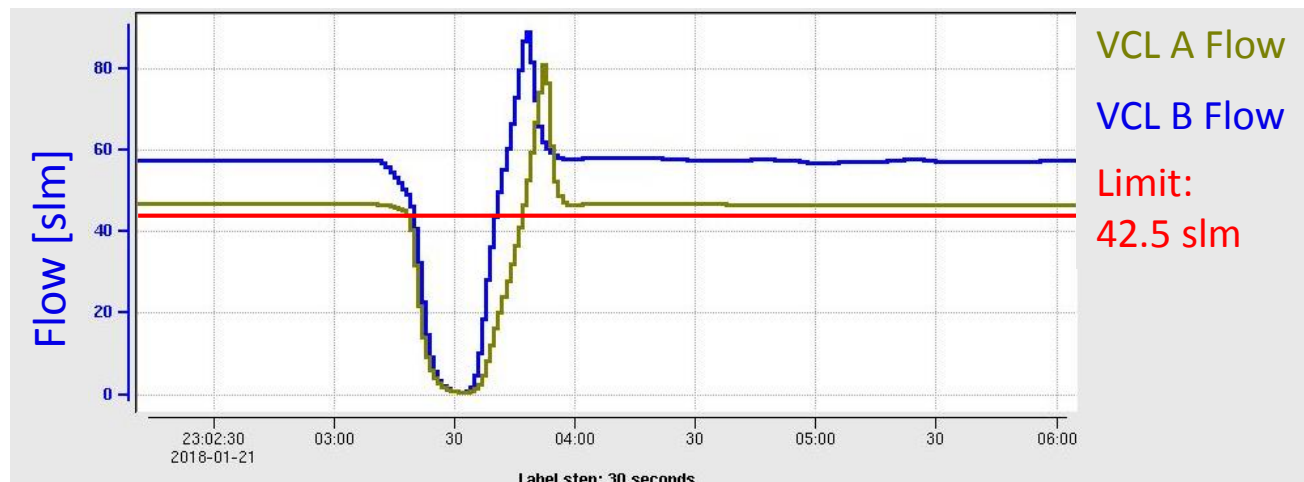
Warm Helium Return Pressure and VCL Flows on January 21 ,2018

VCL Flow Interlock Trip on January 21 ,2018

- Solenoid's VCL flow dropped below 42.5 [slm] threshold, causing controlled ramp down.
 - Decreased VCL flow for Hall B Magnets caused by increase in warm helium return pressure because of Hall A magnets' trip.
- Solenoid ramped back to previous current set point when flow and pressure returned to normal.
