SVT Status

Hall B Engineering Run

SVT 12/8/2017 Incident

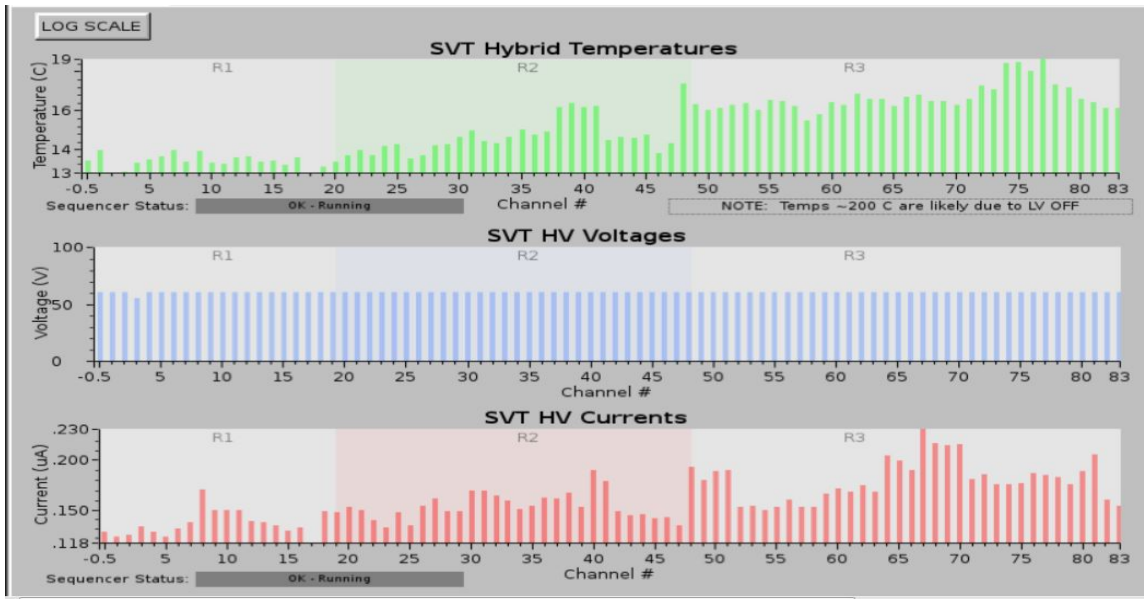
- Radiation damaged the silicon sensors
 - Increases leakage current
 - Reduces signal to noise ratio
 - Less efficient tracking
- SVT Region 1 (closest to beamline) has largest leakage current.

Date	12/07/2017
R1 High Voltage	60 V
R1 Hybrid Temp	~ 13°C
R1 HV Current	~.135μA (Avg)

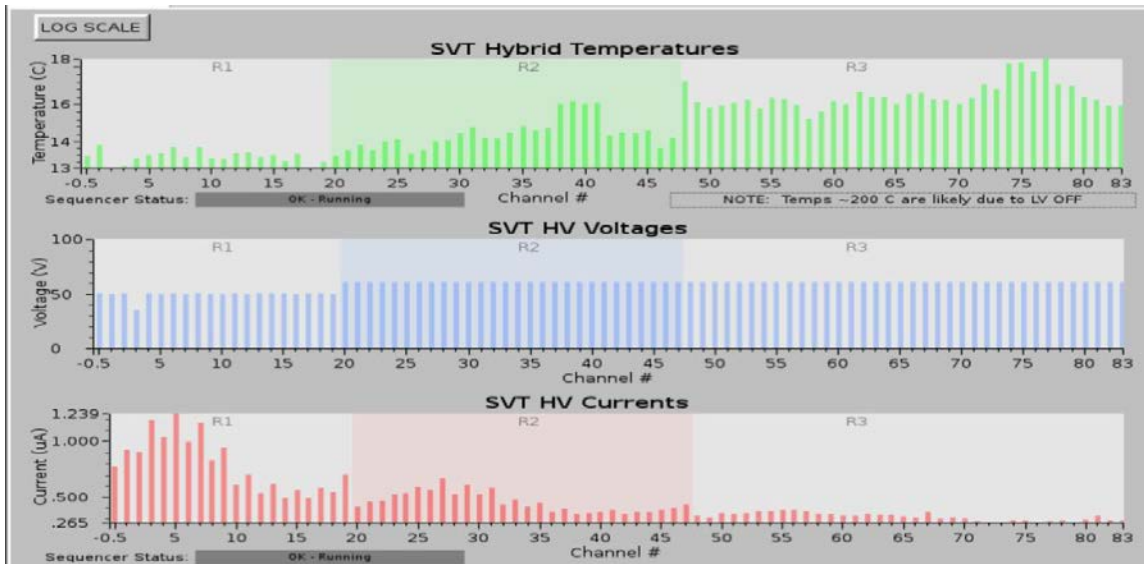
- First day of beam to Hall B.
 - Scraping of the beam occurred in Hall B beamline.
 - SVT received a high dose of radiation.
 - Radiation received exceeded the SVT expected total lifetime dose.

Date	12/17/2017
R1 High Voltage	50 V
R1 Hybrid Temp	~ 13°C
R1 HV Current	~.8μA (Avg)

- Reducing the sensor operating temperature decreases leakage current.
 - Reduced cold plate chiller temperature.
 - Heat exchanger with additional chiller added to cool N₂ gas
 - MFC added to N₂ gas cooling.
 - RTD on order to measure cooled N₂ gas temperature

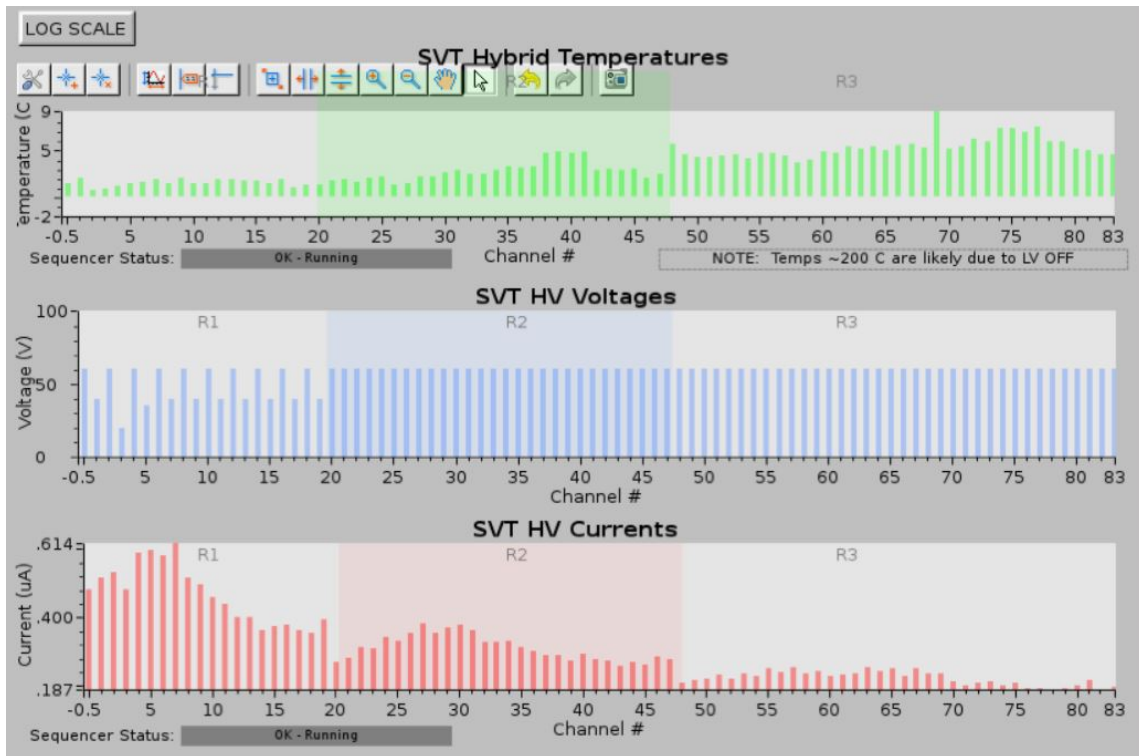
After Cooling System Improvements

Date	1/30/2017
R1 High Voltage	60V (T)/40V(B)
R1 Hybrid Temp	~ 1.5°C
R1 HV Current	~.46μA (Avg)

- SVT sensors damaged due to high radiation dose.
- Reducing sensor temperature decreased leakage current.
- Leakage current is still $\sim 4X$ higher with cooling.
- Current will increase with time due to radiation exposure.
