Detector Health Report

Tyler Lemon

Detector Support Group

April 4, 2018

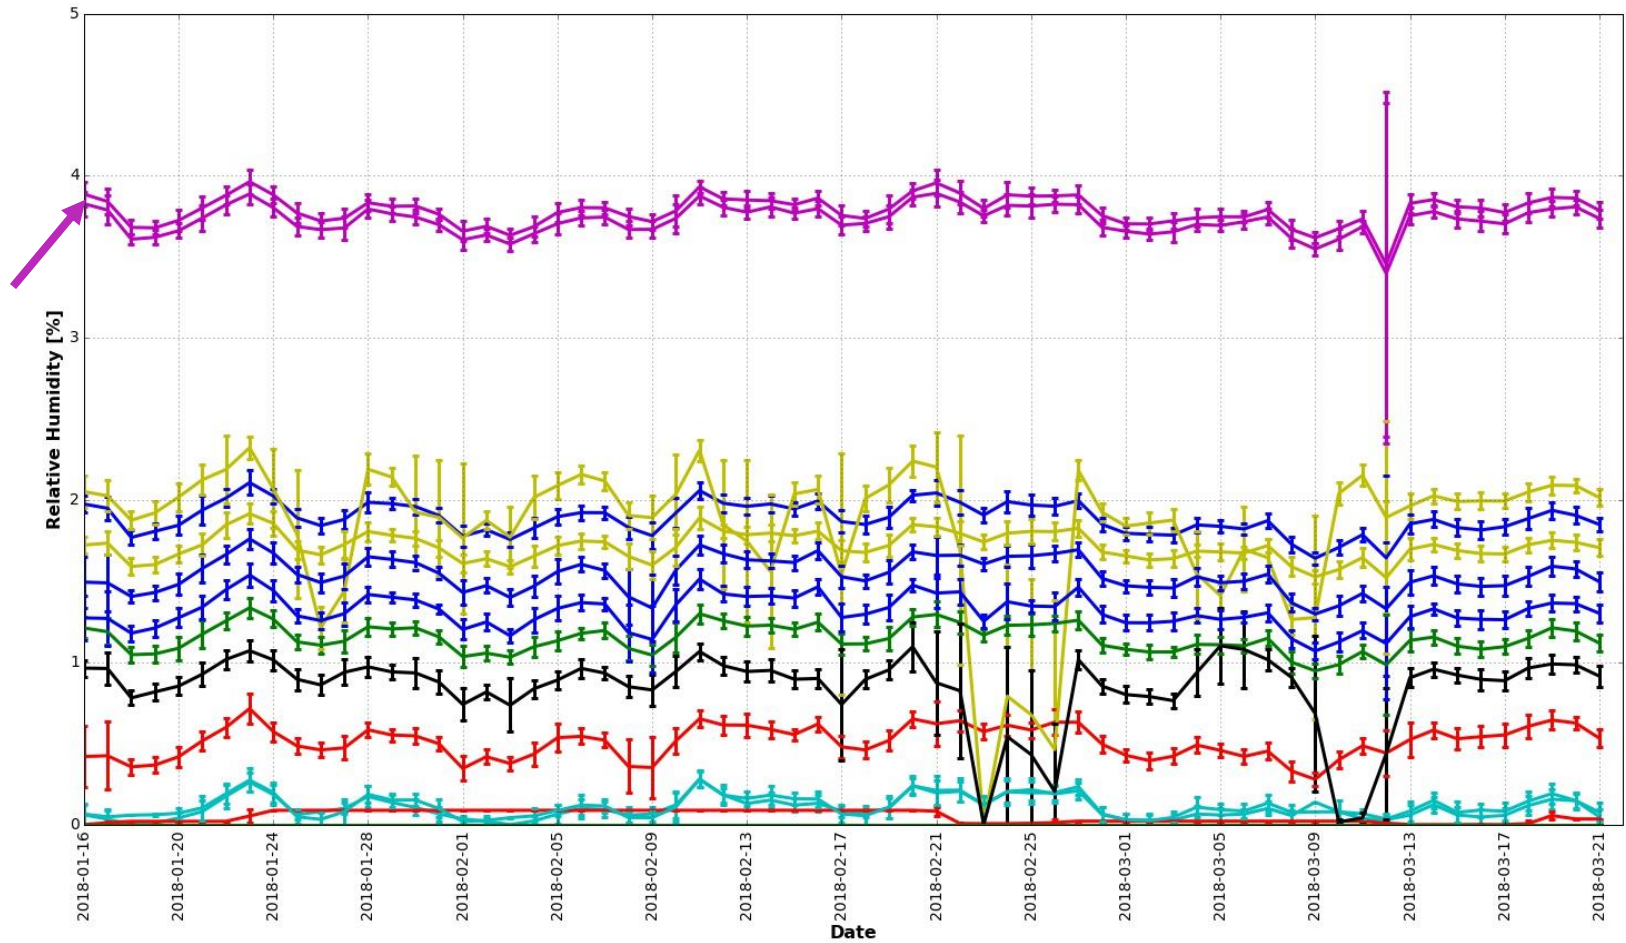
N₂ Volume Humidity History

Humidity
5 and 12
(behind
spherical
mirrors)
are only
sensors
above
3 % RH.

All other
humidity
sensors
below
3 % RH

Humidity 5 and 12 thought to be higher due to placement in RICH behind mirrors.

Bad Sensor

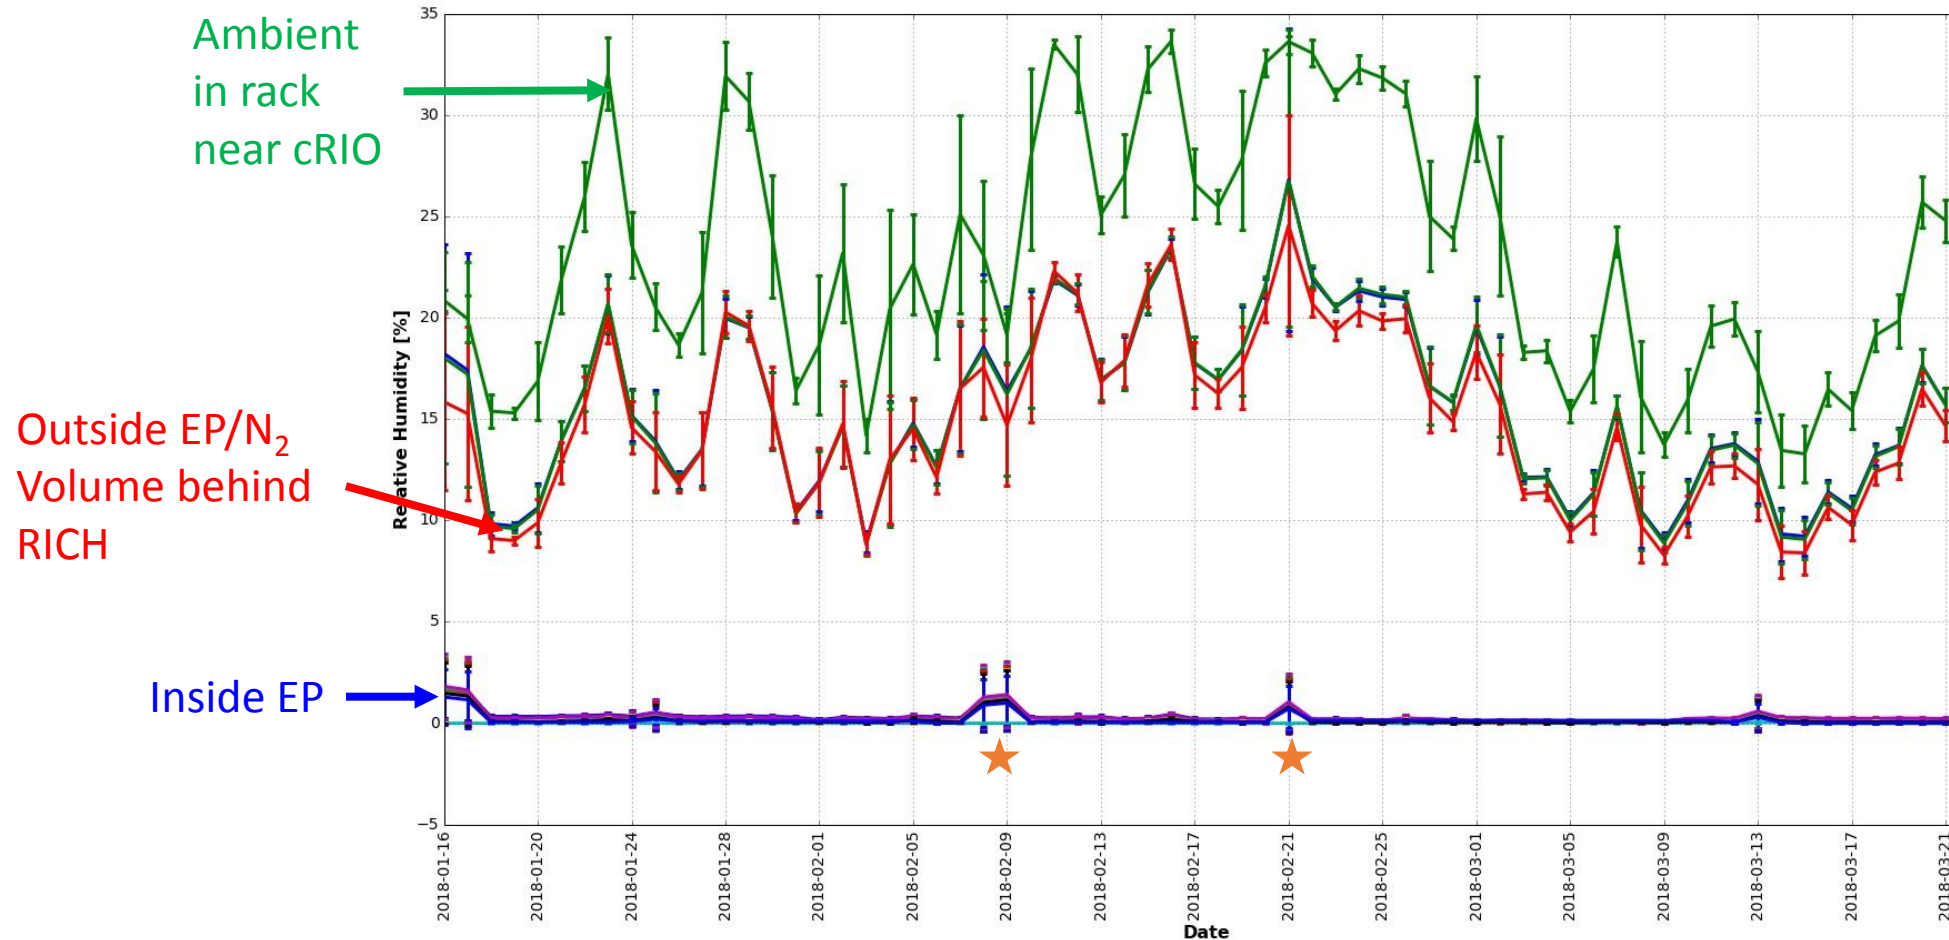
EP Humidity History

★ Slightly higher humidity because both HV/LV were off, causing a lower temperature in the EP. Relative humidity is dependent on both temperature and water concentration.

Bad Sensor (points to sensor 4)

Ambient (points to sensor 16)

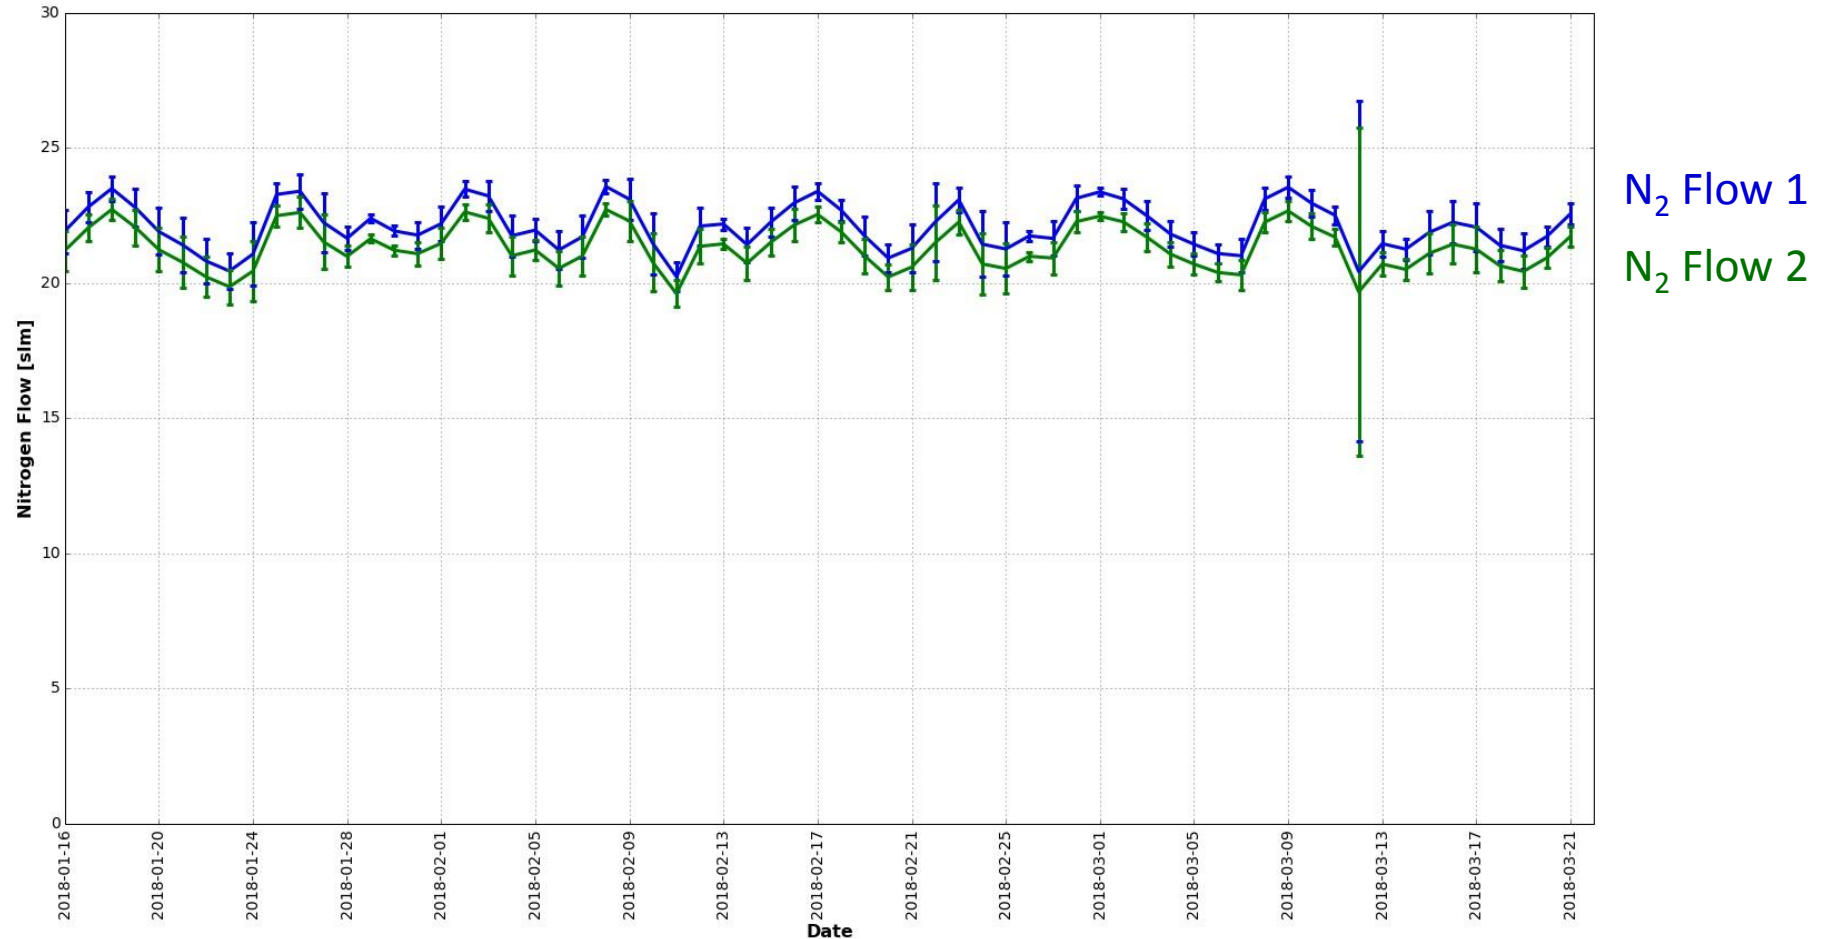
Nitrogen Flow History

Flow is not steady because of changes in supply pressure.

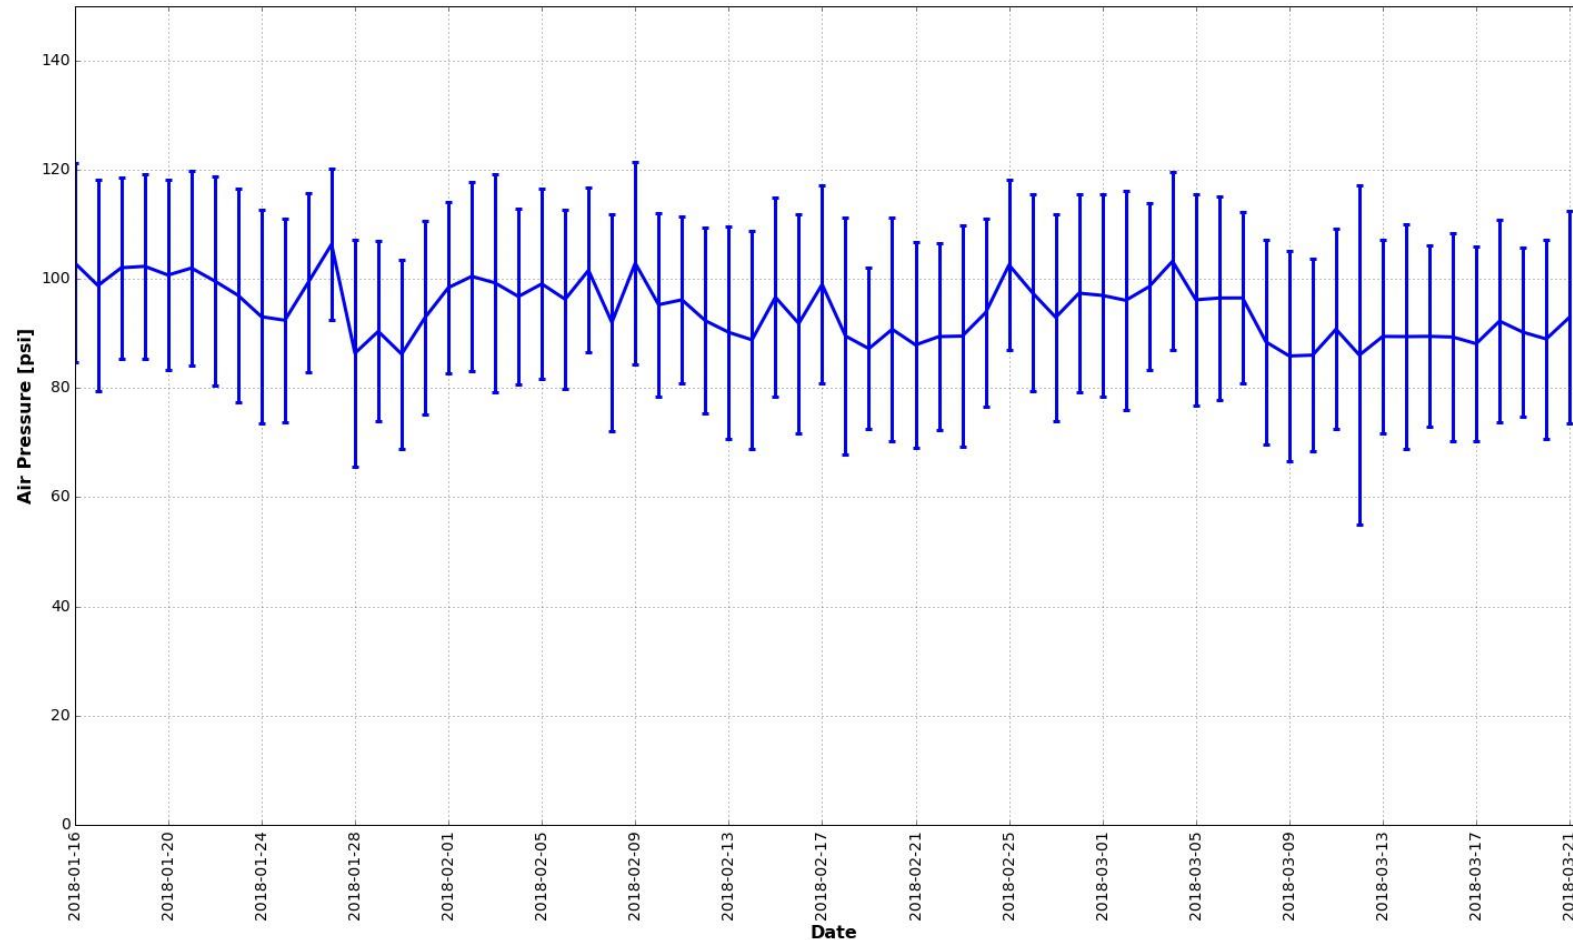
Air-Cooling Buffer Tank Pressure History

Instability of pressure reading caused by oscillations in buffer tank pressure due to compressor's on-off cycle.

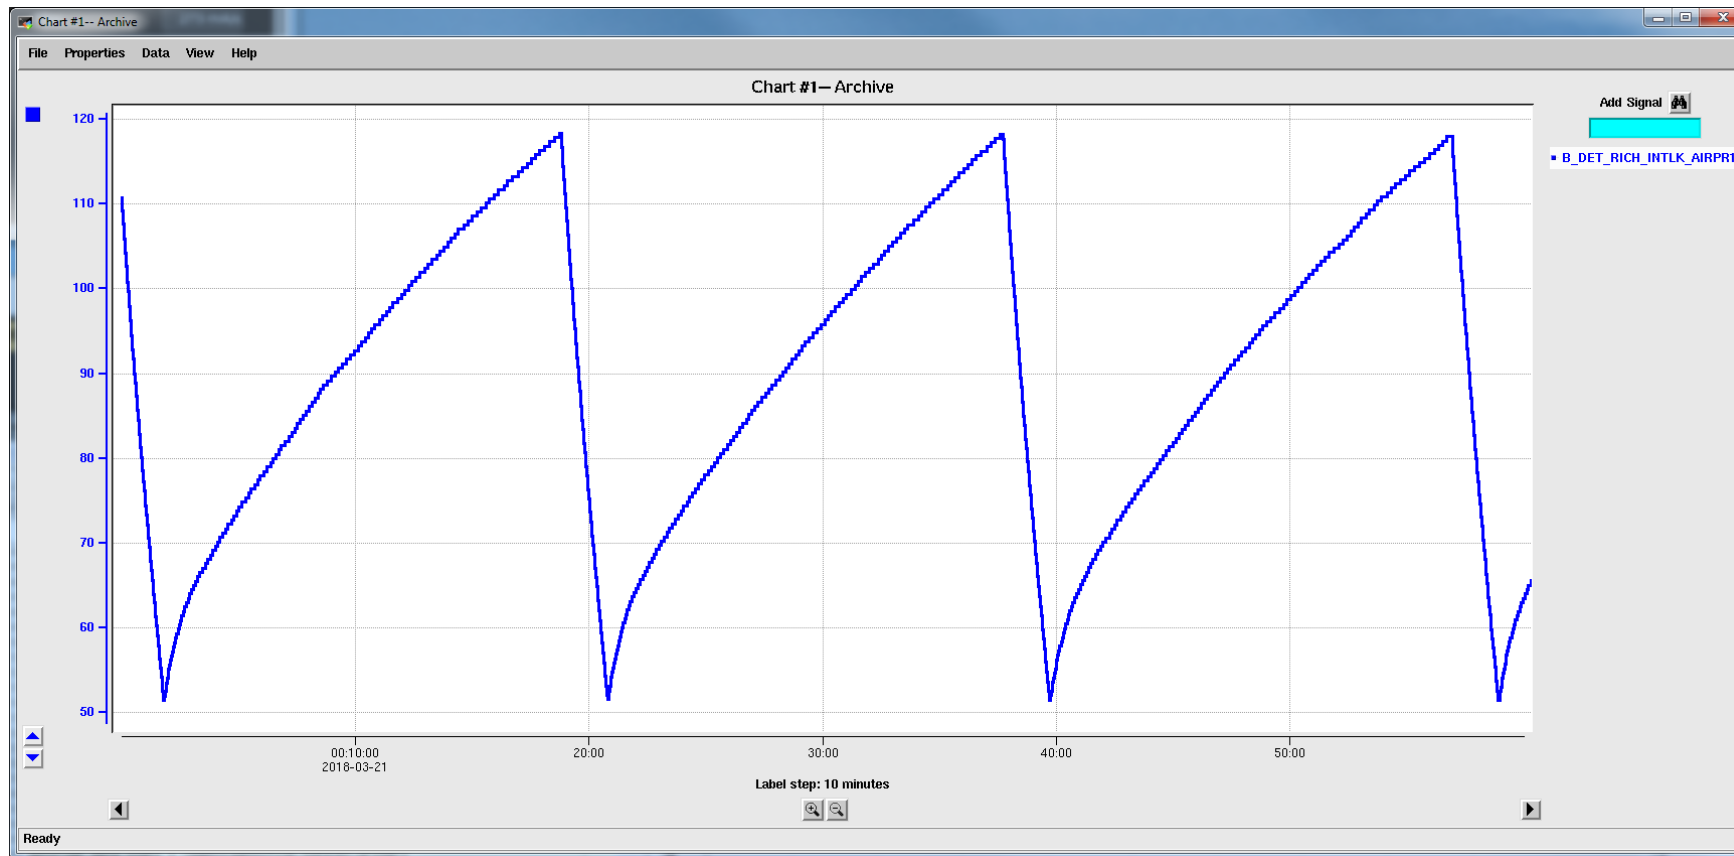
One Hour of MYA Pressure Data

Pressure oscillates between ~120 psi and ~65 psi because of operation deadband set on compressor.

Compressor turns on when its output pressure drops below 104 psi and turns off when pressure increases to 113 psi.

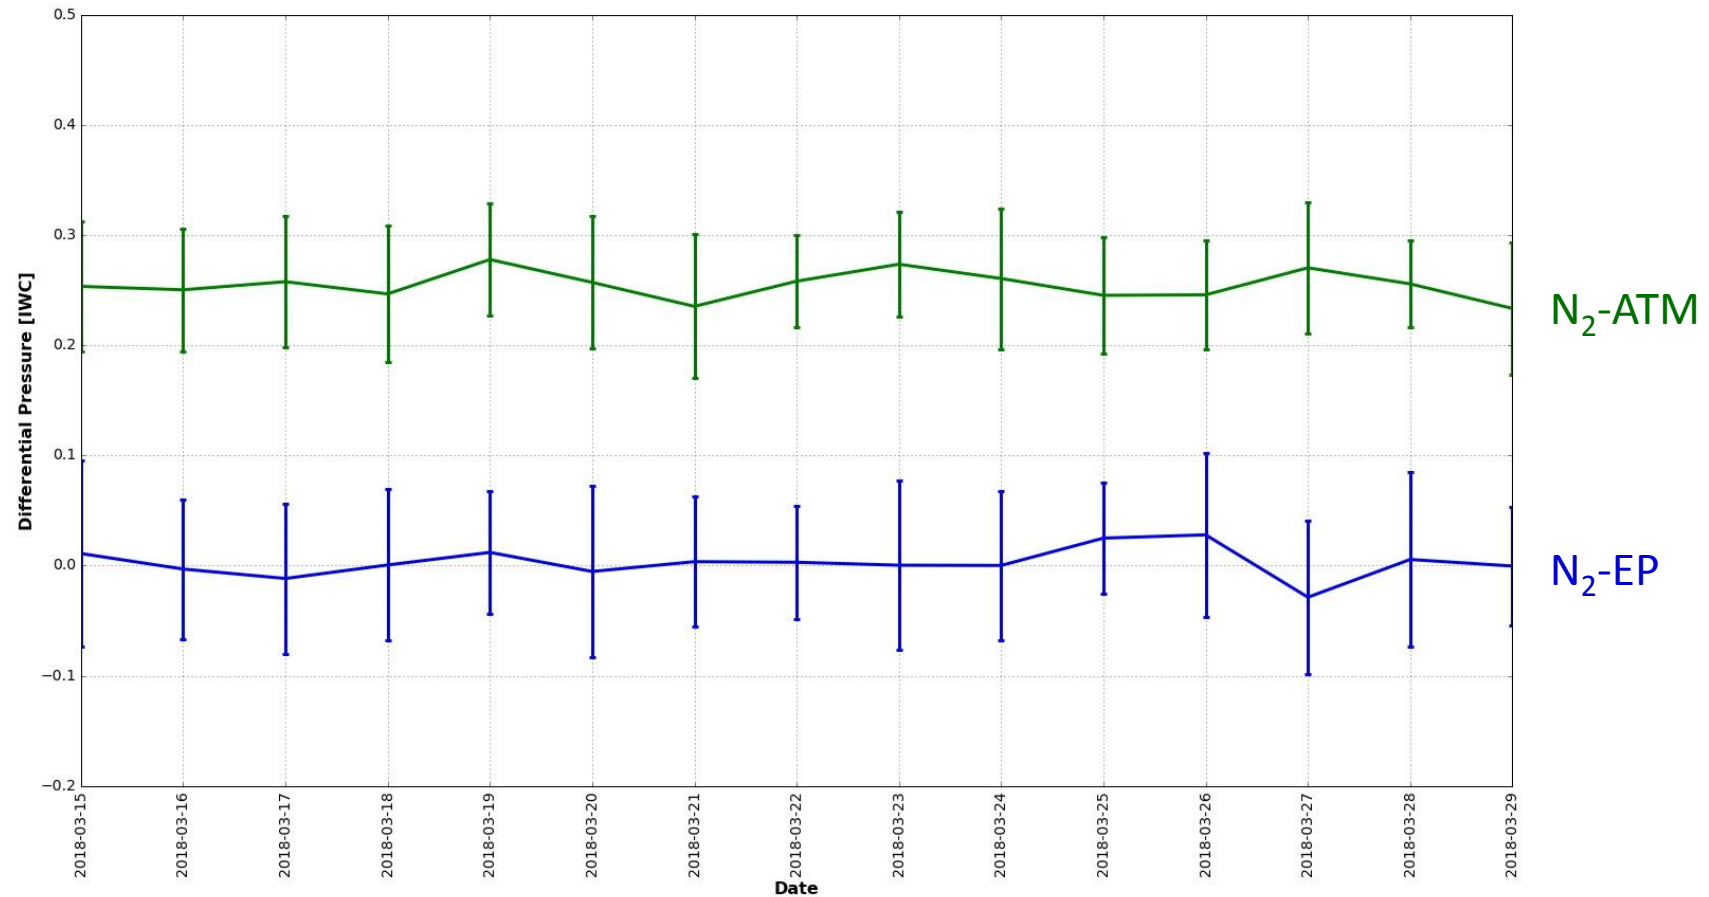
Differential Pressure History

- Two pressure transducers installed to measure:
 - Pressure differential between nitrogen volume and atmosphere
 - Pressure differential between nitrogen volume and EP.
- Goal is to have nitrogen volume over-pressured in relation to EP and atmosphere.
 - Prevents external air from leaking into nitrogen volume.
- Measurements indicate that EP and N2 Volume are at a similar pressures.
- No correlation observed between differential pressures and internal humidity readings.

- RICH detector is in **good health**
 - Humidity under 3%
 - FPGA temperatures under 70 °C
 - Over-pressured in relation to atmosphere
- Items to improve upon:
 - Increase pressure in N2 Volume so it is more over-pressured in relation to EP.
 - Improve reliability of scaler readout.

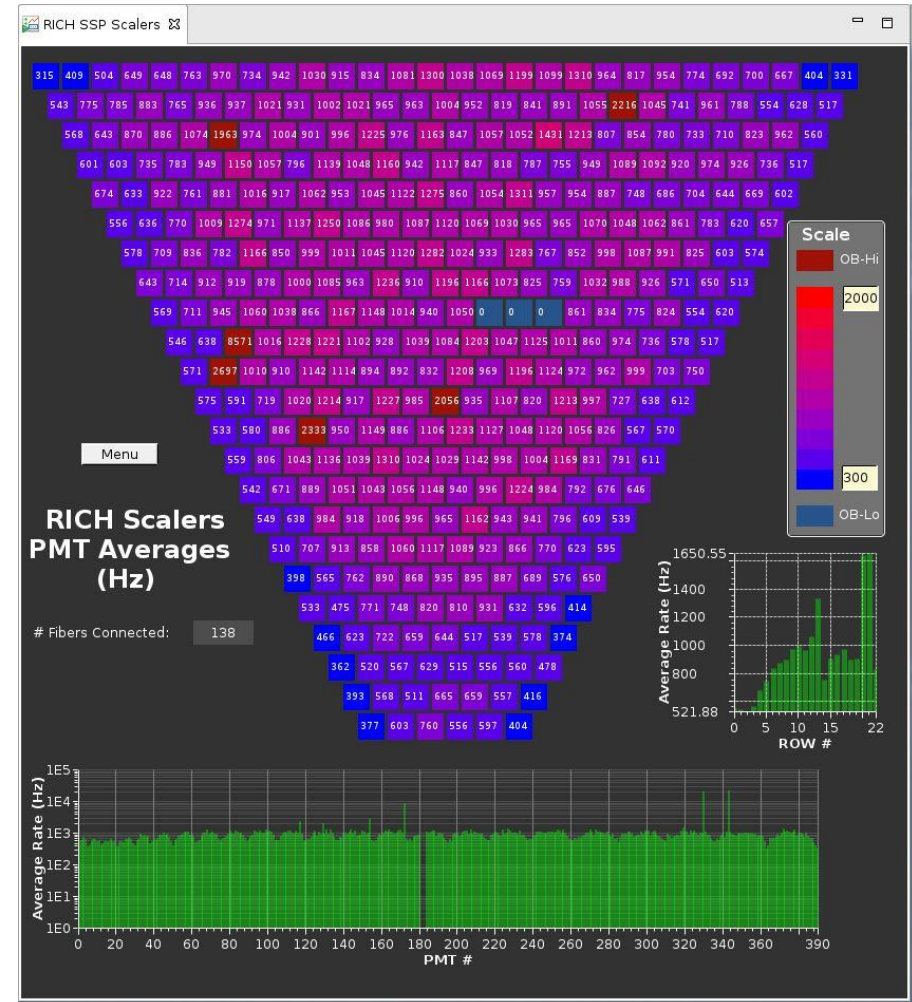
Scalers from February 22, 2018

- Scalers for some PMTs read zero and do not update.
- Bad scalers most likely caused by DAQ initialization error.
 - Readout electronics could not determine whether tile is a 2 or 3 ASIC tile.
 - Error causes PMT data not to be read by DAQ.

- Cycle of LV to RICH and restart of DAQ to reinitialize RICH electronics.
 - Temporary solution; debugging will be done after Spring 2018 Physics Run.
- Present course of action:
 - Monitoring scalers to see if same tile continuously has issues.
 - Could indicate hardware problem with tile or its DAQ connections.
 - Monitoring logbook to note patterns in DAQ starts and PMT scaler issues.
 - If PMT scalers only freeze when DAQ is started, could indicate problem with RICH DAQ initialization.
