Issues with CAEN SY4527 Software/Firmware and A7030TN Modules

Marc McMullen
Detector Support Group
08/21/19

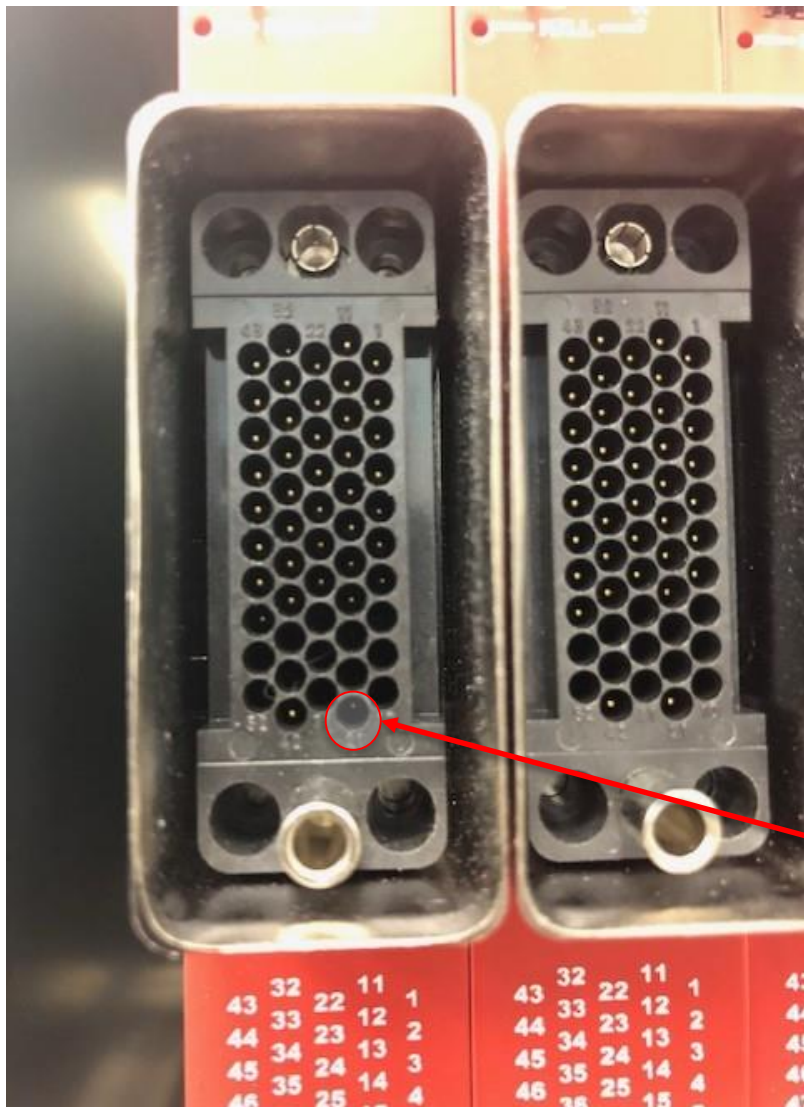
Radial 52 Pin Connector Issue

- Connector's pin retention inadequate.
- Installing process of mating connector often pushes pins backwards.
 - Common on the safety loop contacts.

Safety loop contact pushed in

- CAEN recognized issue (Application Note AN6224 3/2017).
- Instructs end user to epoxy connectors to prevent pushback.

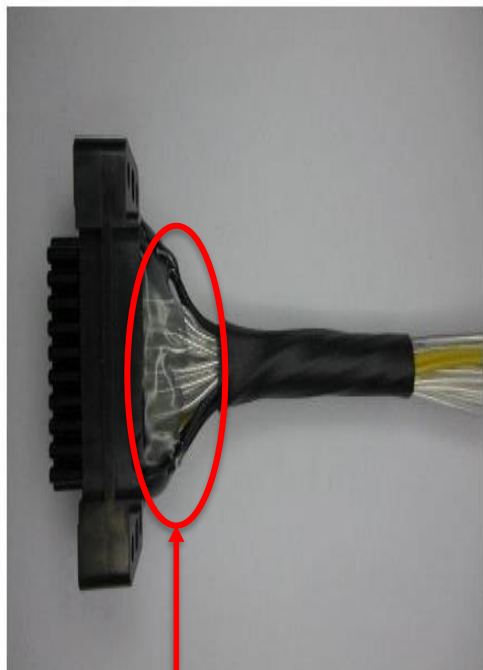
Step 17

Fix Plug connector (2)
The figure shows the plug connector [A1] with high voltage single cables glued and blocked

epoxied connector

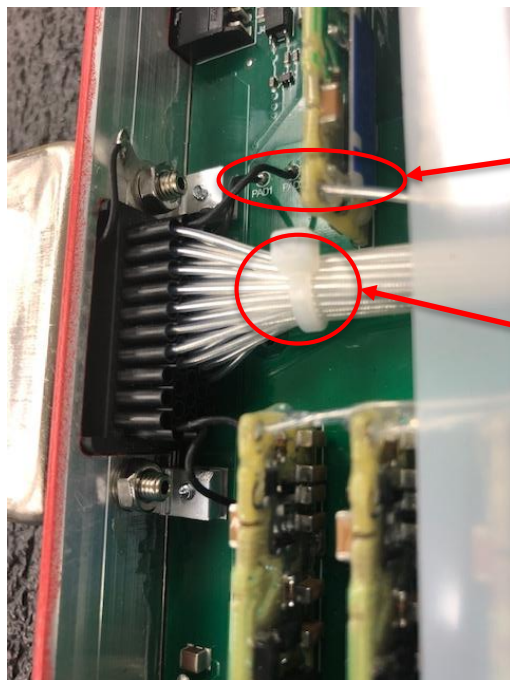
R52 connector of an A7030TN module

Safety loop and returns have no strain relief.

Strain relief.
