Hall B Solenoid and Torus Health Report (Sep 2017 to April 2018)

Pablo Campero

Detector Support Group

04/11/2018

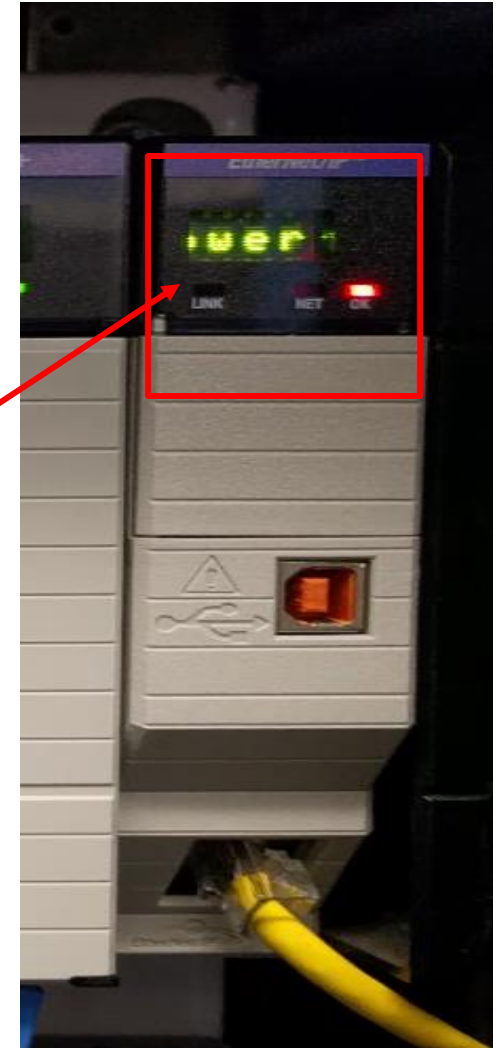
1756- EN2T Ethernet/IP PLC Module

- AB 1756 EN2T Ethernet/IP PLC module lost communication with Hall B network and generated Torus fast dump on 04/01/2018.
 - Local PLC controller complained about I/O Fault in Local:9 (Ethernet/IP module)
 - All remote modules had bad status
 - Ethernet/IP module showed error
 - " Cycle Power to Unit: Assert in File wrhvBspEventHandlers.cpp Line 83"
- Locally power-cycled PLCs' power supplies (local and remote chassis) to solve problem.

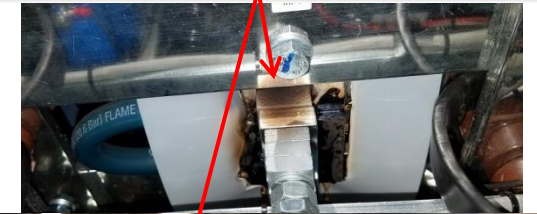
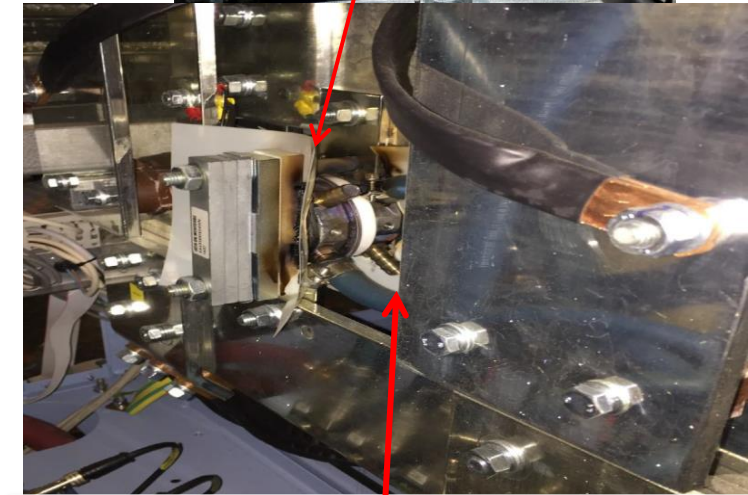
- On 09/28/2017, SCR circuit overheated in Torus MPS
 - Thyristor (SCR) was not water-cooled as expected from factory setup
 - MPS cleaned and found residuals of machining (drilling, milling, cutting)
 - Danfisyk solution:
 - Provide new SCR
 - Install missed hoses to provide proper water cooling to SCR circuit
 - Install missed thermal switches/ temperature sensors with adaptors
- On 11/22/2017, Torus fast dump at 1080 A
 - Previous SCR replacement was installed backwards (anode, cathode incorrect positions), which led to ramping issues and internal trips on MPS

SCR circuit overheated in Torus MPS
Insulation burned

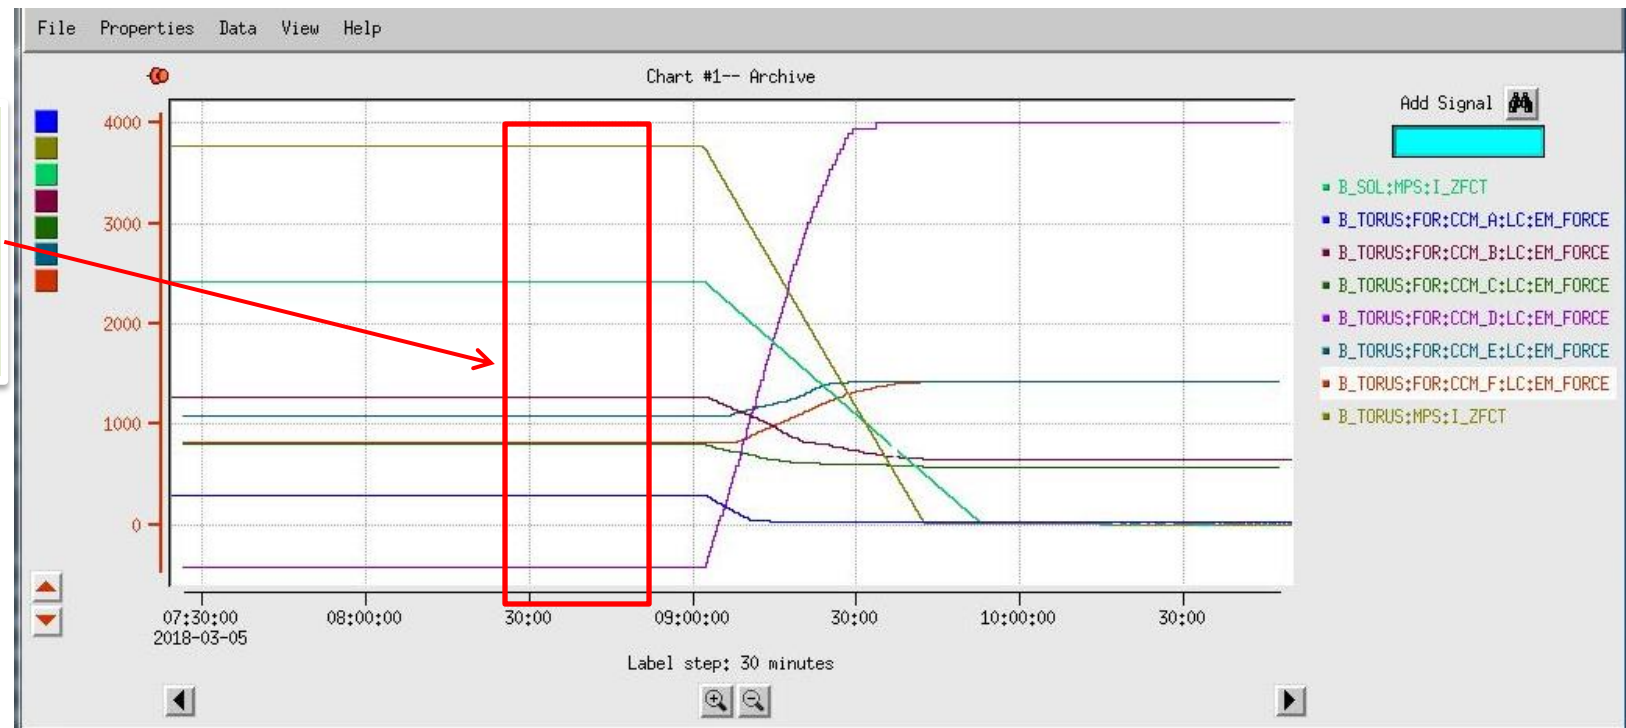
Data entries in table are averages for OOP force values during time shown in red box

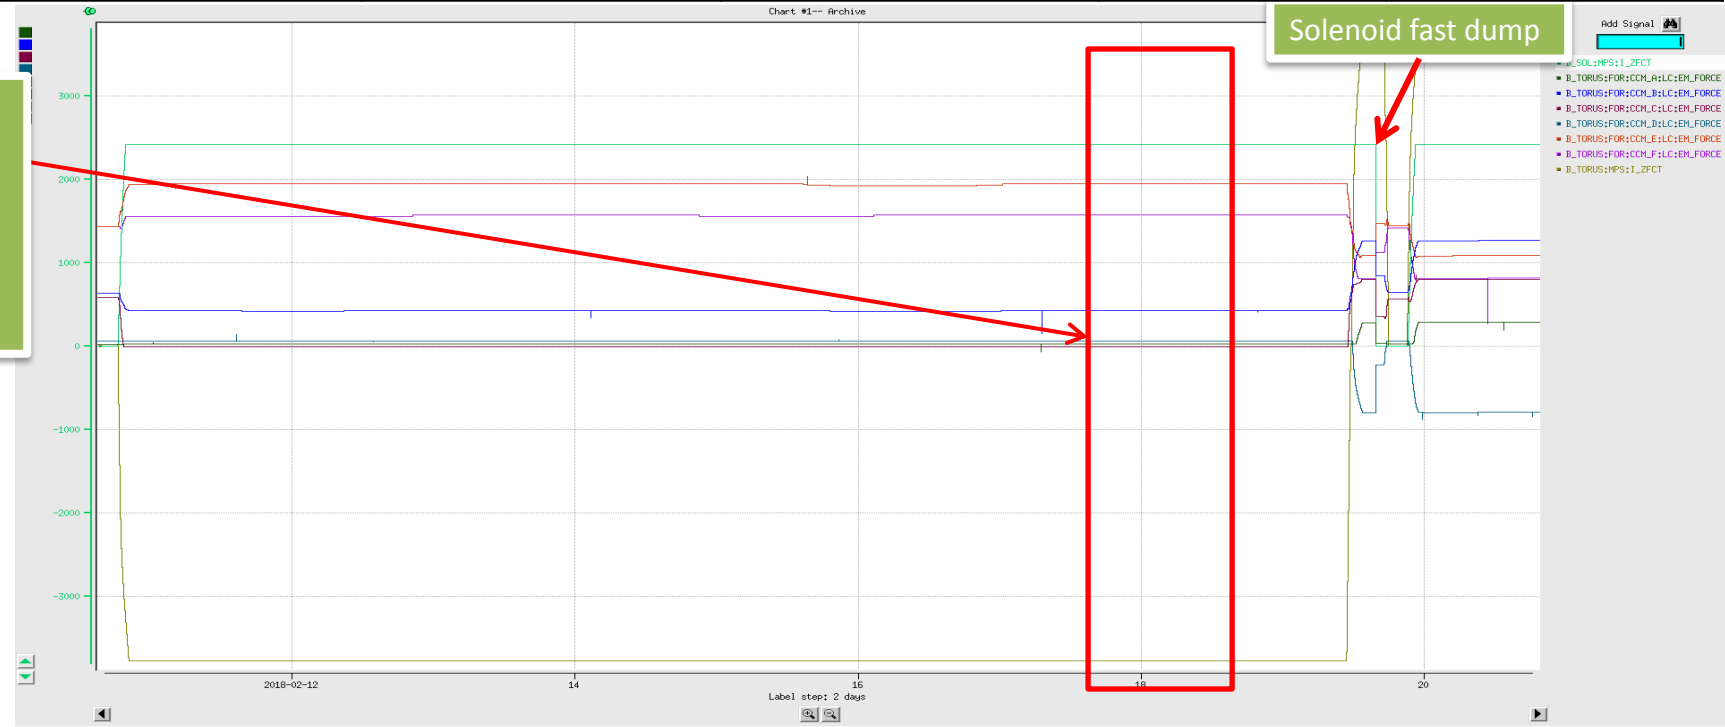
Data entries in table are averages for OOP force values during time shown in red box

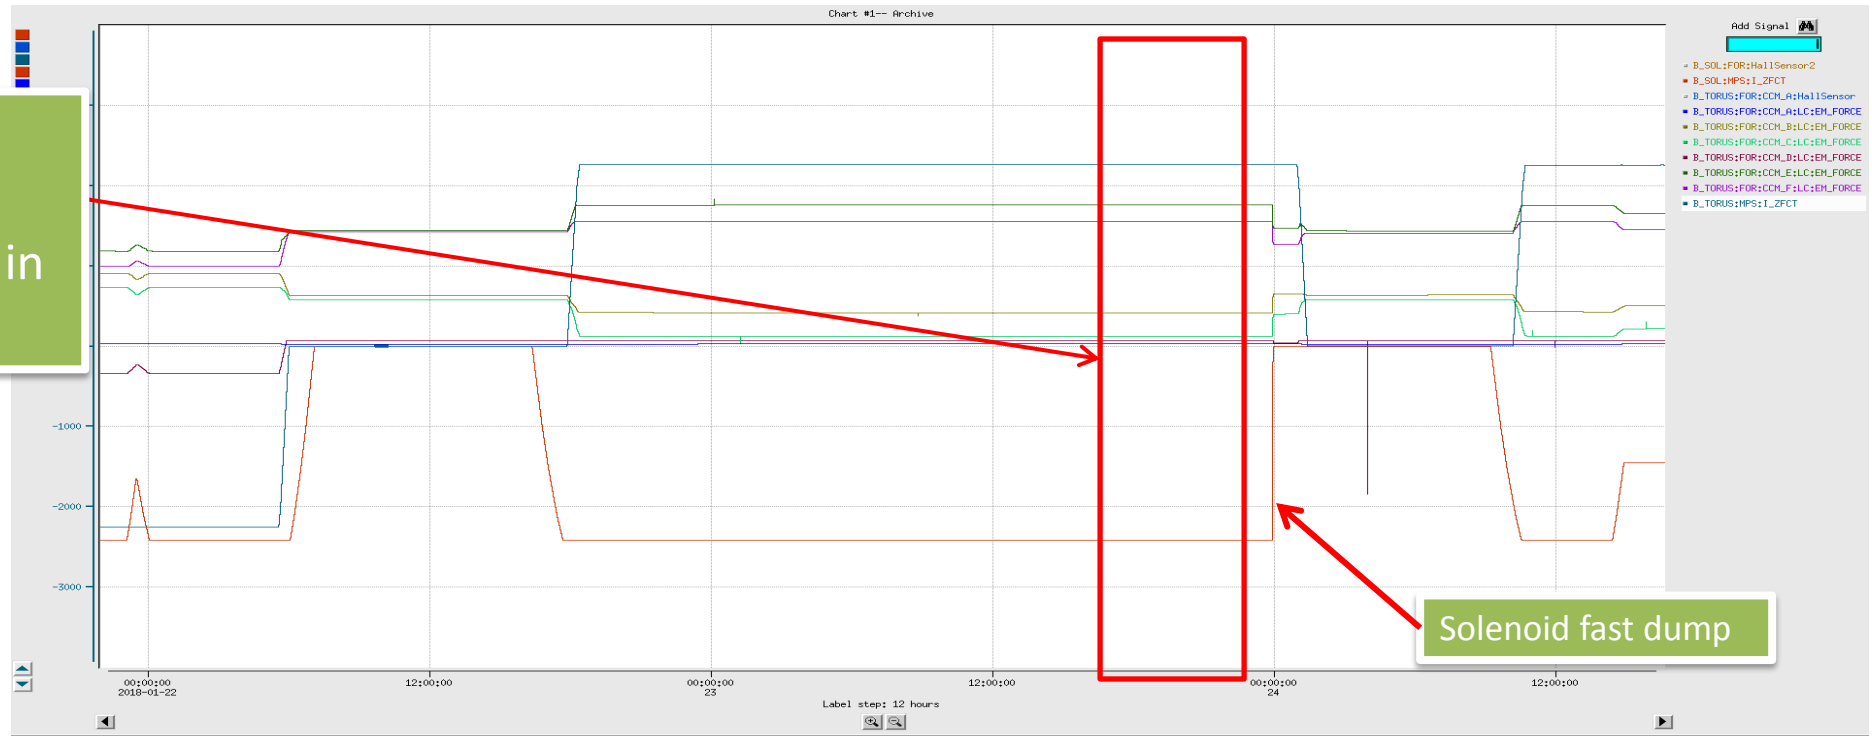
Data entries in table are averages for OOP force values during time shown in red box

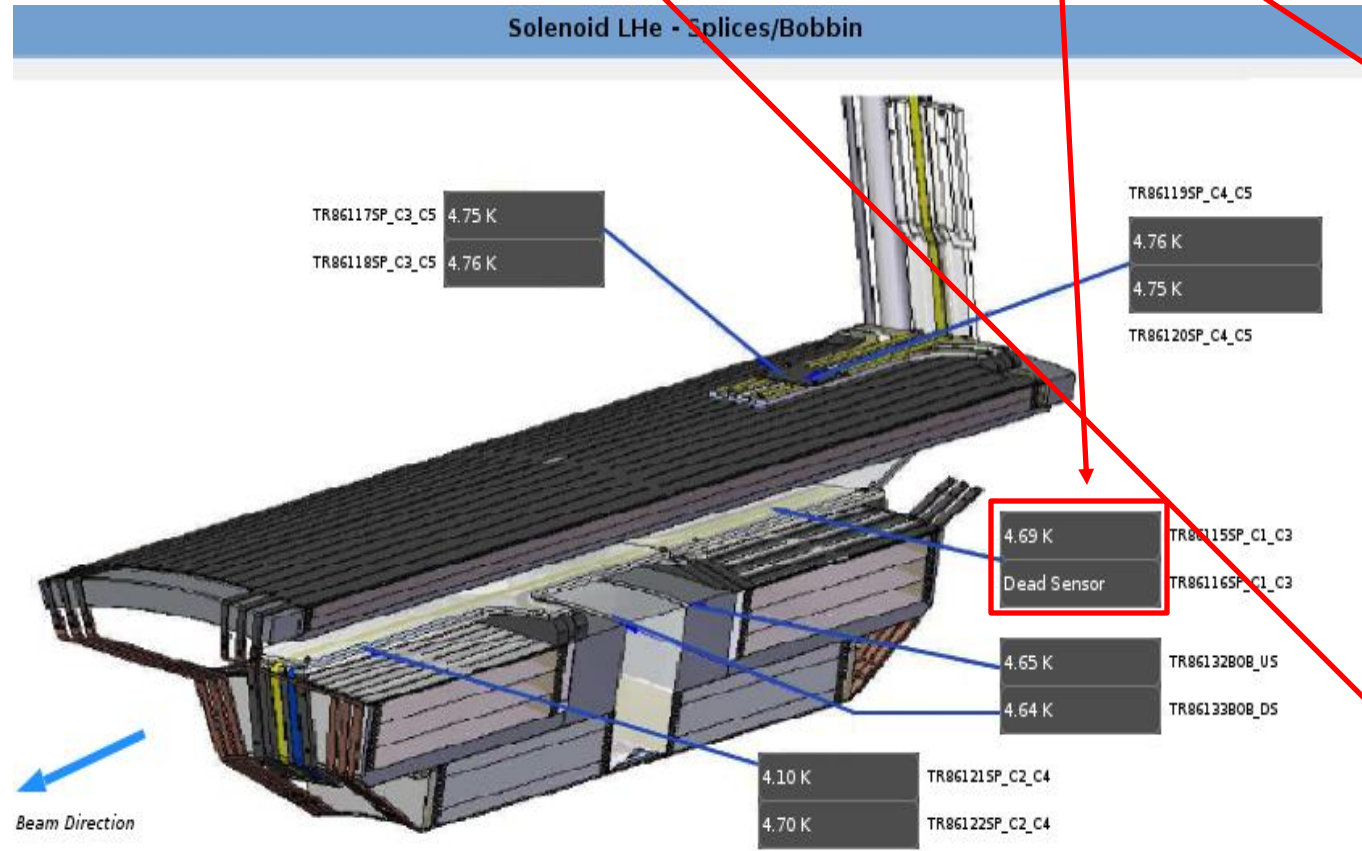
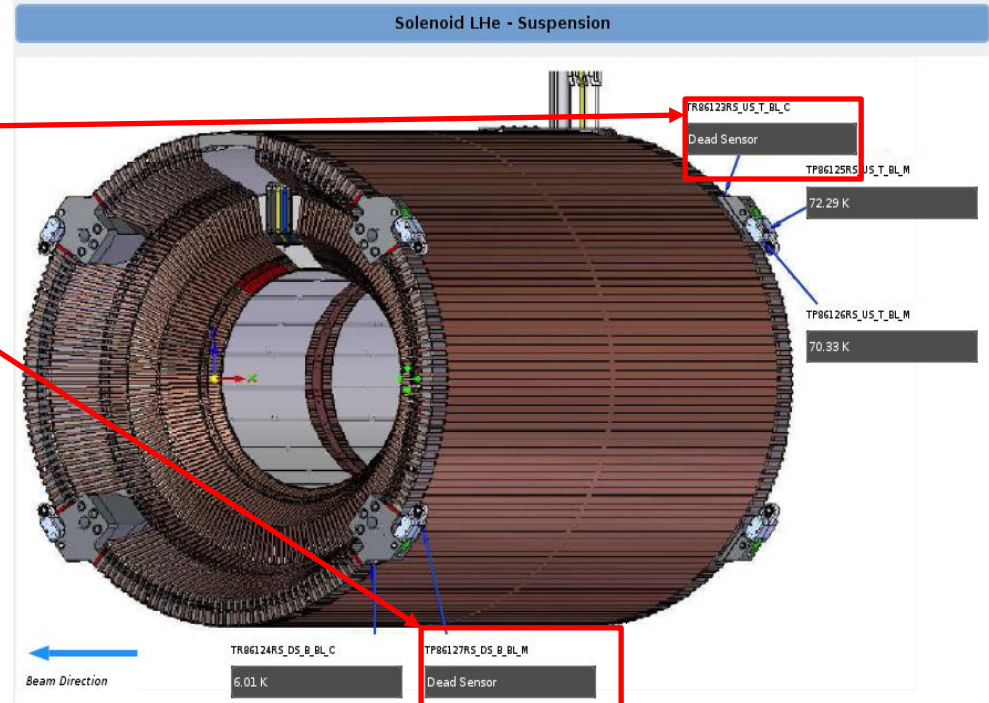
➤ Found dead sensors during commissioning:

- Three Cernox temperature sensors
- One Hall sensor

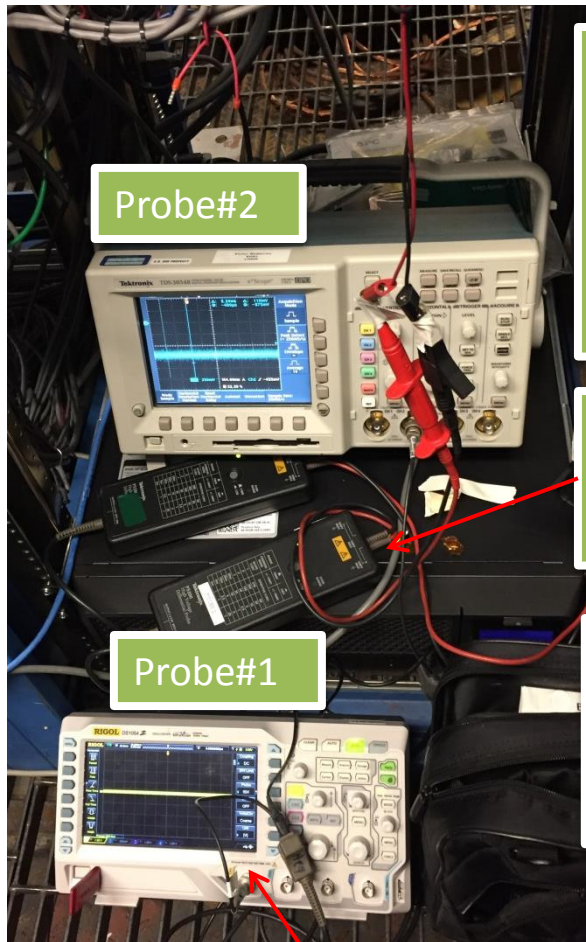
Probe #2 connected to monitor voltage spikes from Solenoid (to compare with FASTDAQ data)

Probe #1 connected to monitor voltage spikes generated internally in QD
