RICH EP Temperature Hardware Interlock Trip

August 7, 2018 at 11:46 AM

Tyler Lemon

August 8, 2018

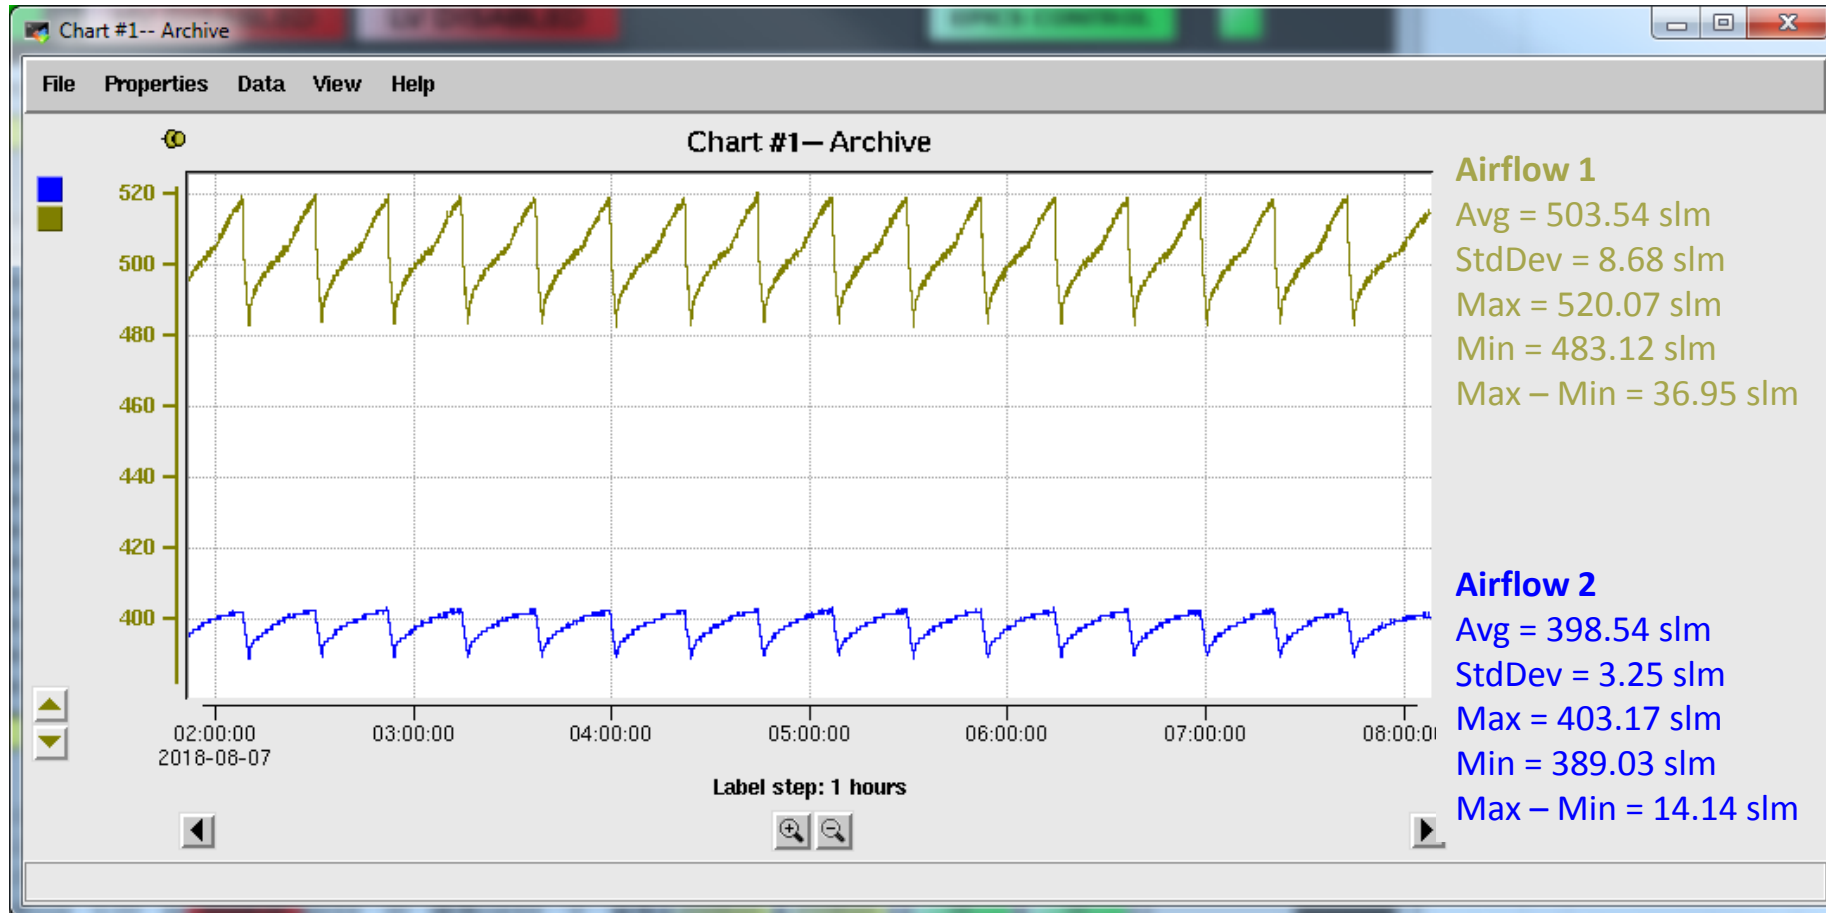
Normal Compressor Operations

NOTE:
“Saw-tooth”
pattern on
airflow
caused by on-
off cycle of
compressor

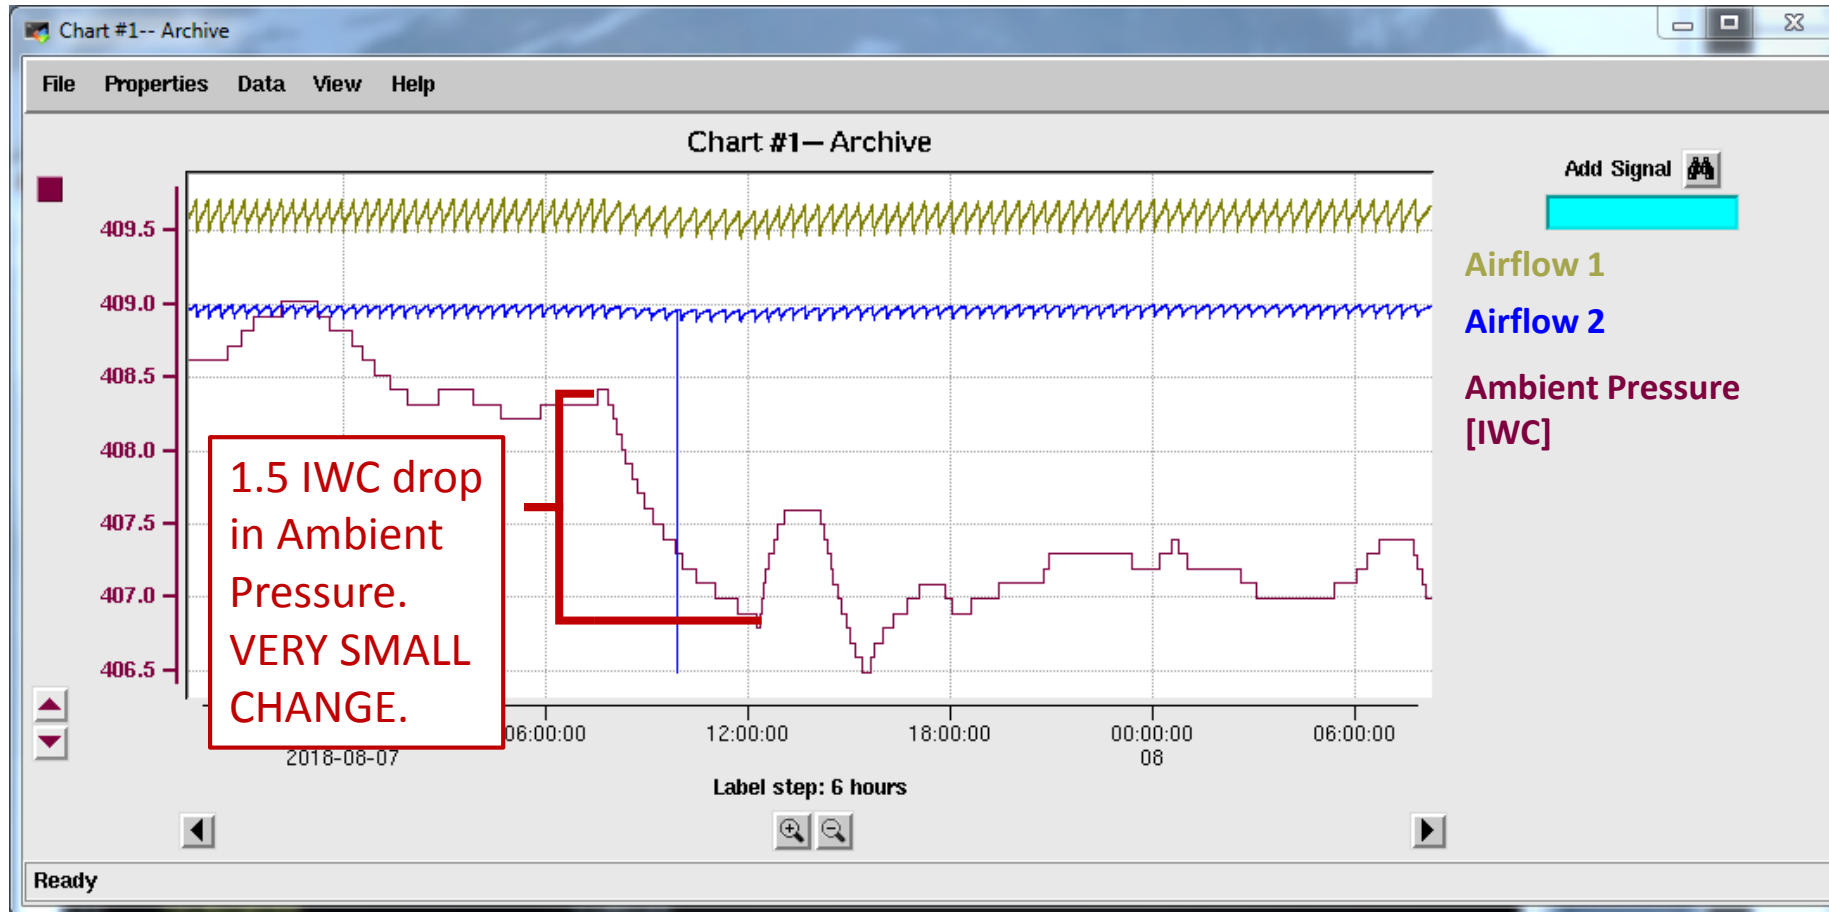
Ambient Pressure Change During Airflow Changes

It is unlikely that changes in Ambient Pressure are affecting airflow.

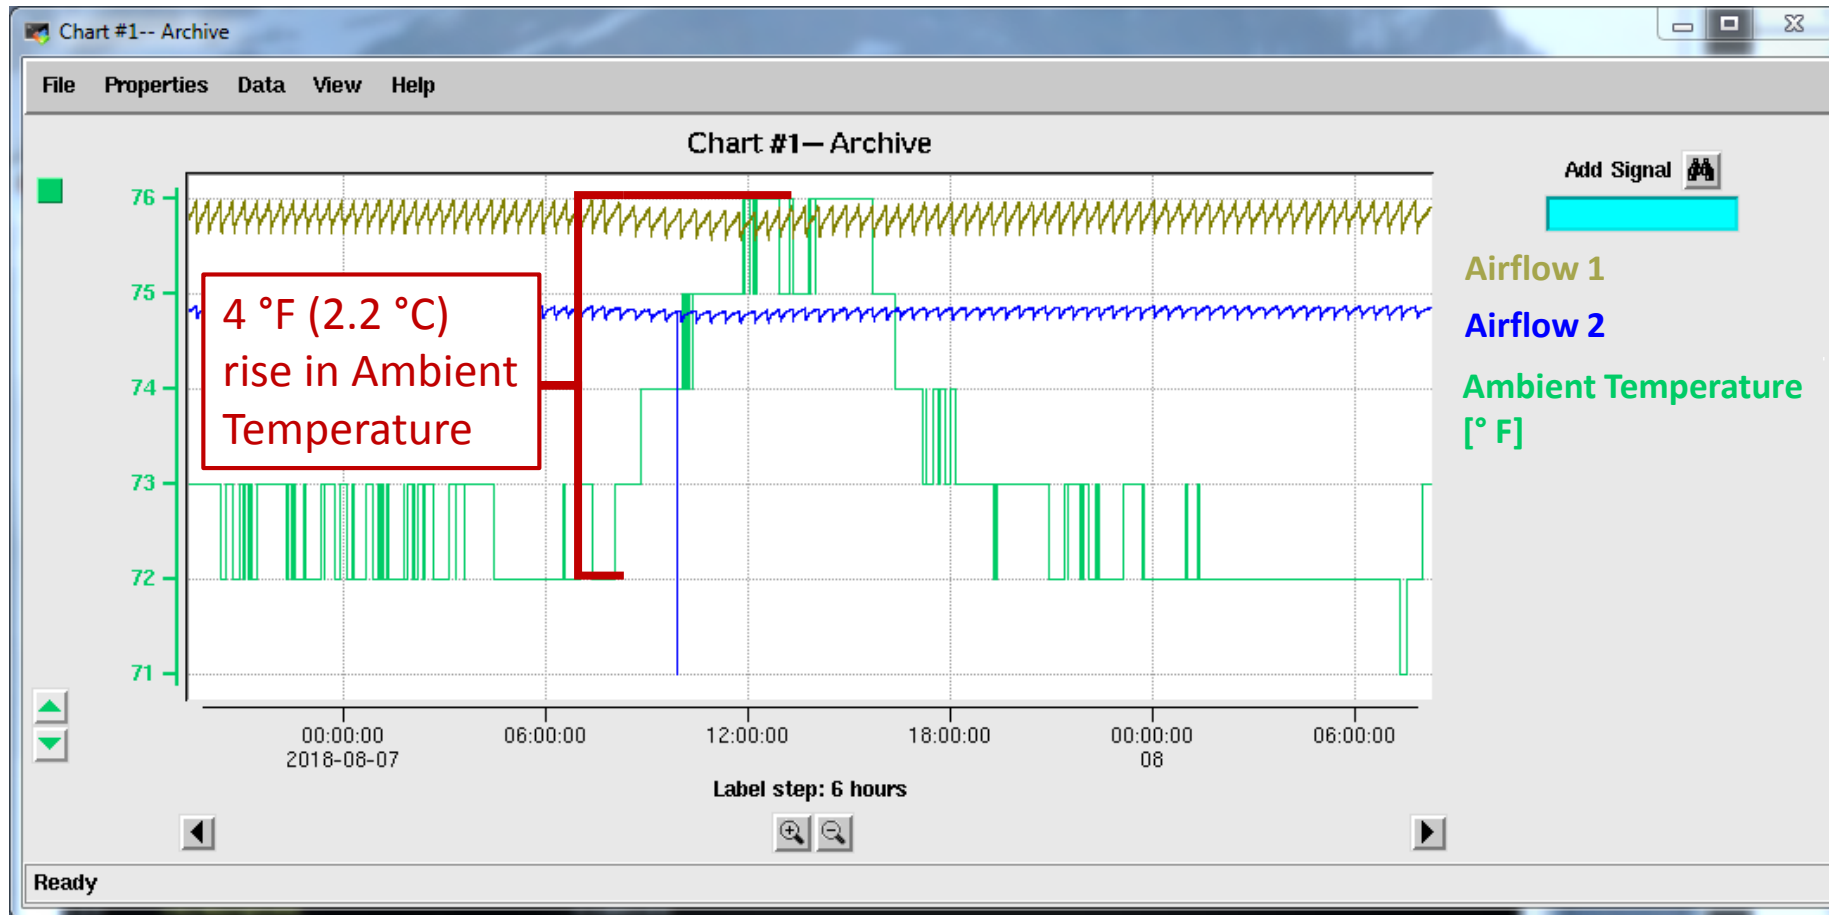
Ambient Temperature Change During Airflow Changes

NOTE: Mass Flow Transducers are affected by changes in temperature. Changes in airflow observed may be due to 4 °F increase in Ambient Temperature, not actual flow changes.

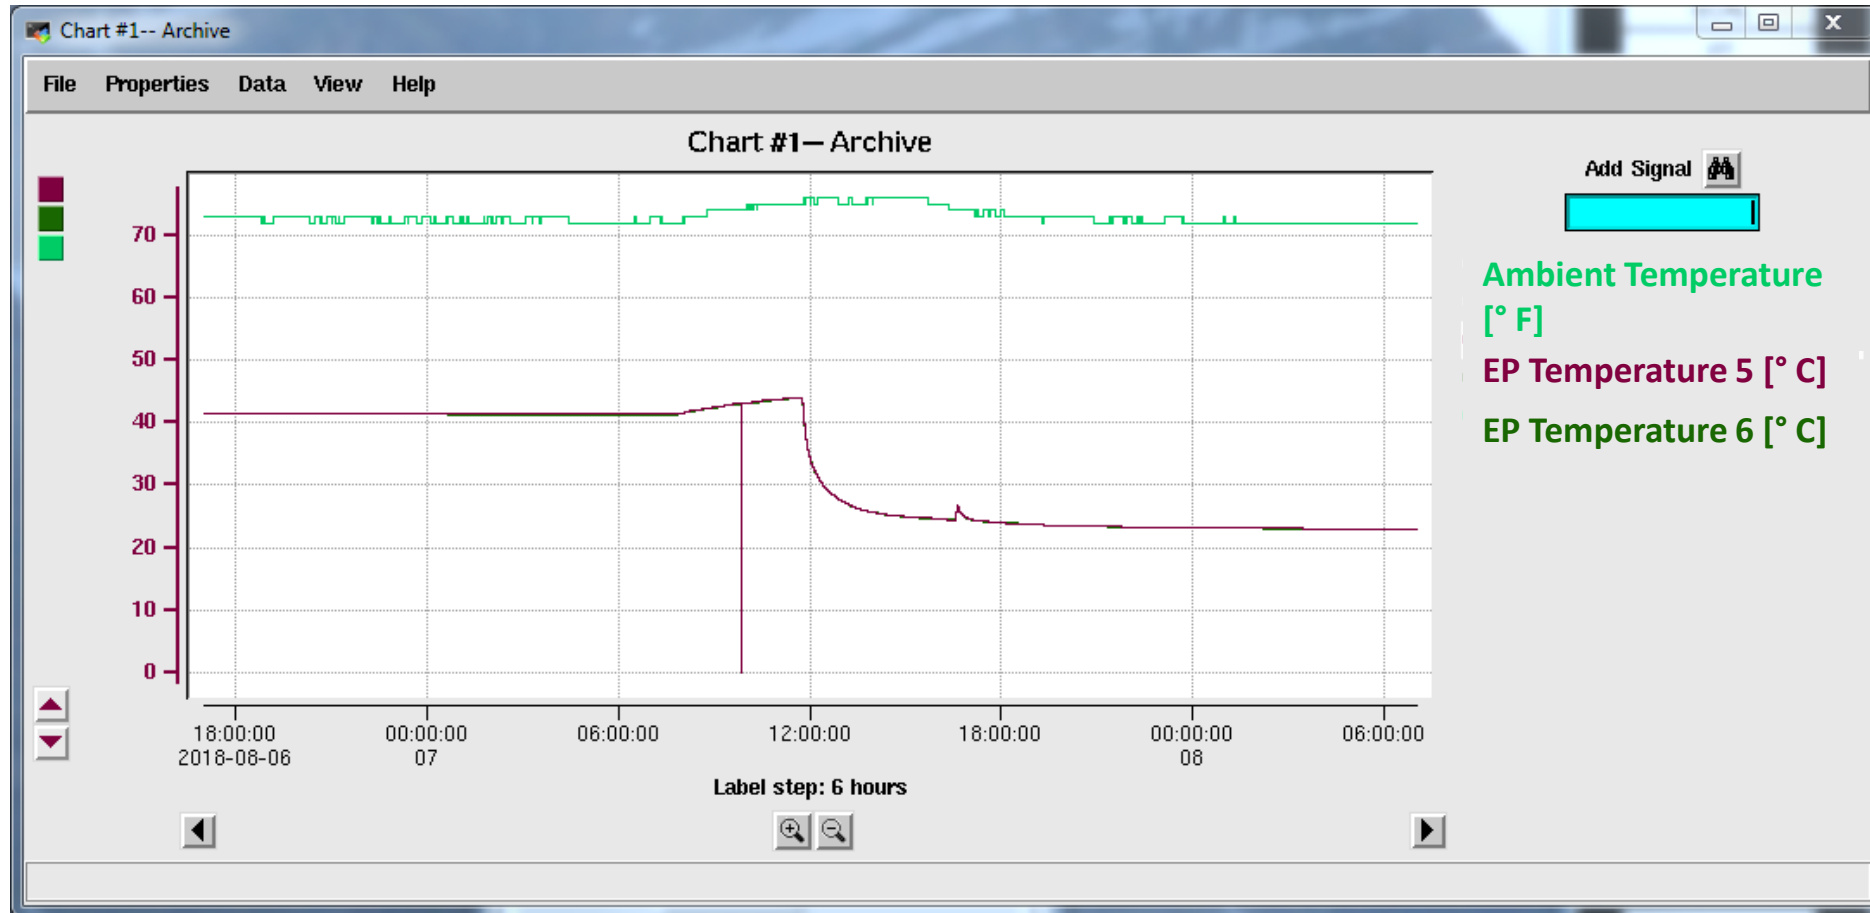
Direct Correlation Between Increases in Ambient Temperature and EP Temperatures

- Changes in Hall B ambient pressure due roll-up door opening affecting cooling airflow.
 - Unlikely, as drop in pressure is small (only 1.5 IWC or 0.003 atm)
- Increase in ambient temperature in Hall B during day.
 - Most likely cause since Mass Flow Transducers are affected by changes in temperature.
 - Direct correlation observed between increases and ambient temperature and increases in EP temperatures.

- Thresholds for EP temperature sensors increased by 2 °C.
- RICH will remain powered off until Hall B ambient conditions become more stable or cause of changes is found
- DSG will move the Ambient EP temperature sensors (T15,16) from the rack near the cRIOs to the air-cooling buffer tank on the top deck of Forward Carriage.
 - Would give better indicator of temperature of cooling air before it flows into RICH.
