# RICH Spherical Mirror Reflectivity Tests

Tyler Lemon

Detector Support Group

August 30, 2017

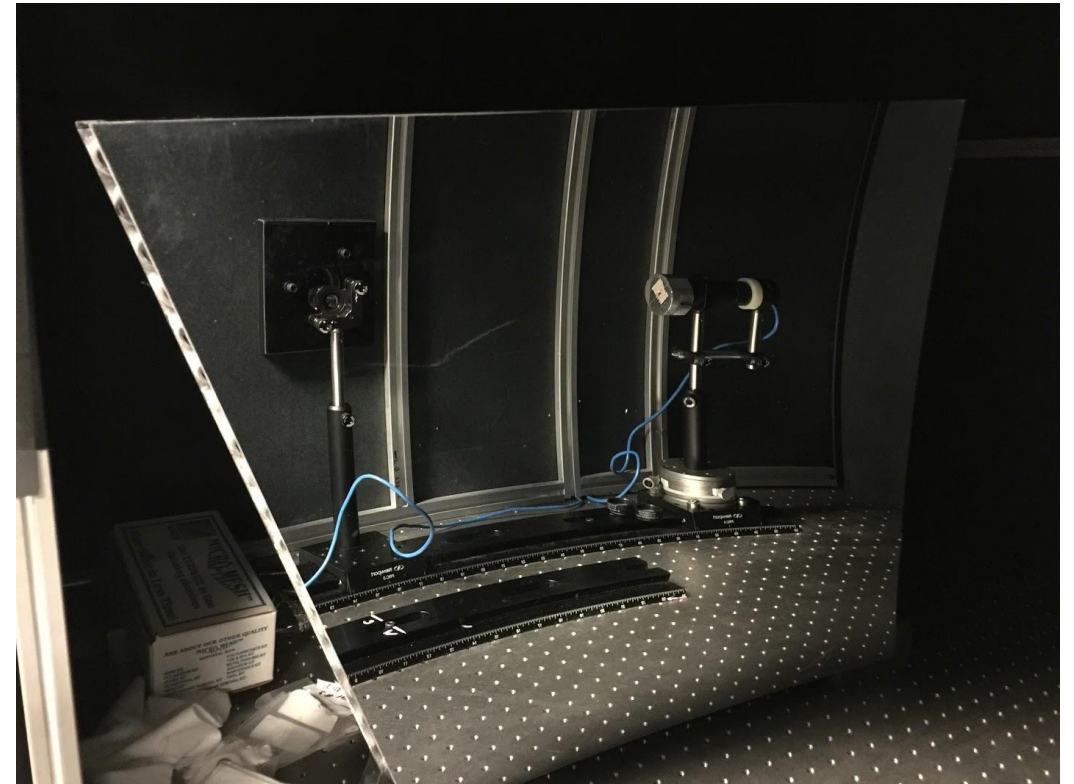
# Spherical Mirrors 3 and 4

- Received at JLab after final coating on June 16, 2017.
- Both mirrors had areas that looked smudged and scratched.
  - Poor surface quality caused by issues with fabrication process.
  - Prompted all spherical mirrors to be sent back to fabricators, Composite Mirrors Application, Inc. (CMA), for rework.
- Mirrors 3 and 4 remained at JLab to be tested with reflectivity test station.

Spherical mirror 3 in reflectivity test station's dark box.

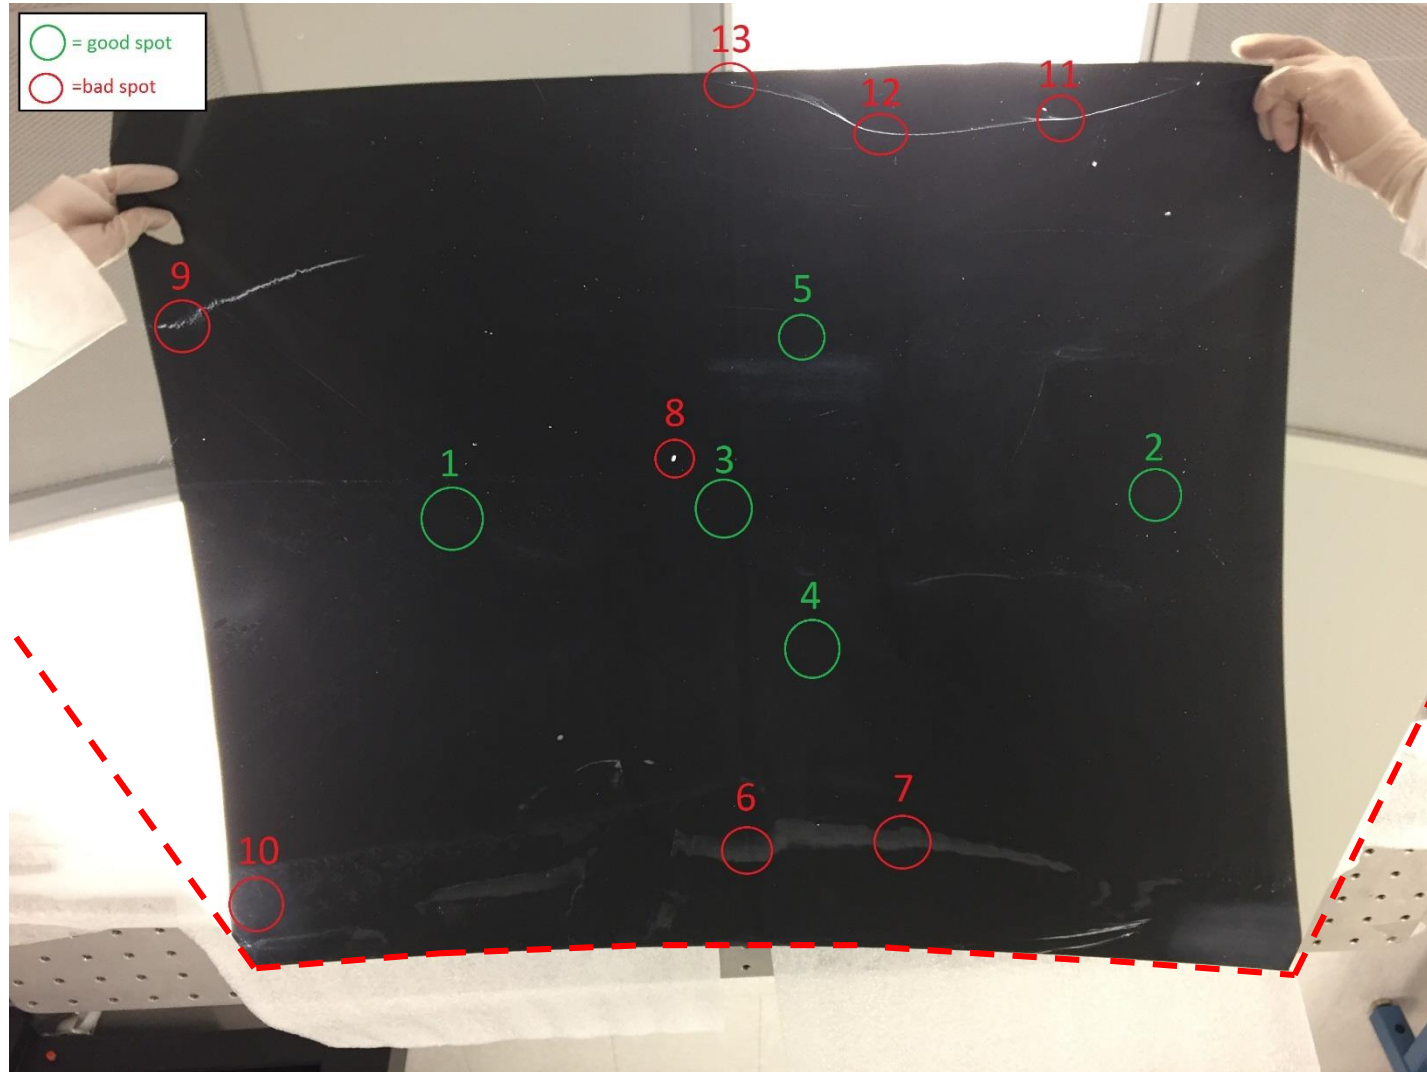
# Mirror 3 Reflectivity Test Spots

- Black sheet held over mirror to be able to see scratches and smudges on surface.
- Red, dashed line marks edges of mirror.

Spot #	Visual Quality of Spot	Reflectivity [%]
1	GOOD	89
2	GOOD	87
3	GOOD	89
4	GOOD	87
5	GOOD	89
6	BAD	83
7	BAD	82
8	BAD	73
9	BAD	84
10	BAD	77
11	BAD	84
12	BAD	86
13	BAD	84

**NOTE:**  
**Alignment on scratches may not have been precise enough to get bad reflectivity result.**

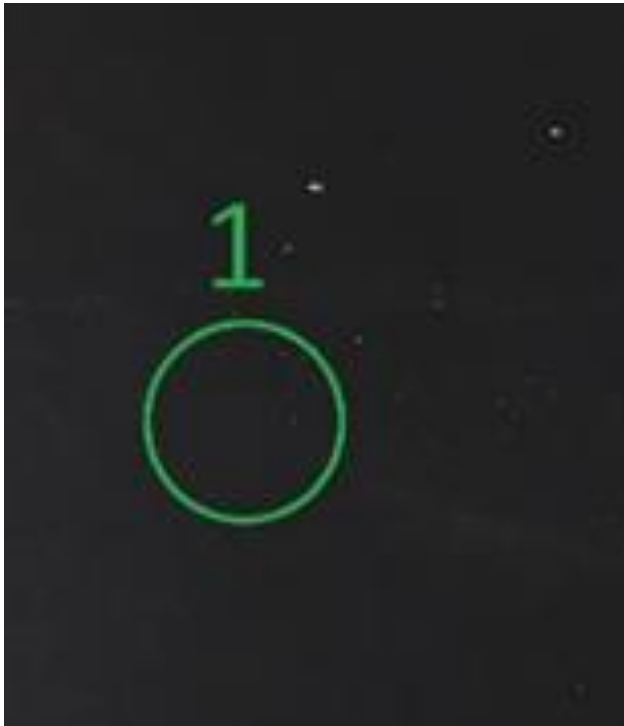
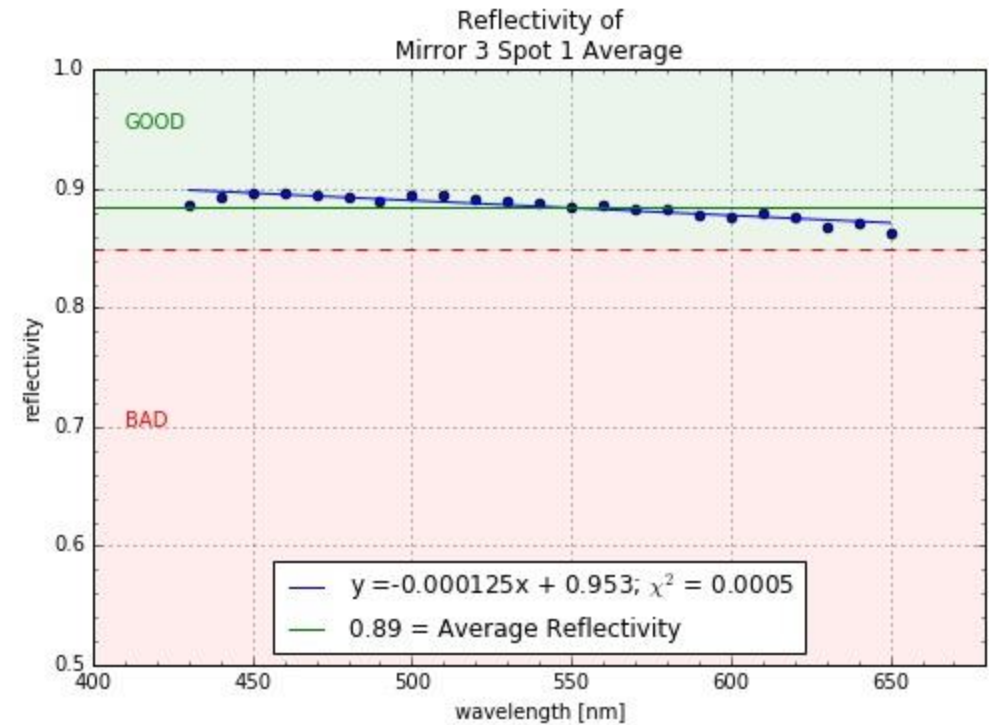
# Mirror 3, Spot 1

Close-up of Mirror 3, Spot 1 from overview photo

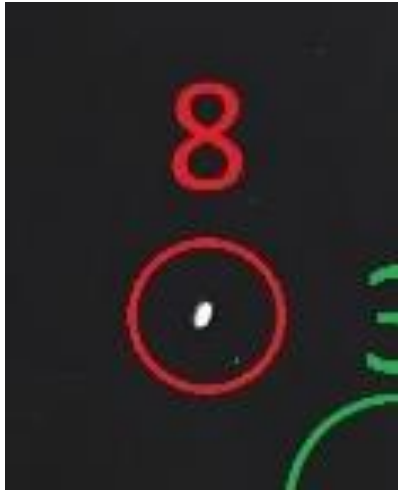
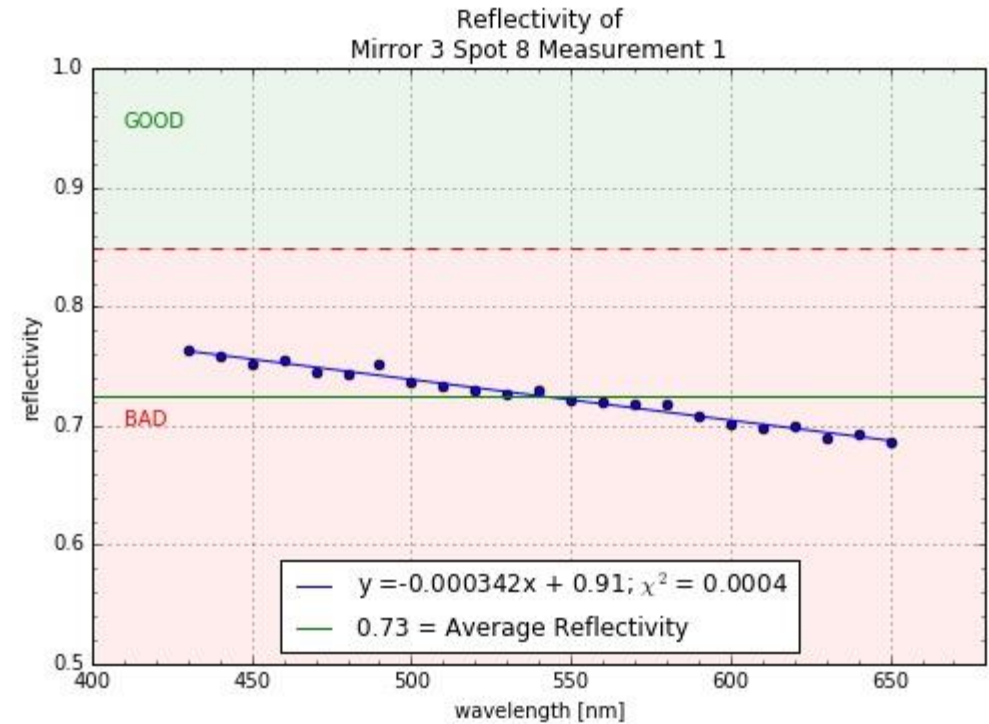
# Mirror 3, Spot 8

Close-up of Mirror 3, Spot 8 from overview photo

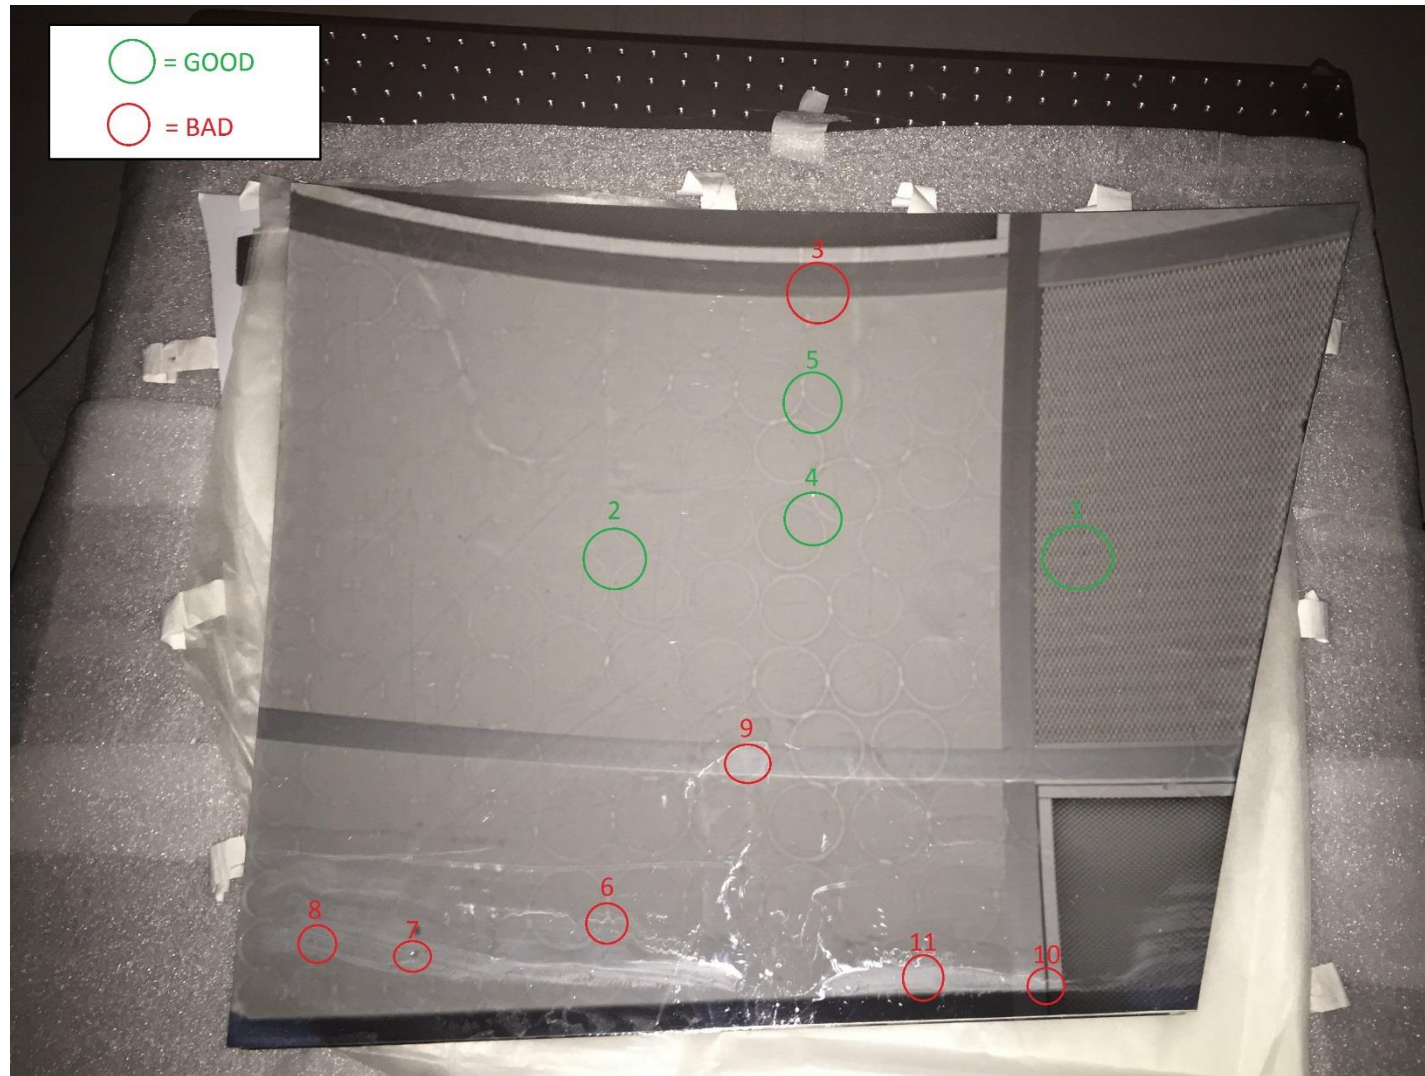
# Mirror 4 Reflectivity Test Spots

Spot #	Visual Quality of Spot	Reflectivity [%]
1	GOOD	88
2	GOOD	80
3	BAD	81
4	GOOD	90
5	GOOD	89
6	BAD	77
7	BAD	62
8	BAD	67
9	BAD	67
10	BAD	81
11	BAD	76

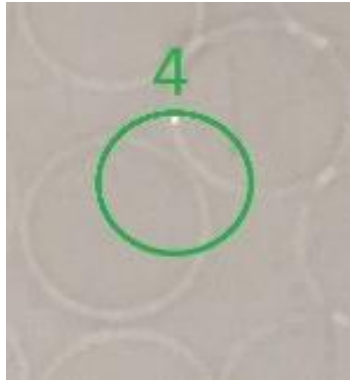
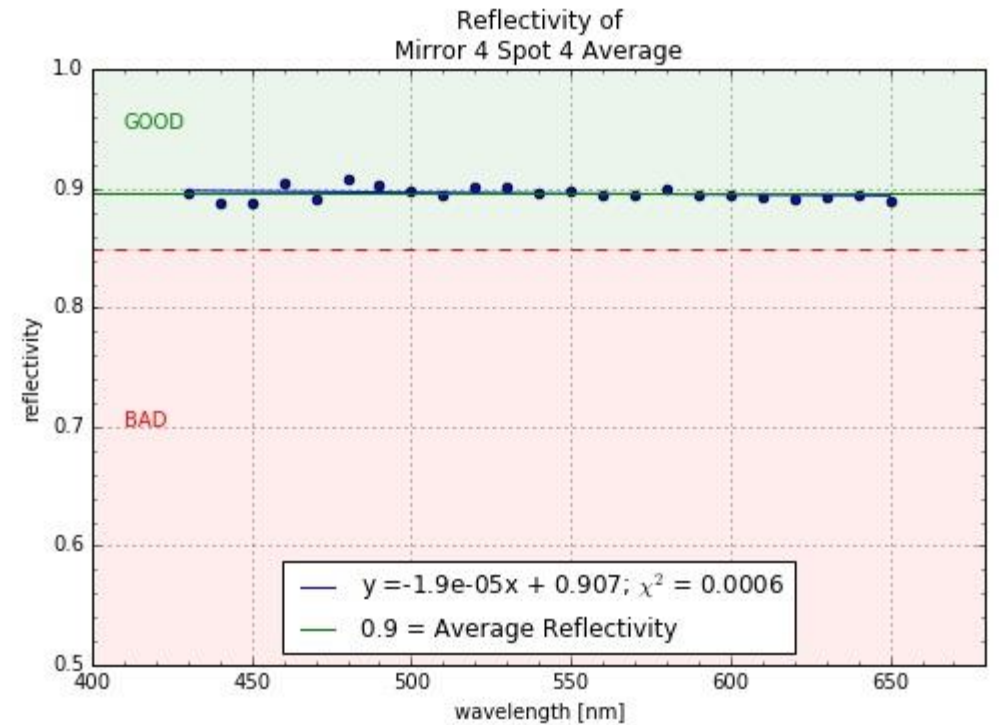
# Mirror 4, Spot 4

Close-up of Mirror 4, Spot 4 from overview photo

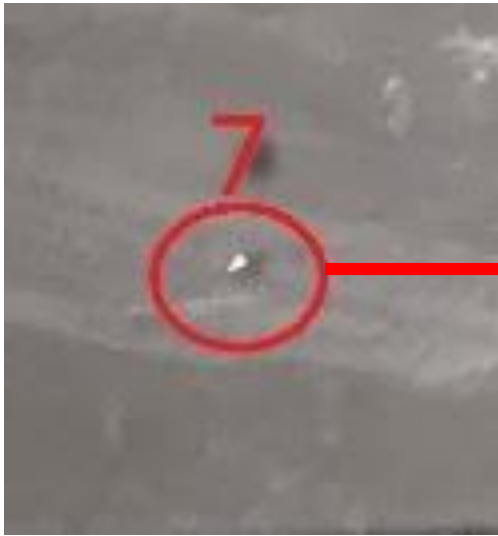
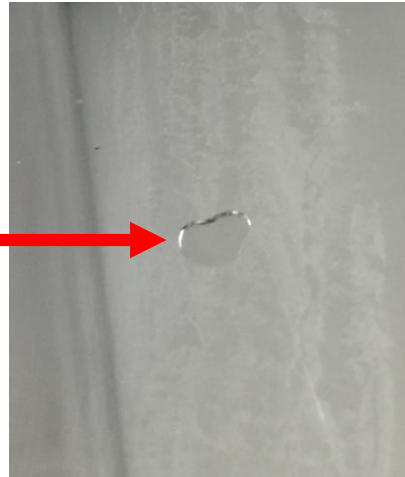
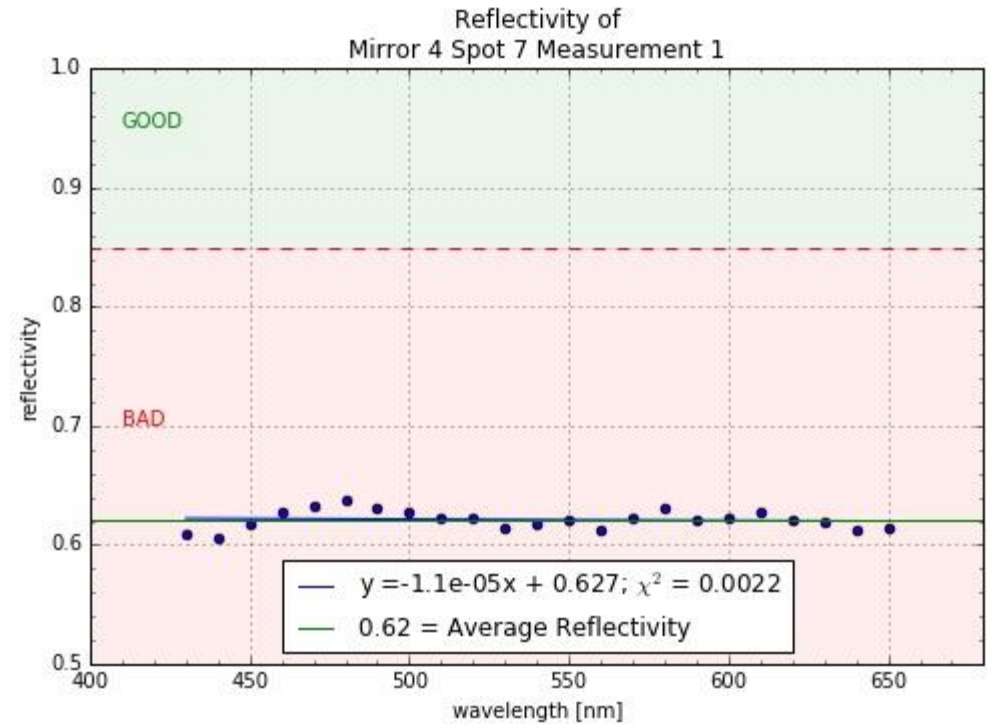
# Mirror 4, Spot 7

Close-up of Mirror 3, Spot 7 from overview photo

Pocket in reflective surface.  
Pocket is ~3 mm in size.

- Good spots have reflectivity close to 90% specification.
  - Lower results could be due to:
    - Bad surface quality
    - Inherent error in test station alignment
- Bad spots have reflectivity ~85% or less.
  - Exceptions possibly due to alignment precision.
- Mirrors are being sent back to CMA for rework.
  - Large areas with bad surface will be fixed.
  - Mirrors 1, 2, 2C, 3C, 4C, 5, 5C, 6 at CMA.
  - Mirrors 3 and 4 shipped, will arrive August 30, 2017 at CMA.
  - After rework, mirrors go to Evaporated Coatings, Inc. for final reflective coating.
