Comparing PLC Project Code After a Major Fault

Brian Eng
2023-02

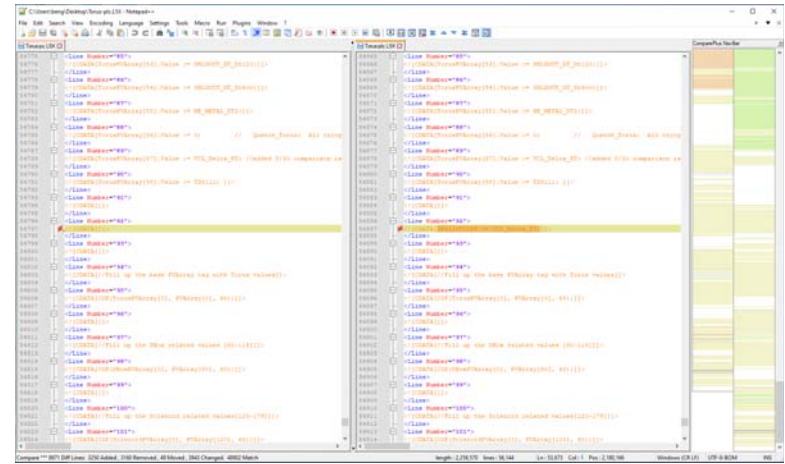
Code Comparison

When saving the code uploaded from the PLC, it was noticed that the code did not match the local copy on the PC, namely the recently added polarity change code was missing. Both the code uploaded from the PLC after the failure and the most recent local copy were exported to an XML format and compared, see figure 2.

The comparison listed 8971 lines different, with those further breaking down to 3250 added, 3160 removed, 49 moved, and 3943 changed. The reason for the discrepancy in numbers is some lines had multiple properties, e.g. moved and changed. Manually viewing the differences, it was found that the vast majority of them were merely tag values being different between the saves. This is expected behavior as many of the tags are just sensor data and would expect to be different. However, some small code changes were noticed other than the missing polarity change code as well.

All the changes were incorporated into the current running PLC code to make the versions match. After manually viewing the file comparison, a Rockwell Automation software package (an optional install) was found that functionally performs the same task (converting to L5X, an XML file, and then running the comparison). Since this is provided by the vendor, it has some added features such as the ability to ignore tag value changes, which greatly reduced the differences (only 53 in total with nearly 30 of them being code comments that were different).
