Debugging RICH-2 Hardware Interlock Trip Delay

Tyler Lemon

2022-06

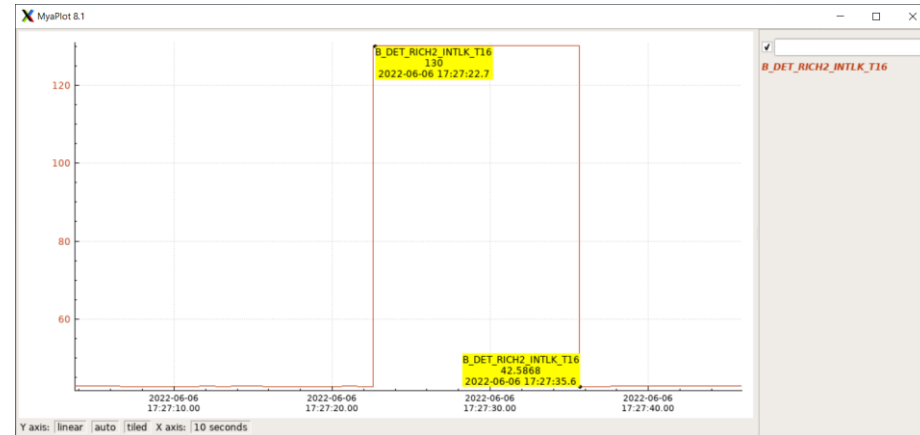
During the first week of the RICH-2 hardware interlock system running in Hall B, there were two occasions where I²C communication errors between the sbRIO and SHT35 sensors saw temperature values jump to 130° C for up to three seconds. Despite logic being included in the hardware interlock system's LabVIEW program to prevent these false, communication-error induced temperature spikes from triggering an interlock, disabling RICH-2's CAEN power supply mainframe, these false readings still caused an interlock on two occasions.

After investigation, a flaw in the Boolean logic used to implement the trip delay was found. In the initial version, the logic was causing a “trip postponement” rather than the desired delay. With the flaw, if a temperature reading was over the set limit, the program would wait 30 seconds, and then trip the interlock, regardless of whether the sensor reading had returned to below the interlock limit. When this behavior was found, the Boolean logic was able to be corrected to implement the desired trip delay.

Fig. 1: Archived EPICS data for RICH-2 temperature sensor 16 showing a 3-second period where it incorrectly gave a 130 C reading. This time period was before the trip delay was implemented.

Since implementing the fix, the RICH-II hardware interlock system has ran smoothly without any false interlock trips induced by I²C communication error.
