Detector Support Group

Weekly Report, 2018-01-17

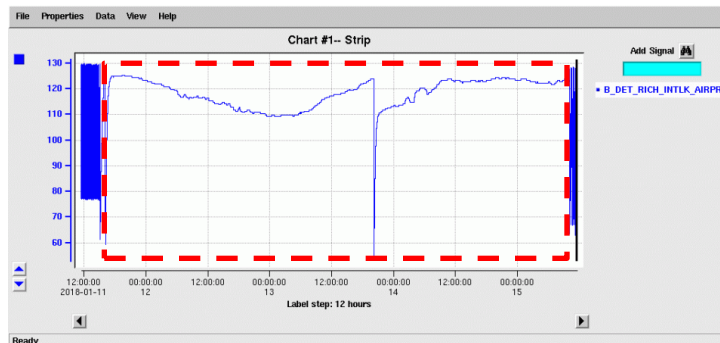
- Troubleshoot of hardware interlock air-cooling tank's pressure interlock trips.
 - ★ Pressure in air-cooling system's tank briefly dropped on January 13, 2018 to below 60 psi, tripping the air pressure low limit interlock.
 - ★ Noted in archived flow and pressure data (plot below), that it seems compressor was not able to provide ~950 slm flow as set on valve panel.
 - Pressure was not oscillating, following on-off cycle of compressor (data in red, dashed box on plot below).
 - Further supported by pressure returning to following compressor's on-off cycle when total airflow reduced to ~900 slm.

Plot of pressure [psi] in air-cooling system's tank from 2018-01-11 at 12:00 to 2018-01-15 at 12:00. Portion of plot in red, dashed box shows that compressor was not able to maintain pressure and operate in its normal on-off cycle.

- High interlock limit was set to 550 slm.
 - * To make airflow more stable and not affected by compressor's cycle, air-cooling panel's regulator setting was decreased from maximum (~60 psi) to ~45 psi.

- Lower regulator setting should help air tank maintain pressure and cause airflow to stabilize and not follow on-off cycle of compressor.
 - * Will continue to monitor airflow stability and adjust regulator again if needed during next hall access period.

- Investigated glitches in air-cooling circuit with Brian, George, and Tyler.
 - ★ Tyler adjusted compressor's cycling dead band from 100 psi – 113 psi to 104 psi – 113 psi.
 - ★ George adjusted the panel's regulator down to 45psi.
 - Flow values remained 500 slm for channel 1 and 400 slm for channel 2.
