Detector Support Group

Weekly Report, 2018-09-12

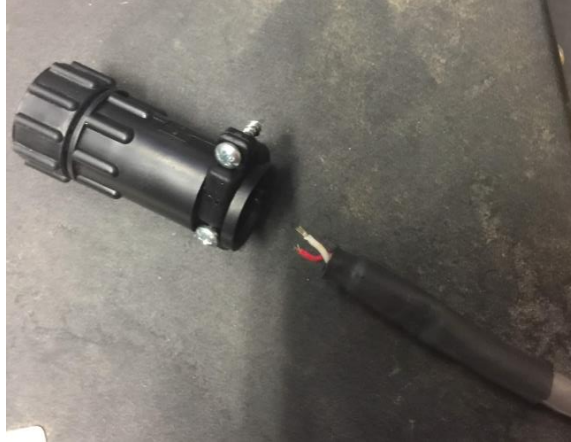
- Debugged cable that enables output of pump relay box.
 - ★ Cable found to have broken connector.

Broken output enable cable for SVT chiller pump's relay box.

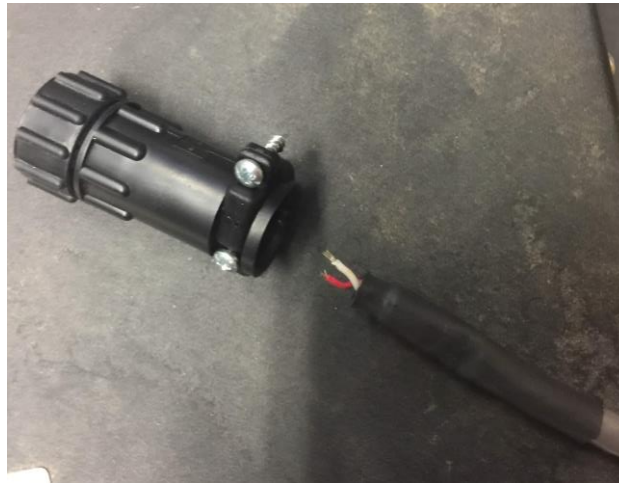
- Powered off **RICH** compressor in preparation for hurricane.
- For **SVT**, found cable that enables output of pump relay box had a broken connector.

- ★ Notified by Hall B that relay box output could not be enabled.
 - ★ Verified all wiring and fuses at cRIO before finding broken connector.

Broken output enable cable for SVT chiller pump's relay box.
