Summary

Detector Support Group

Weekly Report, 2019-04-24

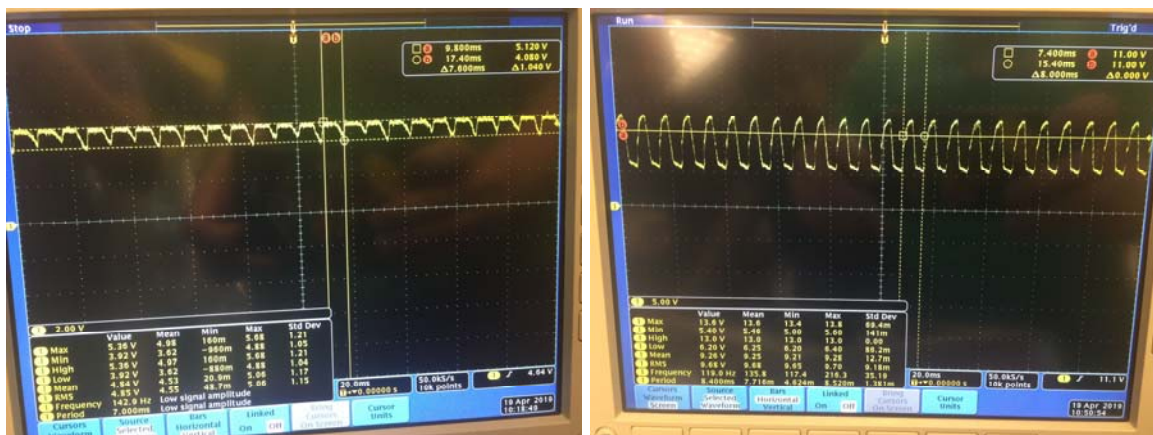
- Bad +5 V power supply investigated in Dilution Refrigerator's Intelligent Gas Handler.
 - ★ On scope scan noticed +5 V supply dropped to ~ 4 V every 8 ms.
 - ★ Unregulated 11 V supply varied between ~5 V and ~13 V.
 - ★ No erratic blinking of LEDs on startup when regulator is bypassed and a benchtop 5 V DC-supply is used.
 - ★ Replacing +5 V regulator and 2200 μ F capacitor in 5 V circuit resolved issues.

Left: +5 V supply before repairs (max = 5.36 V, min = 3.92 V, mean = 4.84 V).
 Right: Unregulated 11 V supply before repairs (max = 13.6 V, min = 5.40 V, mean = 9.26 V).

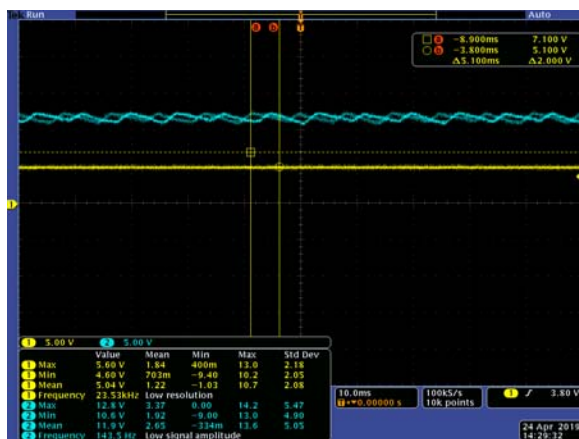
+5 V (yellow signal; max = 5.60 V, min = 4.60 V, mean = 5.04 V) and unregulated 11 V (blue signal; max = 12.8 V, min = 10.6 V, mean = 11.9 V) supplies after repairs.
