State of Adiabatic Damping 10/19/05

IPM1I02 to IPM0R07 in Injector

IPM1C01 to IPM1H04B in Hall A

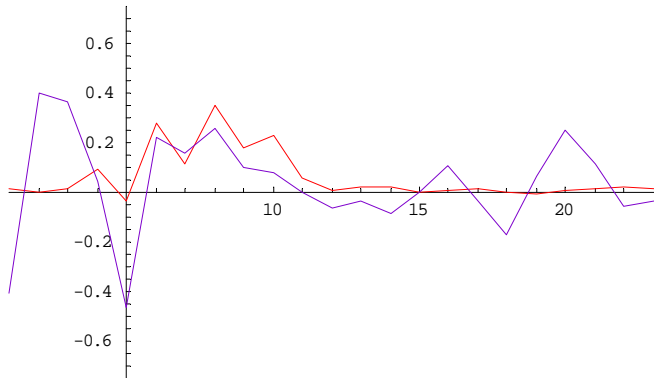
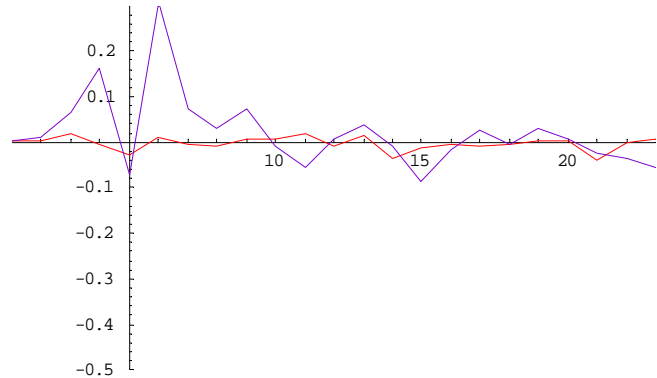
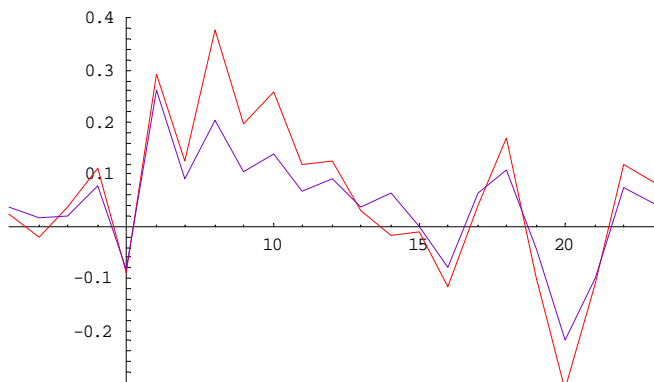
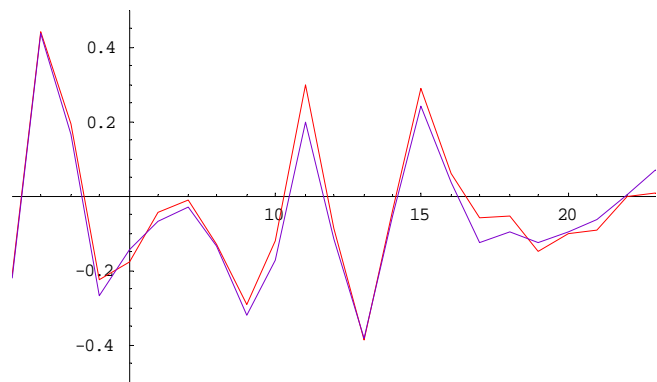
All plots show X & Y components of X PZT in row 1, and the same of Y PZT in row 2 in mm.

Red: 10/19 data (Now); Blue: 10/14 data (Matched Solution)

- X PZT data (top rows) is suspicious given the circumstances. I have asked OPS for opportunistic repeat. Ignore them for now.
- Focusing on Y PZT (bottom rows), apparently some X-plane blowup is developing. This may be the traditional X blowup. There is sign that the PZT signature changed at IPM0L01-02.

- I suspect that Hall A helicity–correlated orbit for the current batch of data will deteriorate somewhat in the X plane compared to 3 days ago.
- We can invoke the PZT guided tuning to minimize this, if it is OK by consensus. It can take minimal amount of time if the observed pattern yields to an obvious combination of knobs, assuming one pass BSY dump setup is still available. This is also a good opportunity to debug a person-independent process that might be needed to respond to further damping deterioration (I'll be away in 2 weeks).

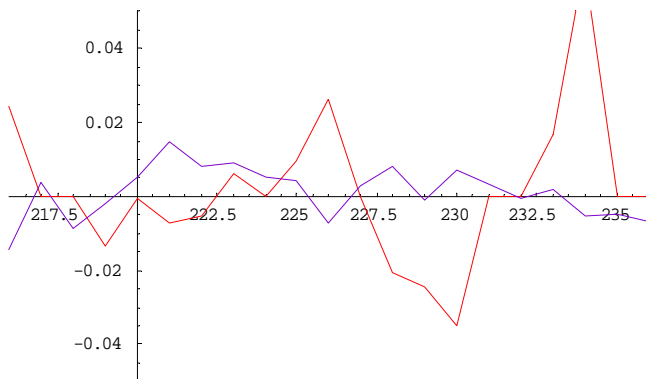
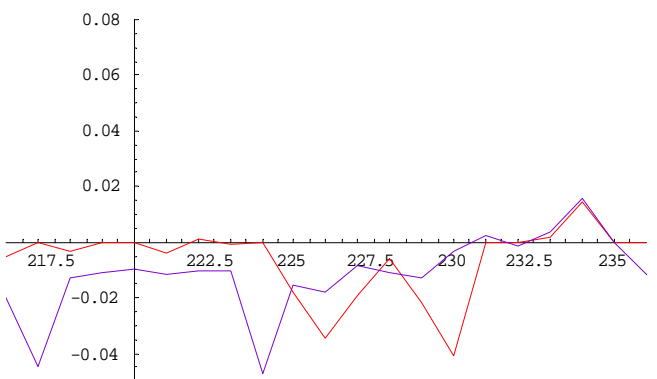
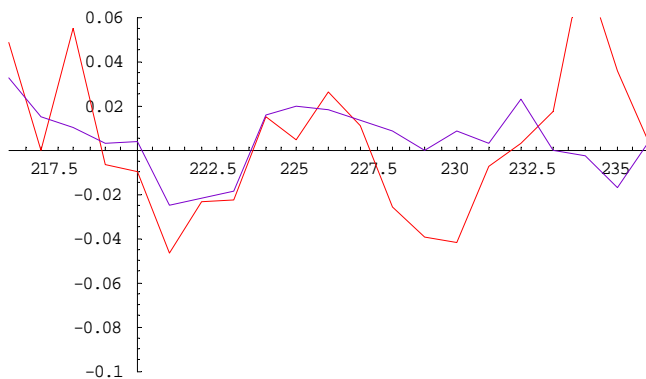
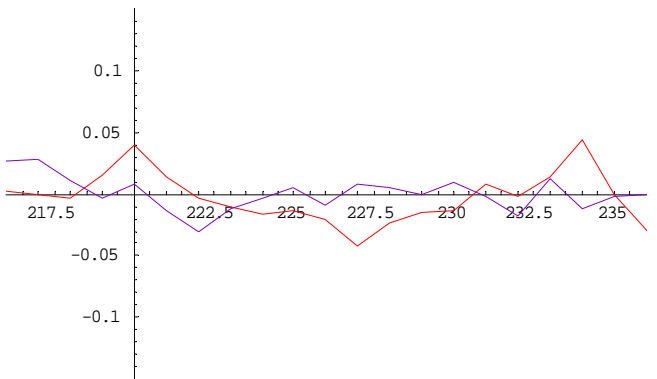
All plots show X & Y components of X PZT in row 1, and the same of Y PZT in row 2 in mm.

Red: 10/19 data (Now); Blue: 10/14 data (Matched Solution)
