Beam Transport Issues in the Fall/Winter 1998 FEL Run

D. Douglas and G. Biallas

Maximum transportable current in the FEL driver was limited to 1.6 mA during the Fall/Winter 1998 run. We discuss various orbit and beam envelope issues which may have contributed to this limitation and suggest remedial actions.

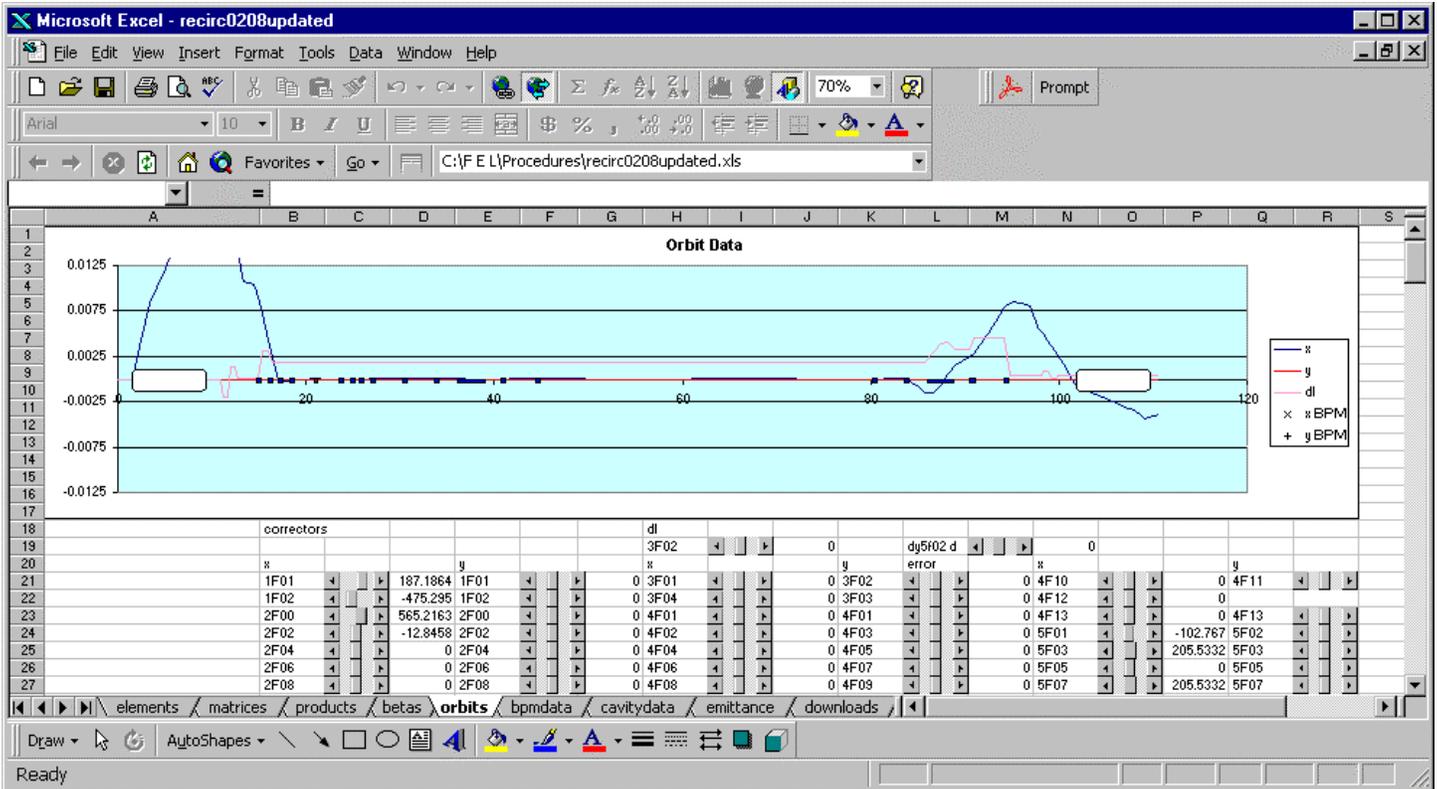
Figure 1 shows the result of the “beam visible on 1F02” steering. Figure 1a) illustrates the steering without a DY excitation error; this case is not centered in QH5F04. With a 7 mm offset after the DY (a 0.35% relative excitation error) the beam is centered in the trim quad, and will be visible on both viewers, somewhat to the right on ITV1F01 and off to the left on ITV1F02 (which was in fact where it was observed). See Figure 1b). This setup had some transmission problems leading to BLM trips on ILM0F062 while lasing. Different steering, with lower losses at the BLM, thus evolved.

Figure 1a): "Beam visible on 1F02" raw steering; no DY5F02 excitation error.

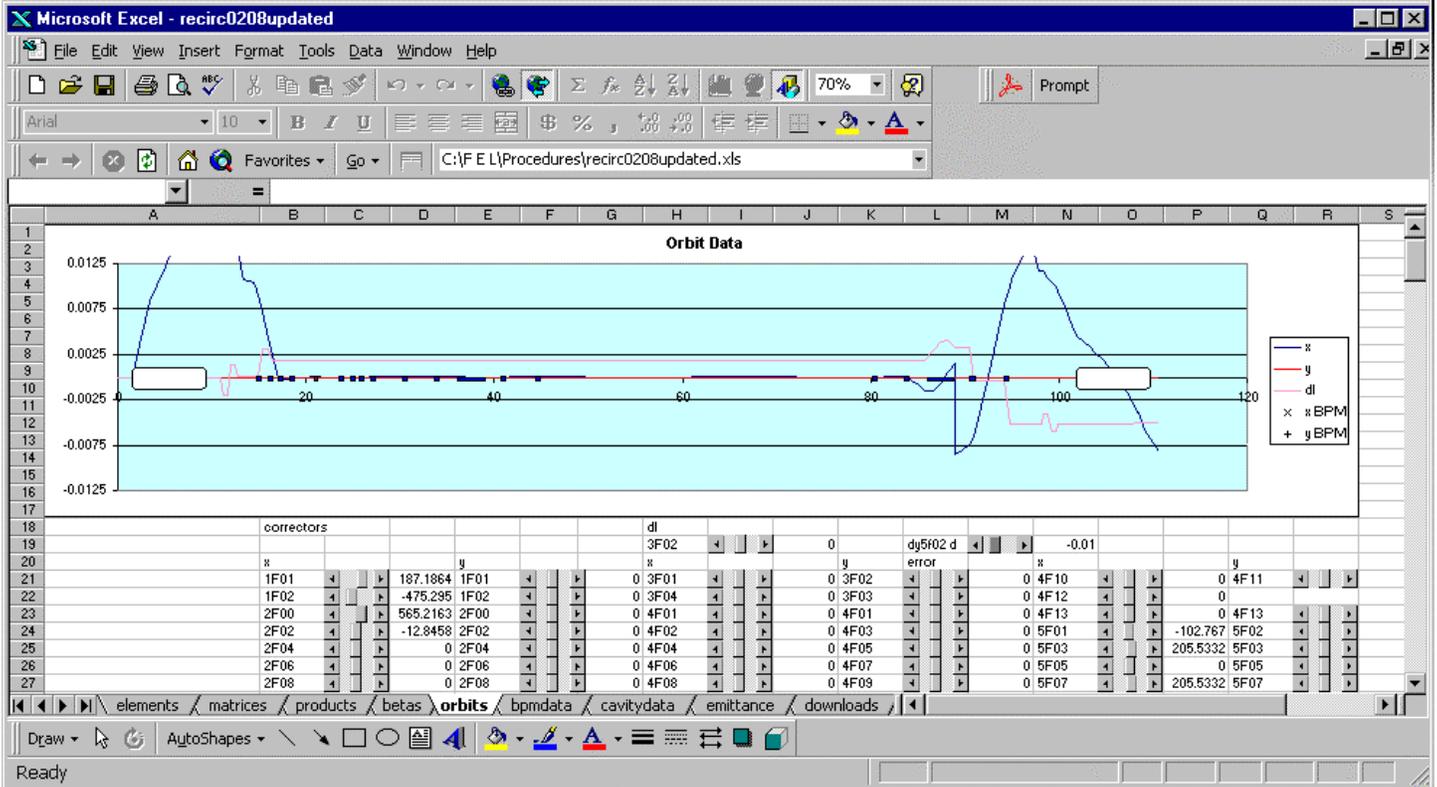
Figure 1b): "Beam visible on 1F02" steering with 0.35% DY excitation error.

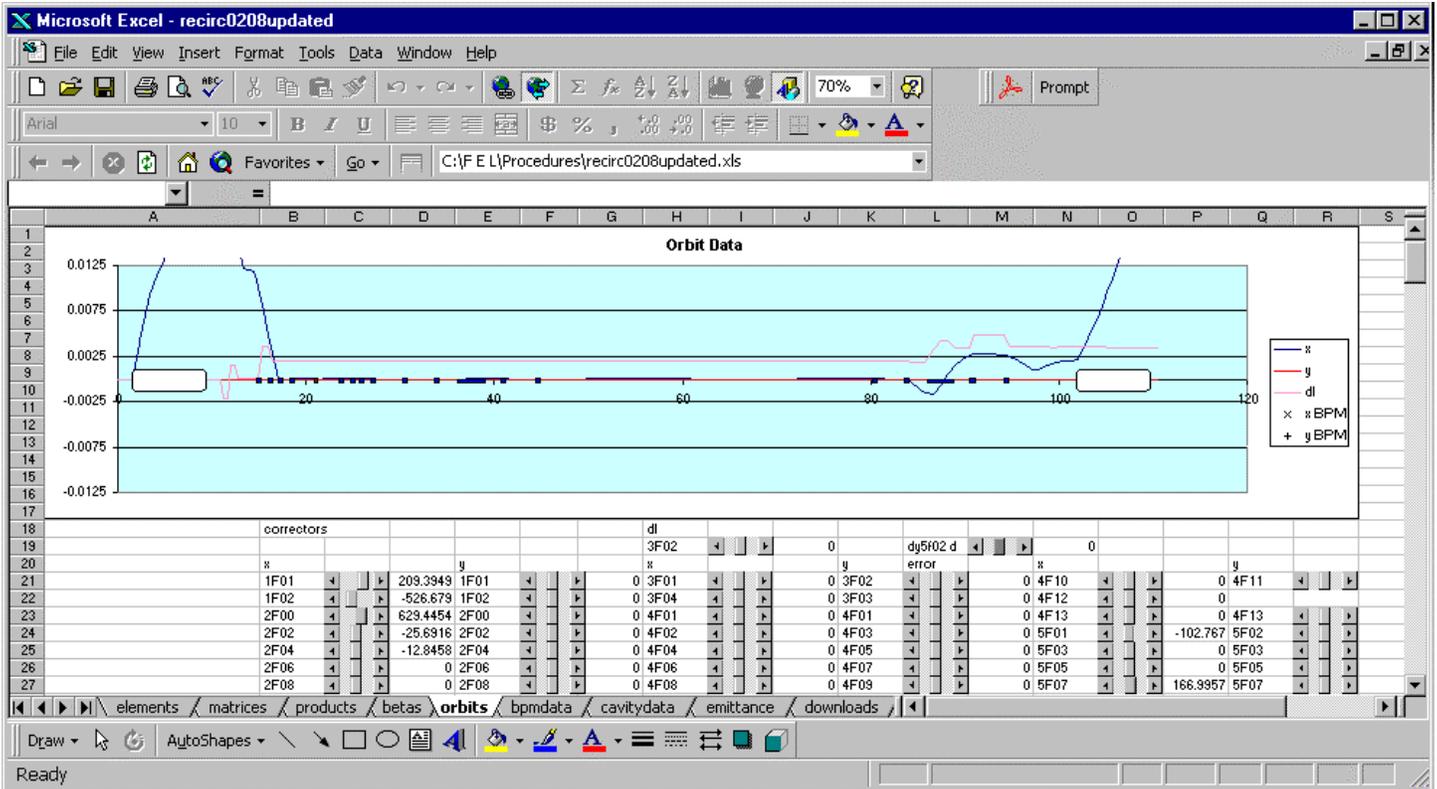
One such steering was devised by Benson [9] and is shown in Figure 2. Figure 2a) illustrates the raw steering; it is not well centered at the trim

Figure 2a): Benson optimization without DY5F02 excitation error

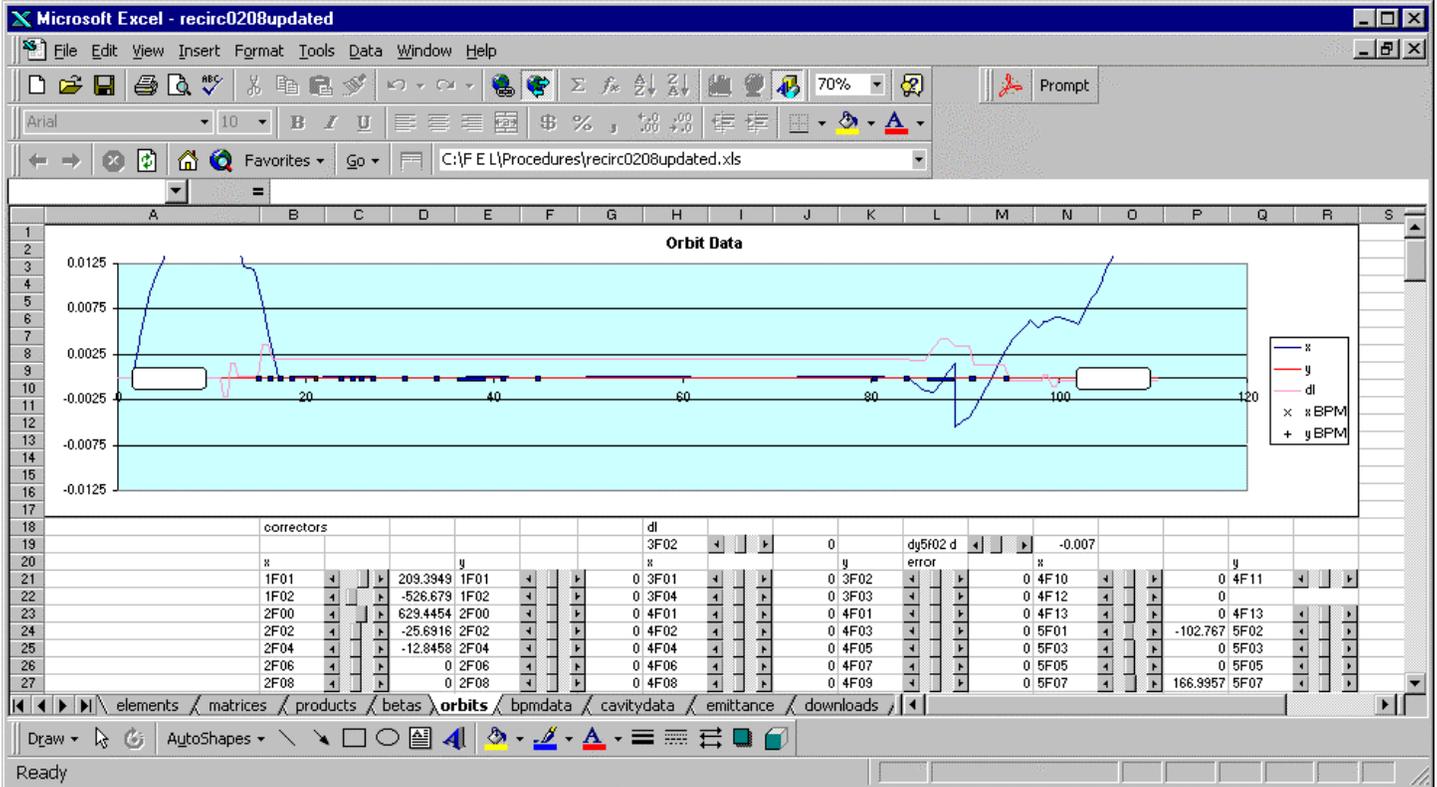
quad. Figure 2b) shows the steering with the aforementioned DY excitation error. This steering is consistent with the assumptions and recollections outlined above.

Figure 2b): Benson optimization with 0.35% DY excitation error.

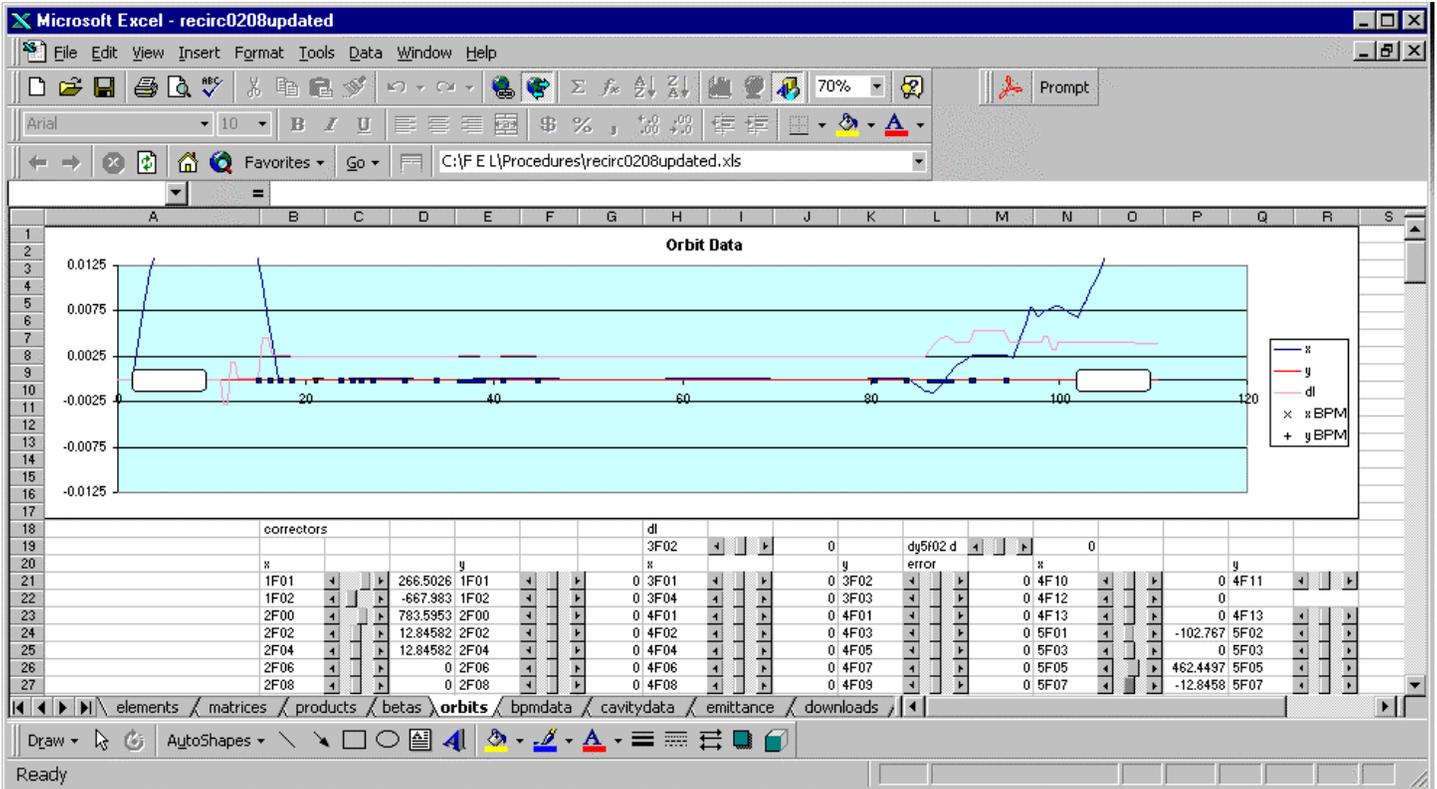
Subsequent steerings used in high power runs were similar in character to the preceding. In each of the two cases shown in Table 1 and Figures 3 and 4, the orbit does not satisfy the observed behavior (Figures 3a and 4a) unless the DY is misexcited at about the 1/3% level (Figures 3b and 4b). Neither of these steerings produced significantly different limiting currents, even though the later one was accompanied by a modification of the recirculation dipole buss. We note that the “beam visible at 1F02” steering differs primarily from the others by the use of the 5F03H corrector. It thereby imposes different entrance angles and positions at the module, with the result that the beam is much farther to the left when it arrives at 1F02. It is also farther to the left at 1F01. This may relate to the impression that steering to the right at reinjection is needed to avoid BLM trips on ILM0F062. Other steerings, particularly the later two, from 12/8/9 and 12/15/98, tend to be farther to the right in this region.

Figure 3a): High power running configuration of 12/8/98; no DY error.

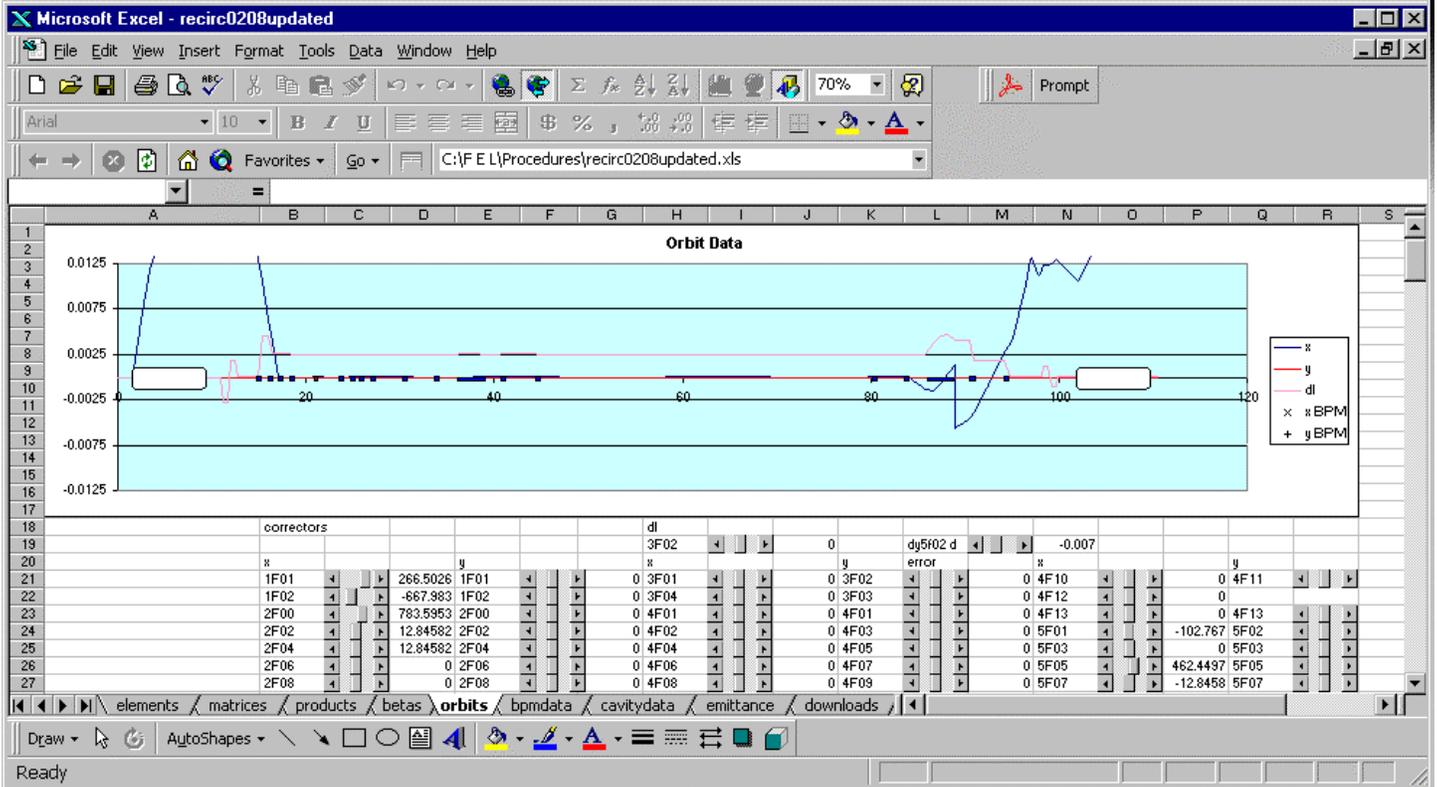
Figure 3b): 12/8/98 configuration with DY error.

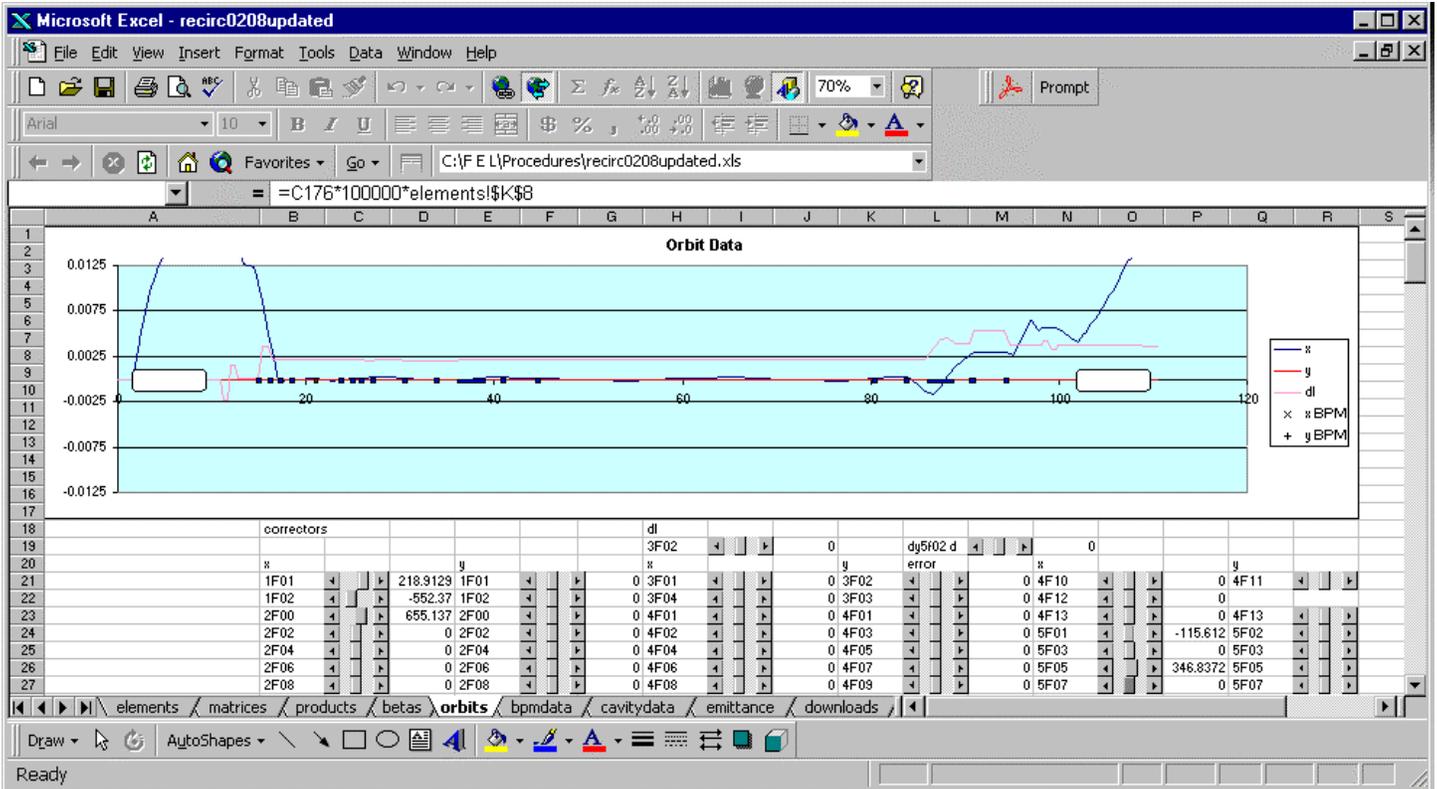
Figure 4a): High power configuration of 12/15/98, no DY error.

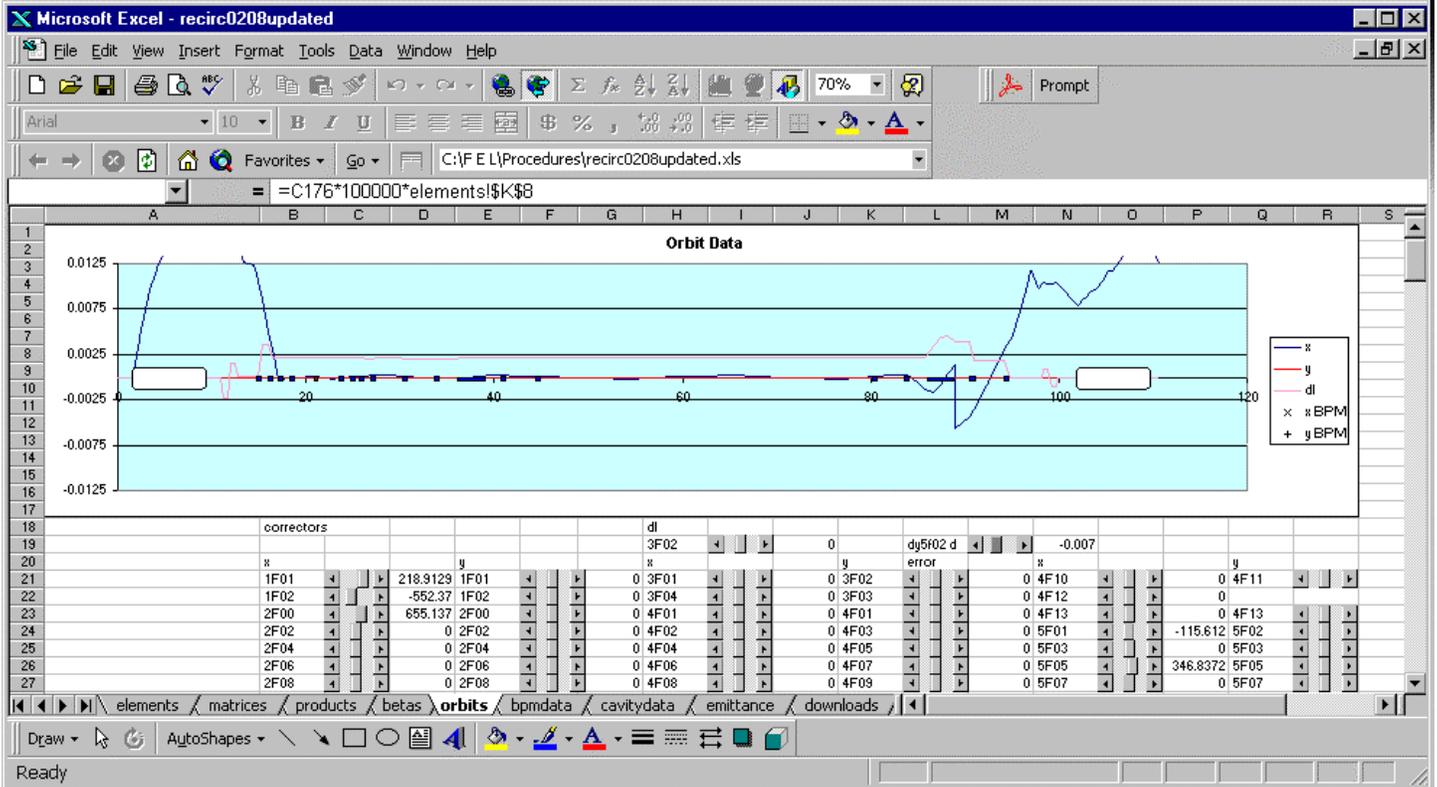
Figure 4b): 12/15/98 configuration with DY error.

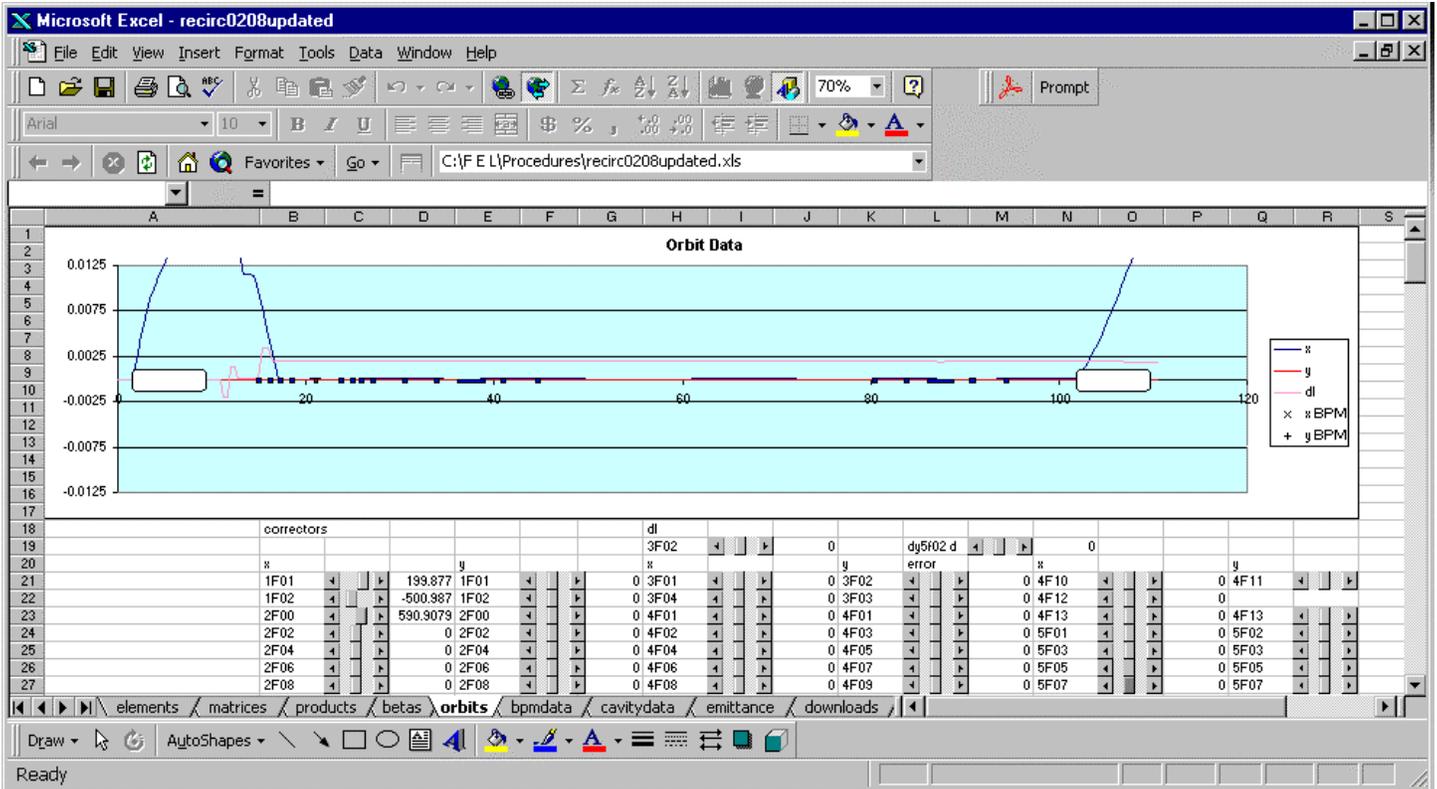
We now consider what happens if the DY is “set right” and all correctors are off. This is shown in Figure 5a. Simply put, the 1F00H corrector (nominally excited to ~200 g-cm to fix some unknown injector problem) blows the recirculated beam away in the module. Figure 5b shows a corrected orbit, in which a beam bump is induced using the 5F03H and 5F05H correctors.

Figure 5a): Corrected DY and 5F region, no compensation for 1F00H field.

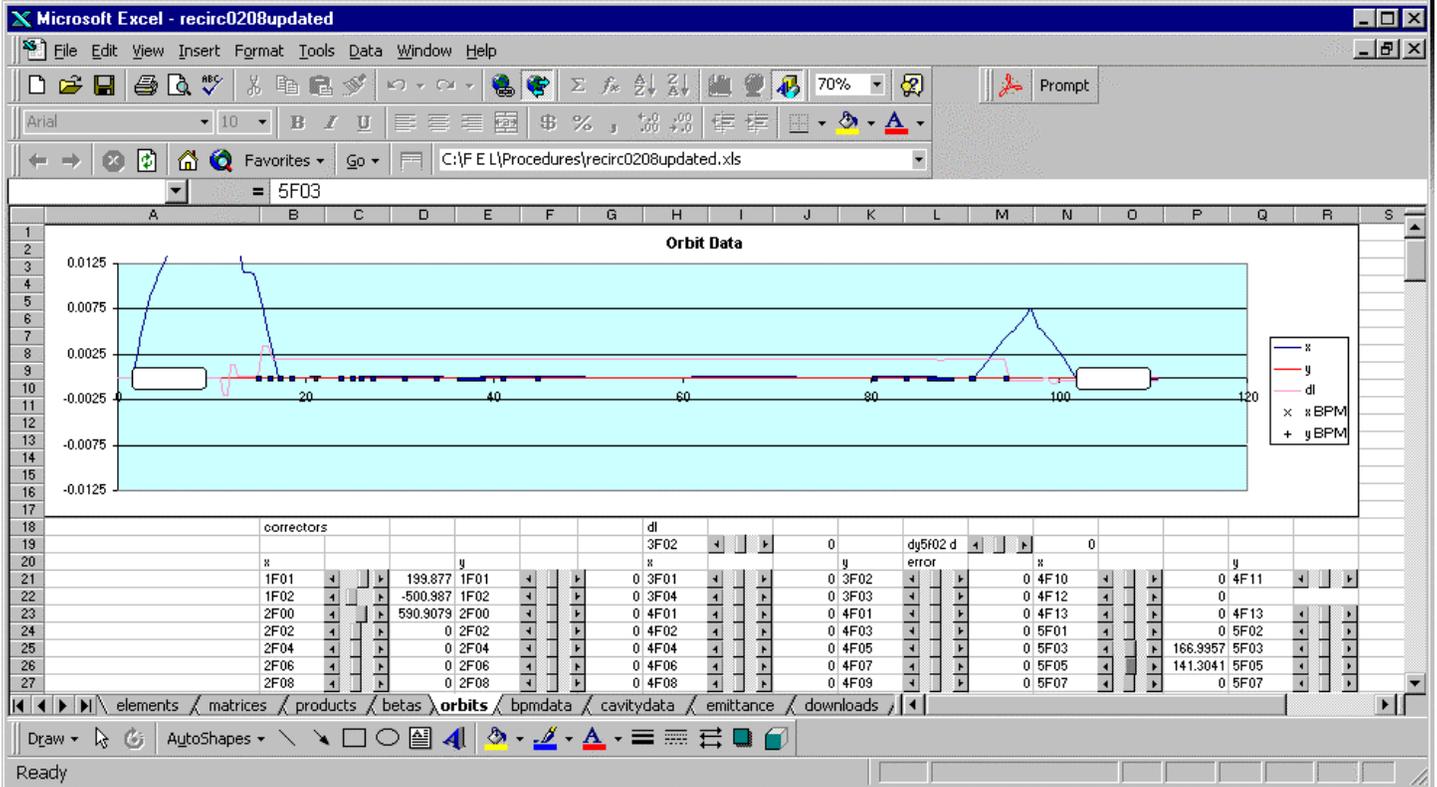
Figure 5b): Corrected DY and 5F region with compensation for 1F00H field.

In summary, we find some evidence in the recorded corrector patterns that the second DY is improperly excited, at a level consistent with the knowledge available from magnetic measurements. We suggest increasing the shunt setting by ~1/3rd percent, and restearing the 5F region, making use of quad centering in the trim quads and the new 5F05 viewer to generate a beam bump in the reinjection telescope so as to offset the apparently necessary excitation of the 1F00H corrector.

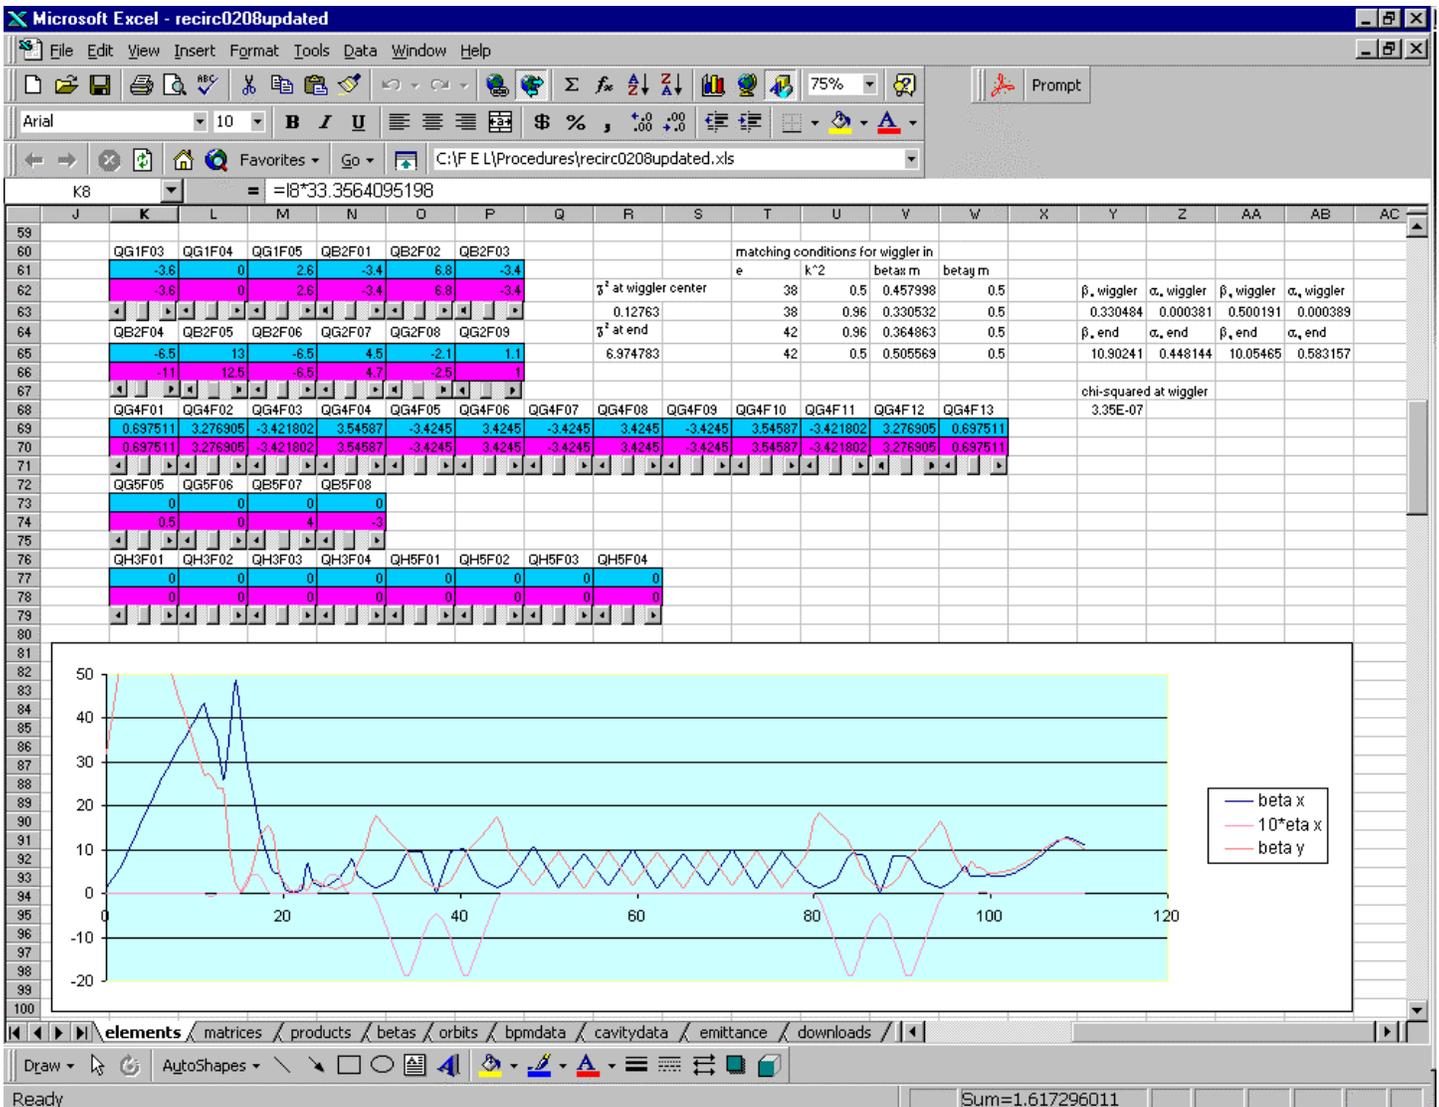
Calculated recirculator optics (based on operational quad settings and an assumed match at the wiggler back-propagated to the injection point) are shown in Figure 6. The wiggler matched values of $\beta_x \sim 33\text{ cm}$ and $\beta_y \sim 50\text{ cm}$ are called out in the screen shot. The regularity of the envelopes in the backleg region indicates correct matching to the recirculator.

Figure 6: Calculated beam envelopes through recirculator.

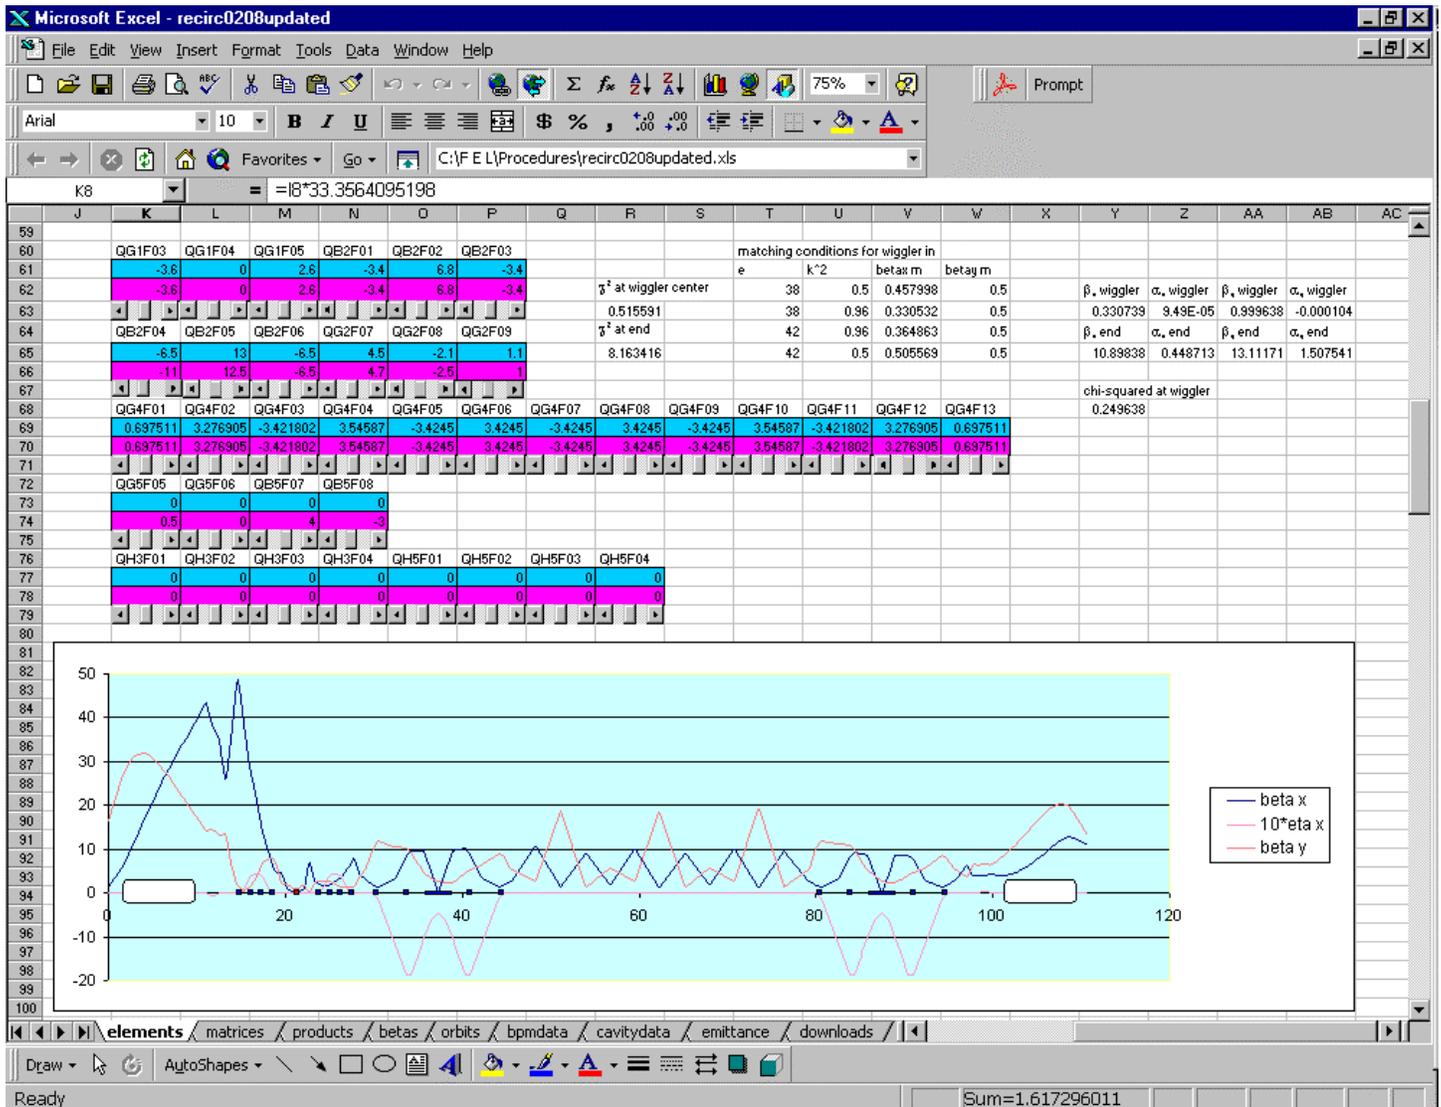
Figure 7 shows the recirculator with the above “design” optics while transporting a vertically mismatched beam with $\beta_y \sim 1$ m at the wiggler. This situation does not seem to lead to conditions particularly conducive to the observed scraping at 4F01 and at reinjection. The peak vertical beam envelopes remain less than 20 m, and the maxima move from the end loops to regions of the back leg that were operationally clean. Figure 8 shows these optics while transporting a vertically mismatched beam with $\beta_y \sim 1/3$ m at the wiggler. This mismatch does appear to lead to conditions conducive to the observed scraping – particularly inasmuch as the peak vertical beam envelopes in the end loops increase to values well in excess of 20 m.

Figure 7: “Design” optics with vertical mismatch $\beta_y \sim 1$ m at wiggler.

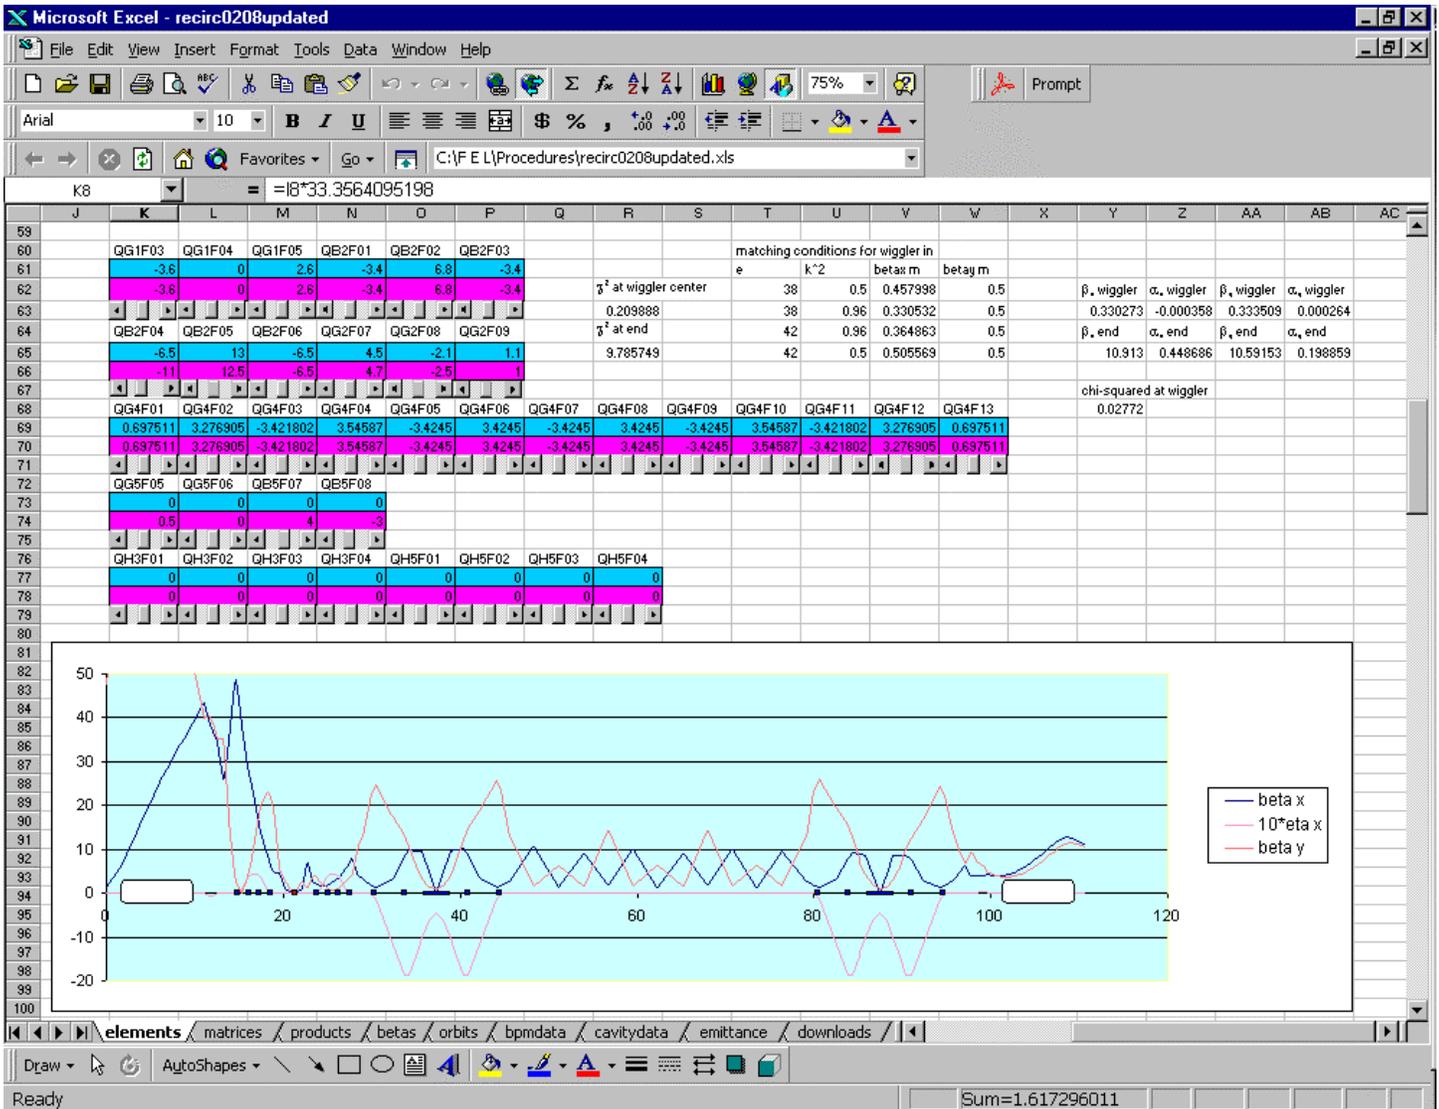
Figure 8: "Design" recirculator with vertical mismatch $\beta_y \sim 1/3$ m at wiggler

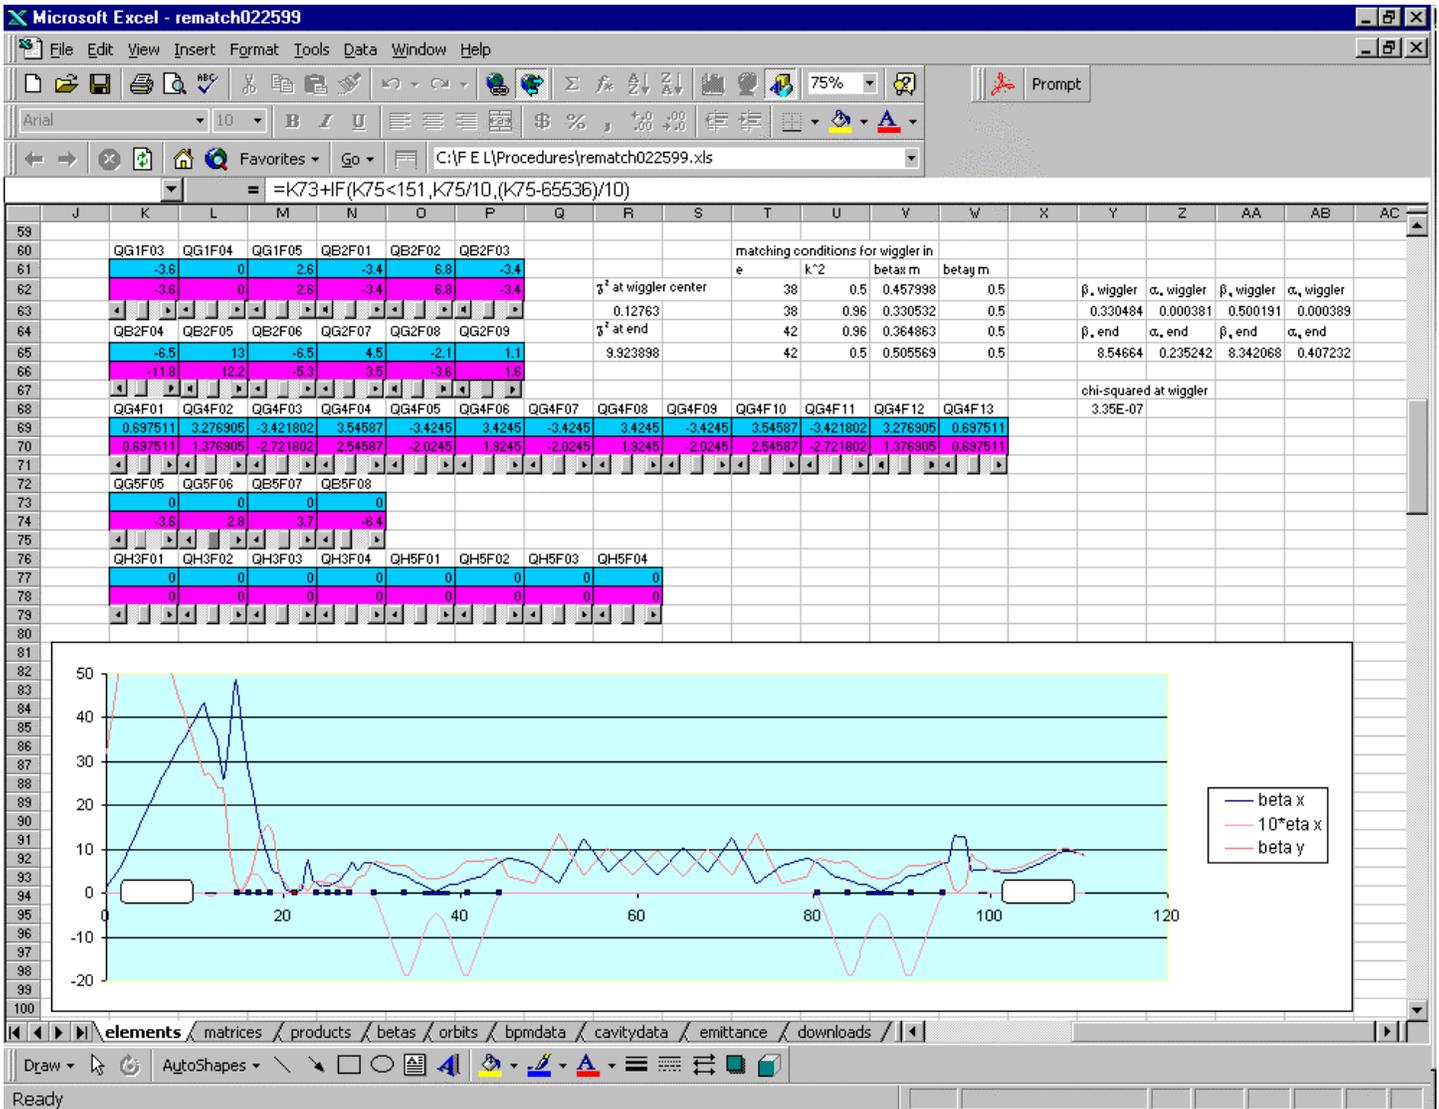
Results of rematching the design phase space ($\beta_x \sim 33$ cm, $\beta_y \sim 50$ cm and upright at the wiggler) are shown in Figure 9. Reduction of beam envelopes (particularly the vertical) in regions with observed scraping and activation is significant and occurs at the expense of minor increases elsewhere (primarily in the backleg). Figures 10 and 11 show the retuned lattice for non-design phase spaces at the wiggler. Figure 10 illustrates the case of a $\beta_y = 1$ m vertical mismatch, Figure 11 the case of a $\beta_y \sim 1/3$ m mismatch. Unlike the design optics, the system is relatively sensitive to large envelopes at the wiggler; it is insensitive to small envelopes at the wiggler. Provided difference orbit methods can be used to certify the lattice, implementation of these alternate matches could allow us to discern the nature of envelope mismatch at the wiggler.

Figure 9: Design phase space at wiggler rematched to recirculator to reduce envelopes in end loops.

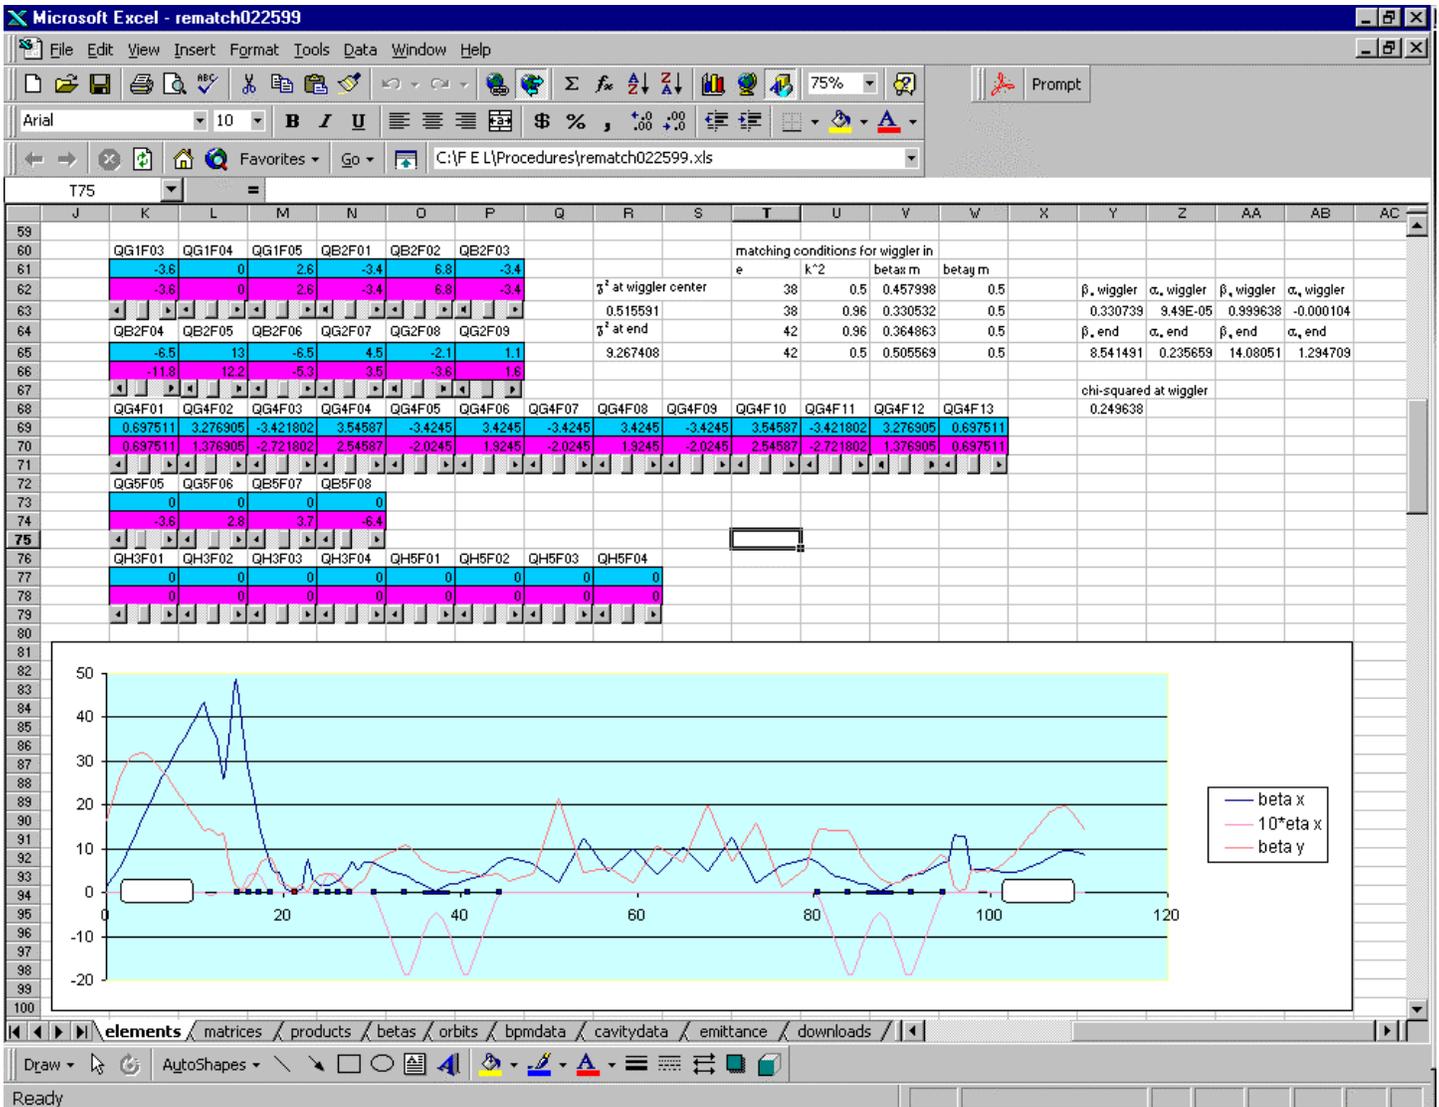
Figure 10: Rematched beam envelopes with erroneous $\beta_y = 1$ m at the wiggler.

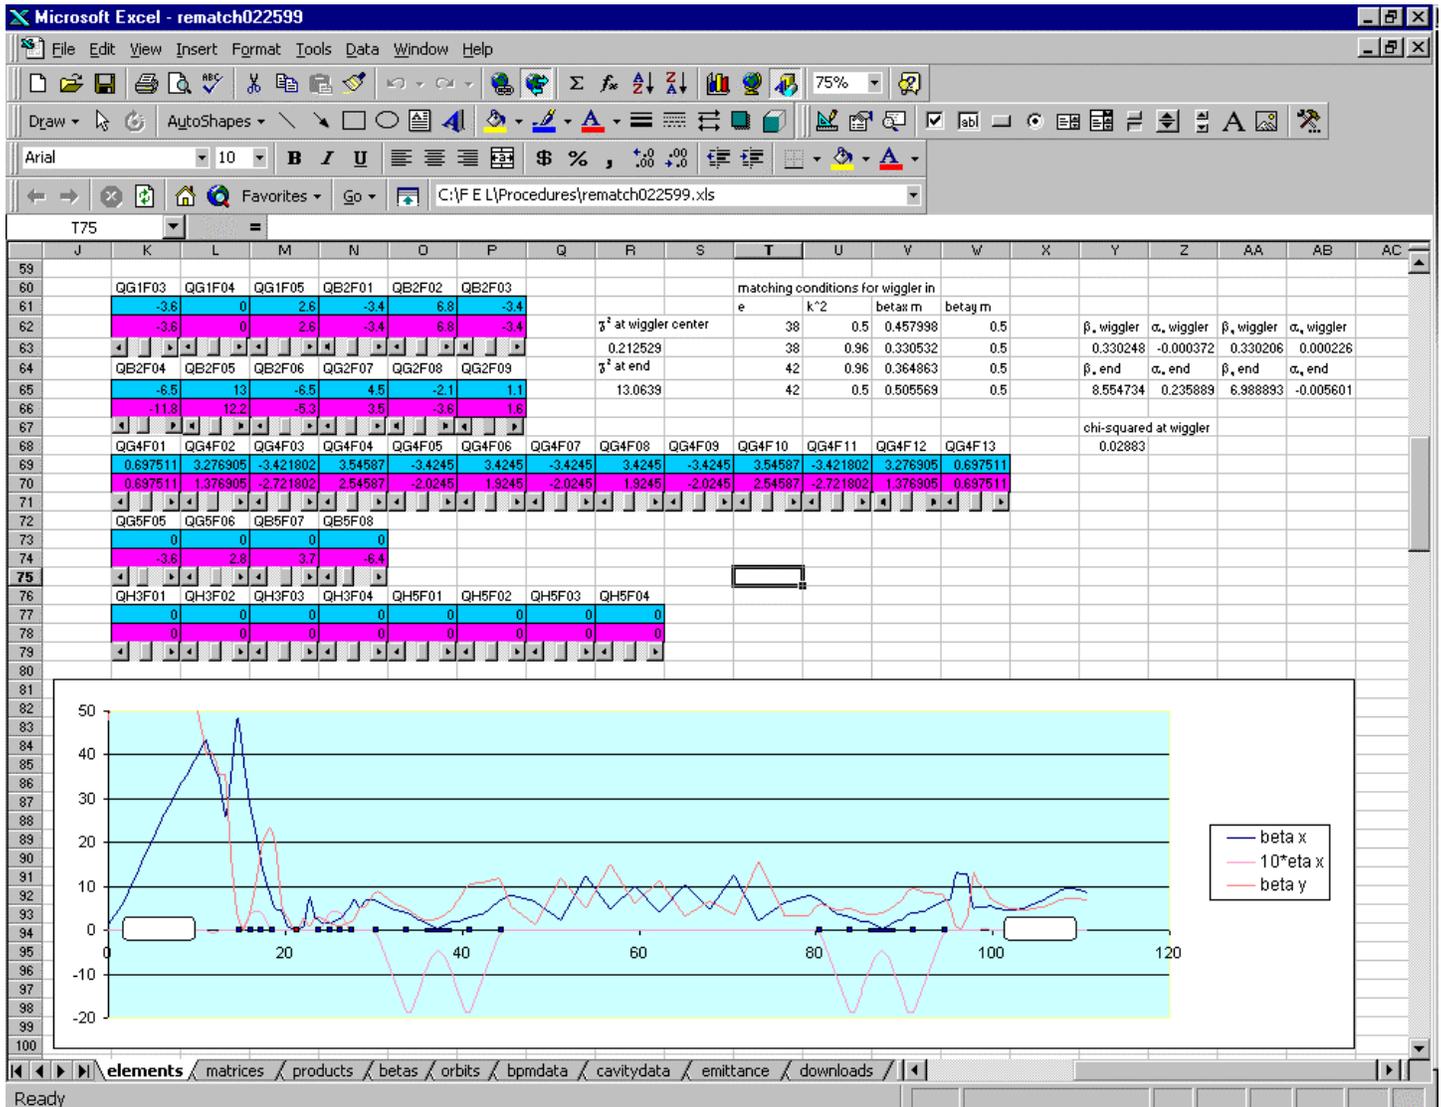
Figure 11: Rematched beam envelopes with erroneous $\beta_y = 33$ cm at the wiggler.
