## Report on the polarized target failure

### ***Brief Description of UVa polarized target***

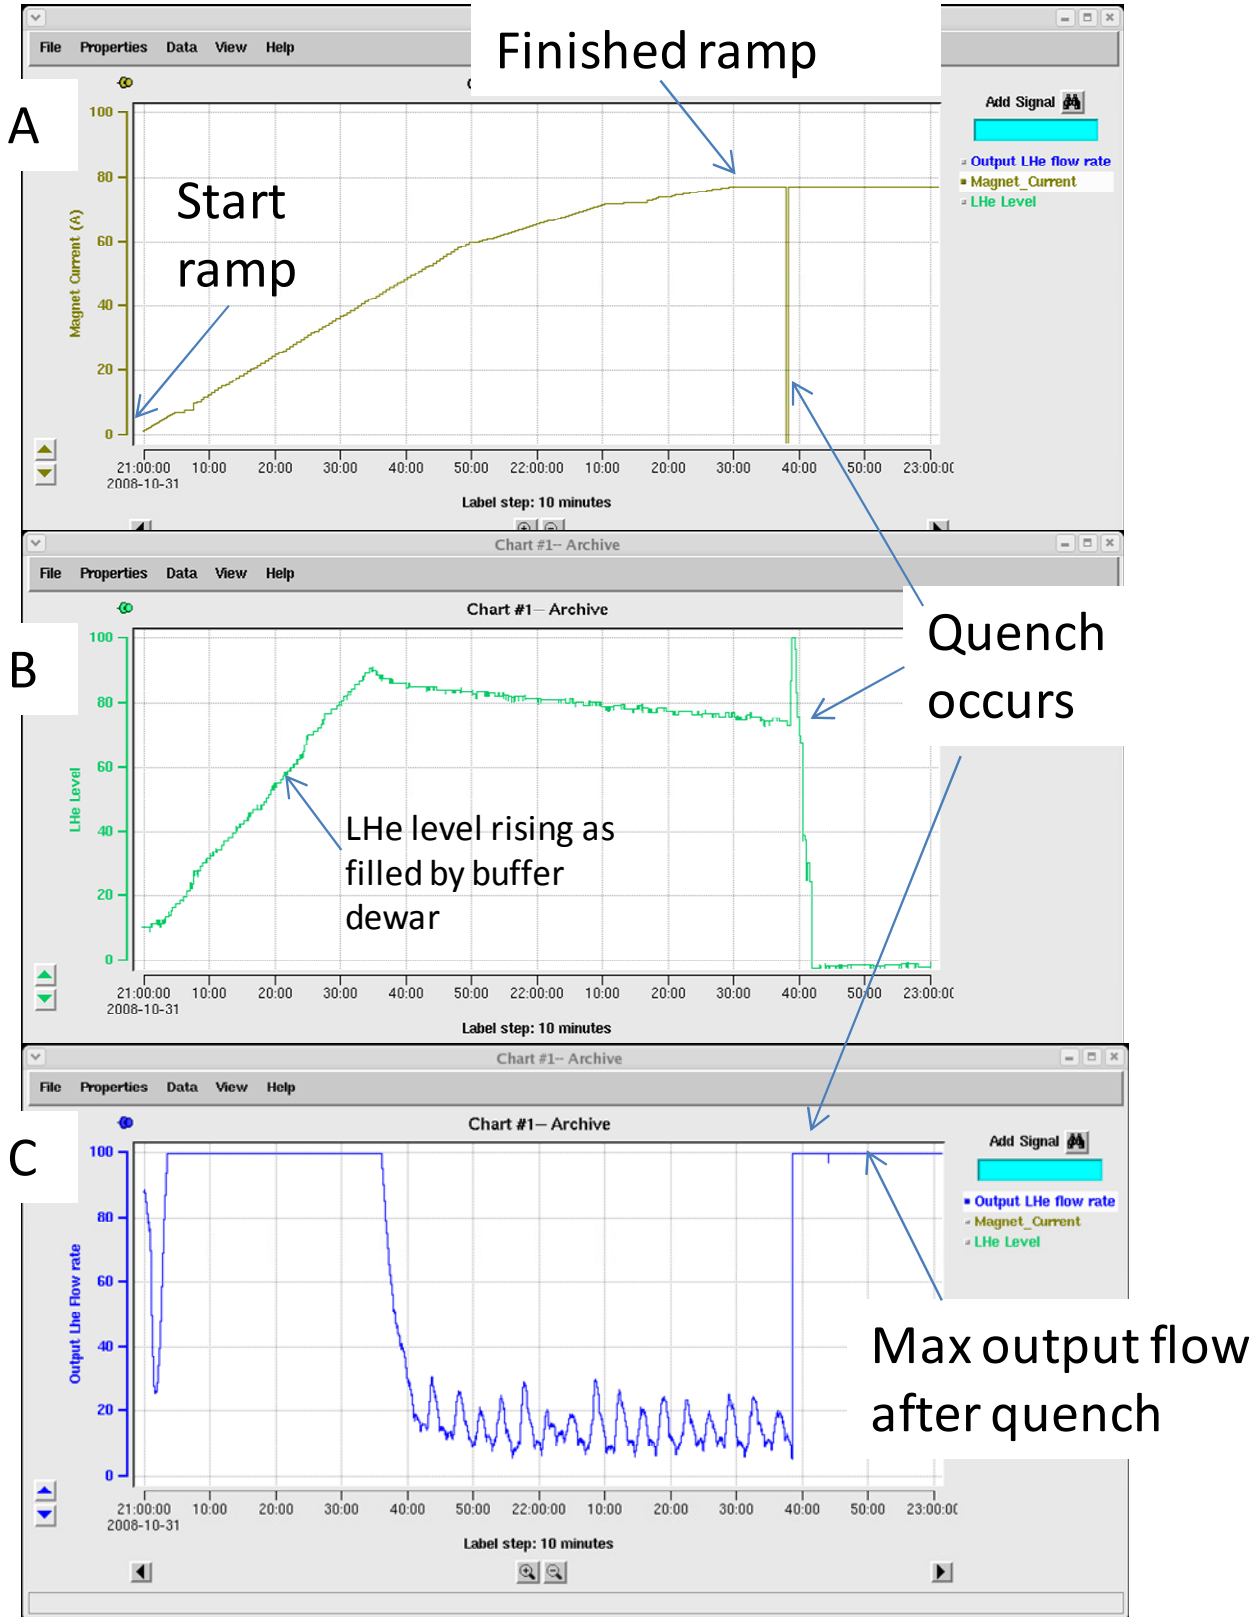
Figure 4 Strip charts of A) magnet current B) Liquid helium level and C) LHe output flow rate during quench on Oct 31<sup>st</sup>.

The first attempt to ramp the magnet to full current was on the evening of Friday October 31<sup>st</sup>. The magnet was ramped in positive polarity to full current using the “First run” rates given in Table 1. The magnet was switched to persistent mode by turning off the heater to the switch and when the magnet power supply was ramped down the magnet quenched. Looking the log file, it was found that heater had been turned off for only 13 seconds before the power supply leads were ramped down. This means that the persistent switch had not gone superconducting, and this caused the quench. There is a timer which counts down 30 seconds to tell the target operator when to start ramping down the current in the leads, but there was communication error which delayed sending the signal to turn off the heater while the counter on the computer was counting down.

In Fig. 4 is a chart showing the power supply current (4A), the liquid helium level of the magnet (4B) and the liquid helium output flow or boil-off (4C). The level meter for the LHe is located about 1-2 inches above the bottom on the helium tank. Therefore when the LHe level reads 10%, there still is liquid helium in the magnet. Looking the LHe liquid level (shown in Fig. 4B) , a batch fill of the magnet dewar starts just as the magnet is being ramped which results in a rising LHe level. As a result of the batch fill, the output LHe flow is at 100 (see Fig4C) . The fill is completed at 21:40. The LHe flow drops back down to its normal level and the LHe level slowly drops while the magnet continues to ramp. This indicates that the magnet is superconducting. Magnet quenches at about 22:40. The flow pegs as a result. The level jumps to 100% (this behavior is due to pressure increase during quench) and then drops to 0%.

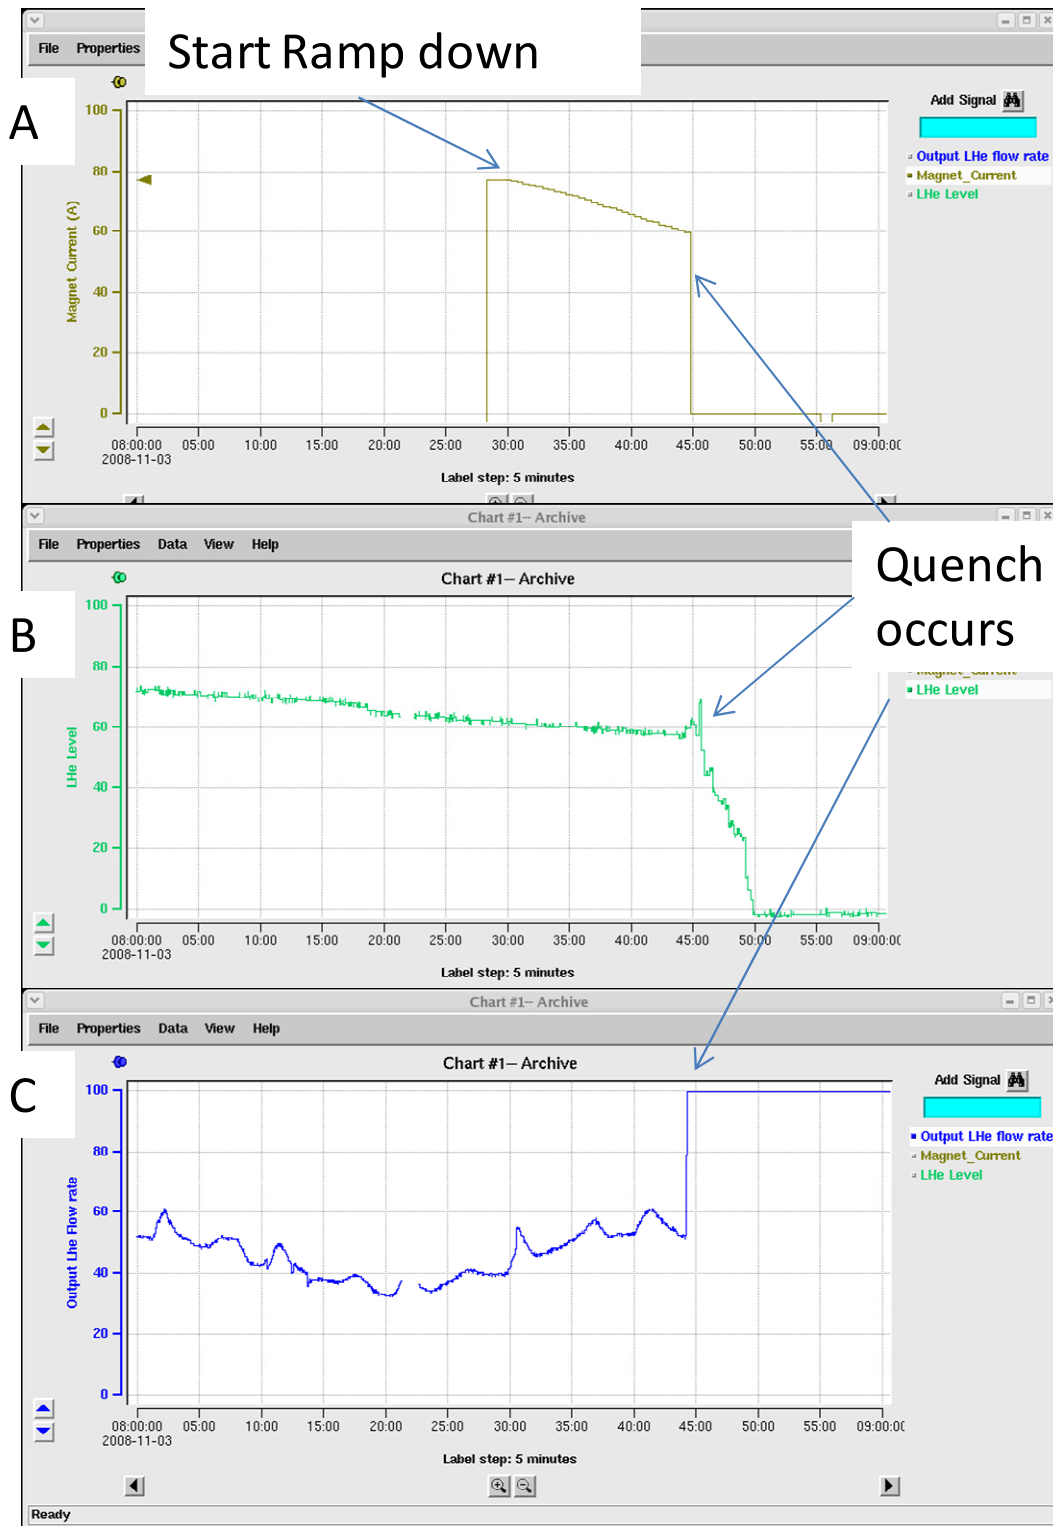
Figure 5 Strip charts of A) magnet current B) Liquid helium level and C) LHe output flow rate during quench on Nov 1<sup>st</sup> at 8am.

On Monday Nov 3<sup>rd</sup> at around 08:30am, the SANE experiment was planning on switching the polarity of the polarized target magnet. To do this the magnet first needed to be ramped down. In the process of this ramp down the magnet quenched. Though the target operator was familiar with polarized targets, this was the first time that the target operator had ramped down this particular magnet. The target operator (by entering data into the LabView control program) attempted to ramp down the magnet at 20A/min. The top panel for Figure 5 shows the current versus time for the quench. One can see that the actual ramp rate started out as 1.0A/min as programmed into the power supply. When the current dropped below 72A the ramp rate changed to 1.5A/min. The fact that the target operator was trying to ramp the magnet at a faster rate was ignored by the power supply. The magnet quenched when going below 60 amps and the ramp rate was increased to 2A/min.

Fig. 5 shows the liquid helium level in the magnet in the middle panel B and the LHe output flow rate or boil-off in the bottom panel C. A slow drop in LHe flow and level is seen before the heater to the persistent switch is turned on and the ramping down of the magnet began. The magnet was at +77 amps when it was taken out of persistent mode at 8:27. Note that flow increases slightly (due to current in magnet leads and persistent switch heater), but is still reasonable. The magnet coils are still superconducting. The magnet quenches at 60 amp (08:45), immediately followed by a liquid level spike and a drop, and the LHe boil-off flow pegs at 100.

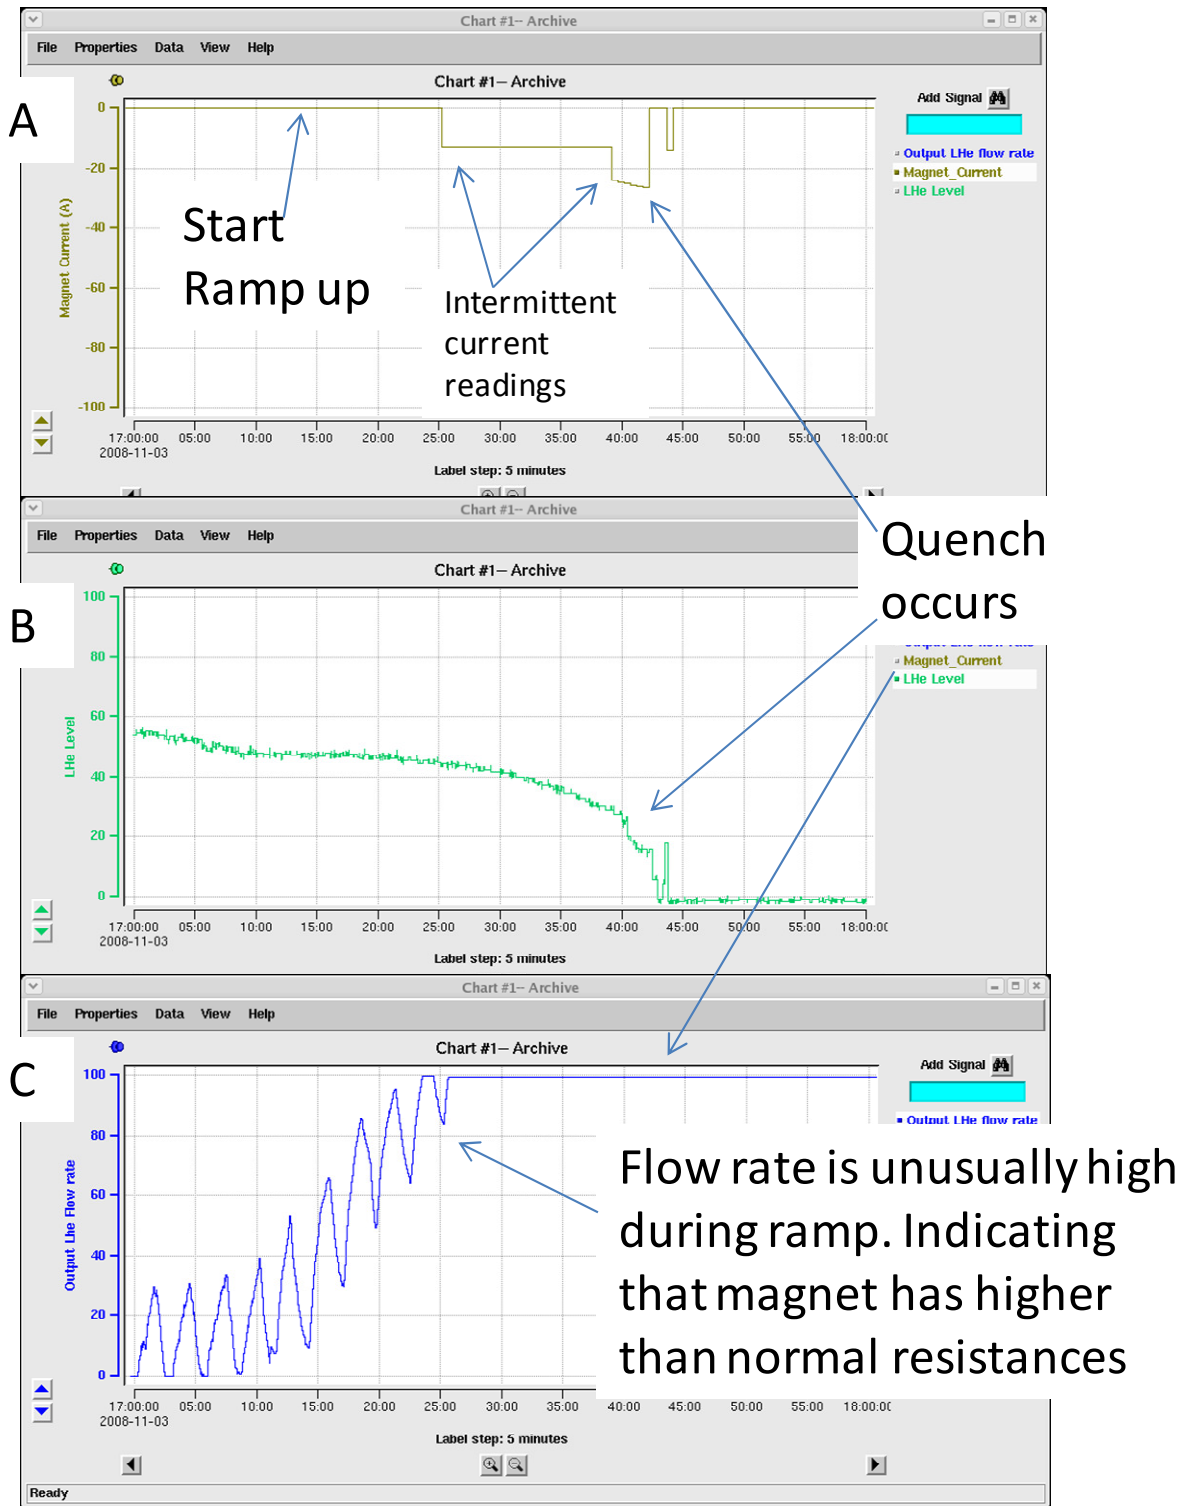
Figure 6 Strip charts of A) magnet current B) Liquid helium level and C) LHe output flow rate during quench on Nov 1<sup>st</sup> at 5pm.

The magnet was cooled down during the rest of day on Monday. Around 5pm, an attempt to ramp up the magnet in negative polarity was made, but the magnet quenched at 26A. In Fig.6, a chart shows the power supply current (top panel A), liquid helium level of the magnet (middle panel B) and the liquid helium output flow (bottom panel C) during this quench. Unfortunately the reading of the magnet current was intermittent at the beginning of the ramp so it is hard to see exactly when the ramping started. One point to note is that the magnet is ramping in negative polarity which is indicated by a negative current. By extrapolating back, the approximate start of the ramp is indicated in the top panel of Fig.6 at about 17:10. There are current measurements of -12 amps at 17:25, and -23 amps at 17:38. After this reading, there is a steady reading of the current and one sees the current increasing steadily to -26.4 amps. The magnet quenches at 17:42. Looking at the LHe output flow in the bottom panel of Fig. 6, one sees that the output flow quickly rising at the magnet ramps up and is at 100 when the magnet is only at 12A. This indicates that the magnet has a higher than expected resistance and that there is a problem.

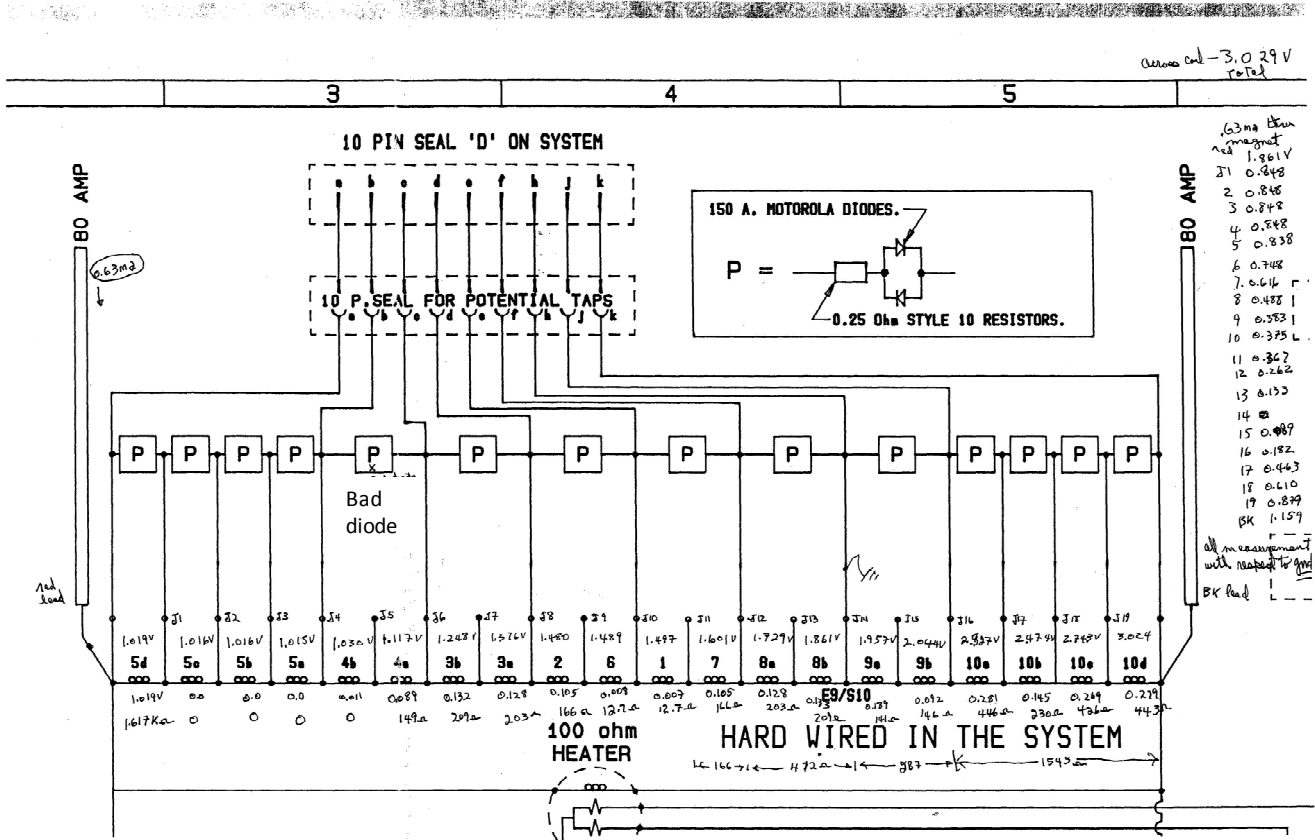
Once the target was warmed up and removed from the pivot, the magnet coil package was removed and taken out of the hall. It was taken to the EEL where the top cover of the magnet was cut off. Initial investigation found a diode that was broken, but no obvious signs of problems. The location of the broken diode is between coils 4b and 4a, as indicated in Fig. 7.

Figure 7 Circuit diagram of the magnet.

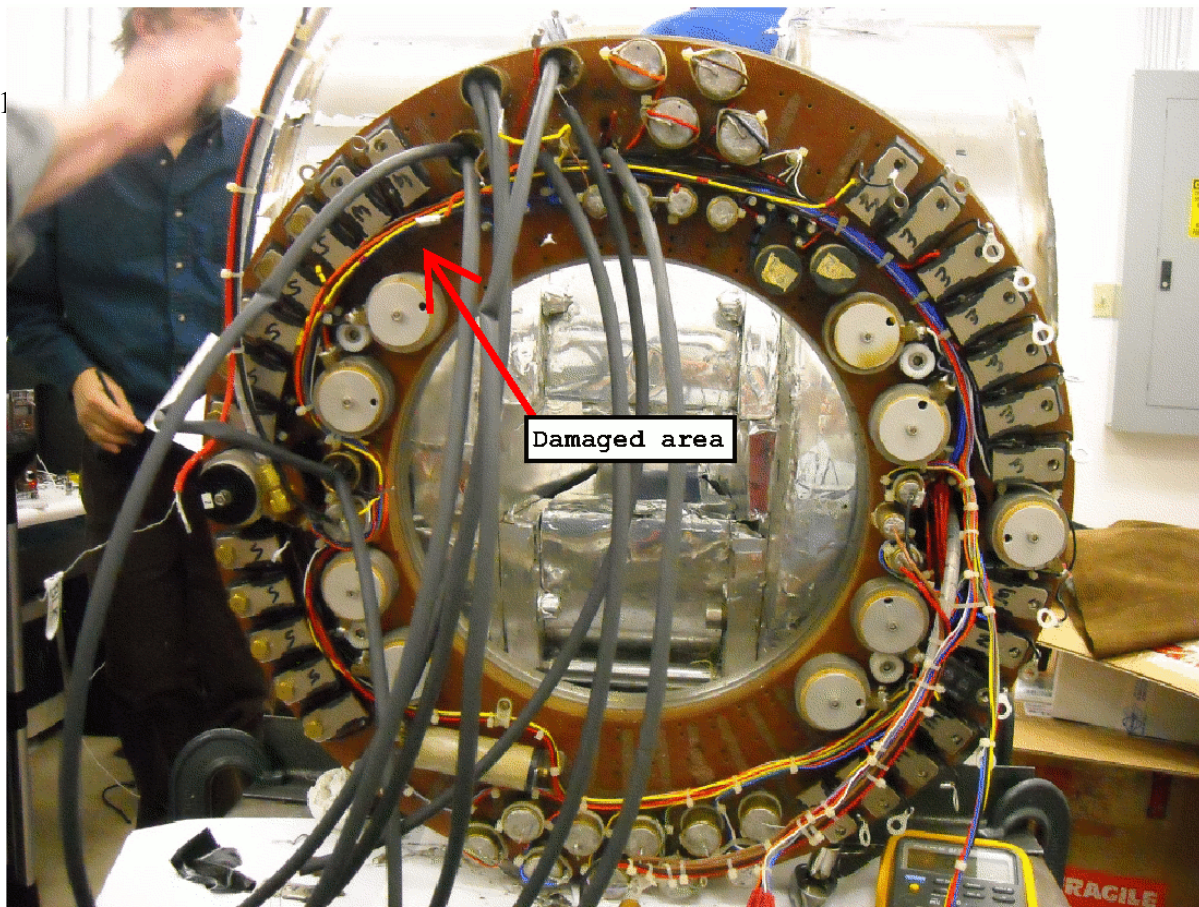
Bill Vulcan took some voltage measurements. First he disconnected the heater switch by taking out the solder from J0 and he also disconnected the diodes. He then put a source of 0.63mA through the circuit as indicated in the Fig. 8. In the Fig. 8 (above the 5d, 5c, etc) are the voltages relative to the red lead and below are the differential voltage and calculated resistance. For the one side of the magnet (coils 1, 7, 8a, 8b, 9a, 9b, 10a, 10b, 10c, 10d) the resistances agree fairly well those expected for the coils. The surprising discovery was that at J1 a resistance drop was measured which was what one expects by adding 5c+5b+5a+4b; however voltages drops across the individual J2 through J5 are zero. Bill also measured the junction points relative to ground that is the list of voltages on the right side of the Figure 8. After discussion with Oxford we decided to remove solder from joints J1 through J5 and measure the resistance of each coil individually.

*Figure 8: View of magnet electronics, with area of damage pointed out.*

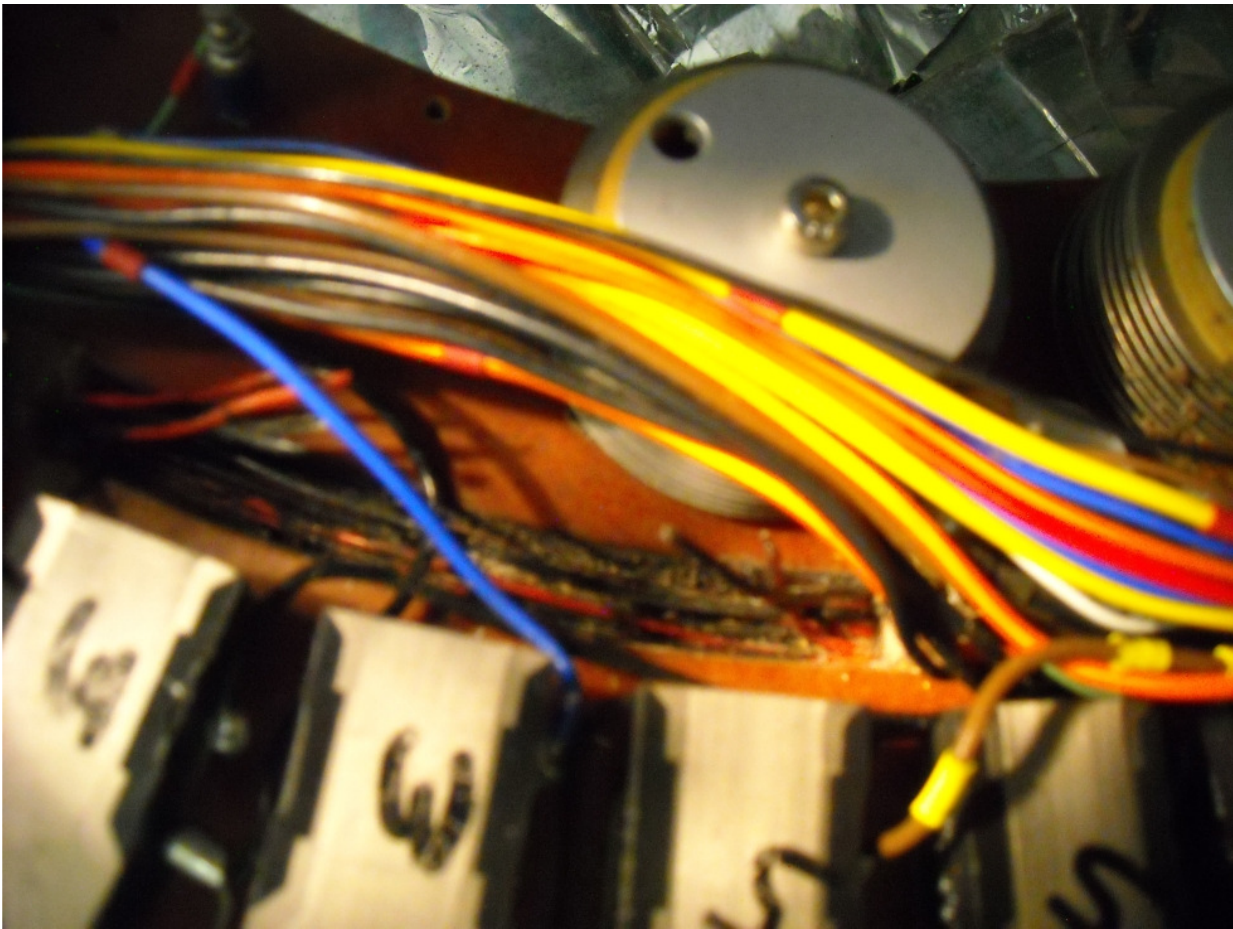
Each of the joints at J1-J5 was opened and the resistances were measured for each coil. The results were still puzzling. In contrast to the previous readings with the J1-J5 joints closed, several infinite resistances were found. While investigating a lead with infinite resistance, the superconducting wire was pulled out with only a short amount of extra cable. This indicated that the wire had broken in a location near the joint connection. The leads of coils are packed into a channel to get from the coils to the individual joint cups. In digging out the plasticene that held the wires in place damage to the wires was found. The location of the damage is shown in an overview in Figure 8. In Figure 9 is shown a close-up where damaged and/or broken wires were found. Six broken wires were found. After a systematic process of elimination that involved matching red to black (and vice-versa) leads, the 6 broken wires were identified and are listed in Table 3. Comparing the resistances between matching opposite coil found agreement at the 2% level indicating that the rest of the coil was in good shape. After consulting with Oxford, it was agreed that there was enough superconducting cable (about 4 inches) coming up through the hole that goes down to the coils to make a new joint for each damaged lead.

*Figure 9: Close-up of magnet electronics, where broken and/or damaged wires were found.*

On Monday Nov 24<sup>th</sup>, Oxford engineer Paul Brodie arrived to work on repair of the magnet. Joe Beaufait and Paul Brodie worked on making new joints for the broken wires. Oxford instruments shipped extra materials for the repairs and provided instructions for making repairs. After consultation with Joe it was decided to make a superconducting joint for the first inch and then a copper to copper connection for another 3 inches. The superconducting joint was made by stripping off the copper and using an ultrasonic soldering iron (provided by Mike Seely) to make the connection. The copper to copper was a regular solder connection. After the new joints were made, the resistance was measured to check that it was the same as before. To determine the polarity of the leads, current was sent through one good coil and the direction of the field determined with a compass. Each coil was connected to the supply and the polarity of the leads was determined by matching the direction of the field to the good coil. Once the polarity of the leads was determined, the leads from nearby coils were joined together as before and put in the joint cups. Connection to the rest of the circuitry was made. The bad diode was removed. It could not be directly replaced, but a new diode was put in place (see Fig. 10) and connected into the circuit with new cables. Because the new superconducting joints are short, the magnet will not be a “high” persistent mode magnet when it is re-installed. Originally, the magnet decay was 5 parts in  $10^8$  /hour. This is not a problem, as the polarized target will work with poorer magnet persistence. Therefore, once installed, we will set the magnet in persistent mode and see how the magnet field decays. If the magnet is not persistent, it can be run constantly from the power supply. The current from the power supply is stable at  $1.5 \times 10^{-4}$  which is sufficient for the experiment.
