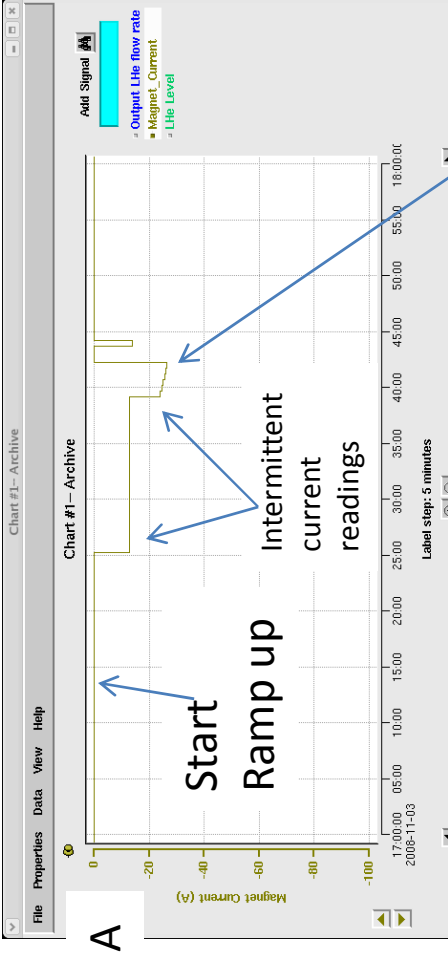
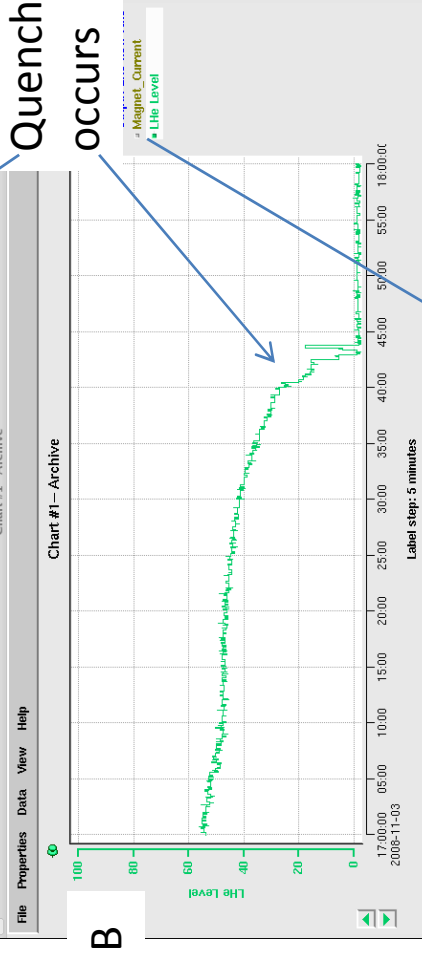
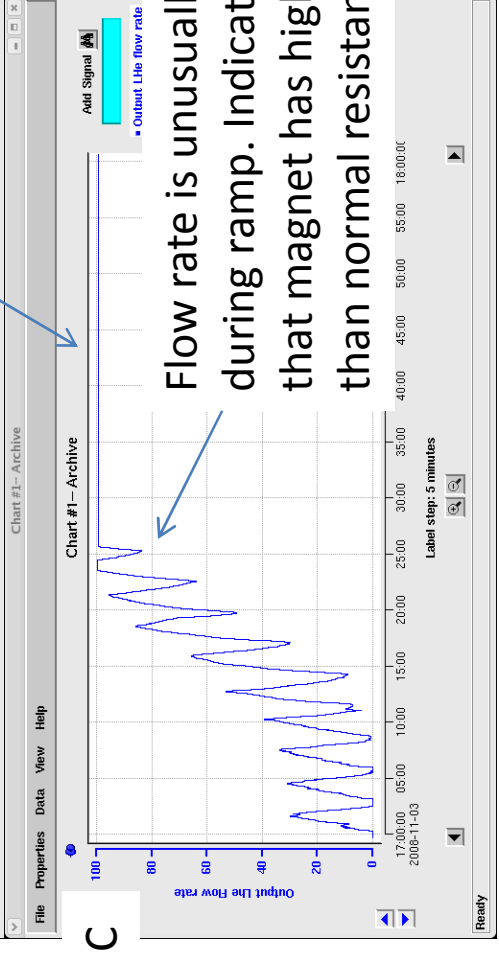
Quench occurs

Flow rate is unusually high during ramp. Indicating that magnet has higher than normal resistances
