# OPERATING EXPERIENCE AND RELIABILITY IMPROVEMENTS ON THE 5 KW CW KLYSTRON AT JEFFERSON LAB

R. Nelson, S. Holben, Thomas Jefferson National Accelerator Facility, 12000 Jefferson Avenue,  
Newport News VA USA 23606

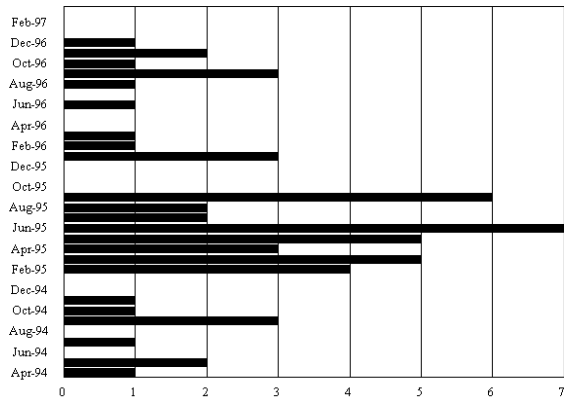
The spec requested tubes with at least 20-25k hours life. Overall, even with a high number of early failures, the MTBF was around 22k hours by 1994. Currently, the hours/failures ratio shows about 90K hours of filament operation and 67k hours of HV operation average. None of the failures so far has been from normal wear out, that is, cathode depletion. Instead, catastrophic failures have ranged from open heaters to external arcing.

Figure 1 - Klystron Failures by Month

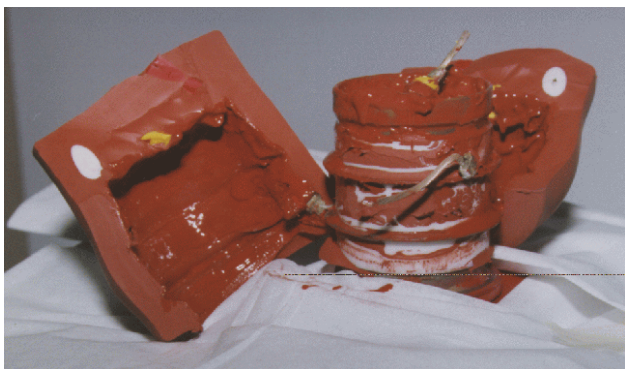
The largest number of failures were the result of *external arcs* across the ceramic of the gun assembly. The gun assembly is potted with a silicone RTV to prevent problems with dust and humidity. In many cases, the RTV closest to the gun reverted to either a thick soup of silicone oil and solids or a dry and crumbling material. While the RTV was rated at 250 °C [2] and measured surface temperatures according to data provided were well below that point, silicone supplier GE Silicone felt the material was being exposed to temperatures too high.

Figure 2 - Gun assembly showing degraded potting

Recognizing that we couldn't consistently spot bad potting or predict failures, a decision was made to repot all the tubes in the machine. This time the RTV was Stycast 5952 from Emerson & Cuming., a product with higher thermal conductivity [3] and one that didn't require stage curing.

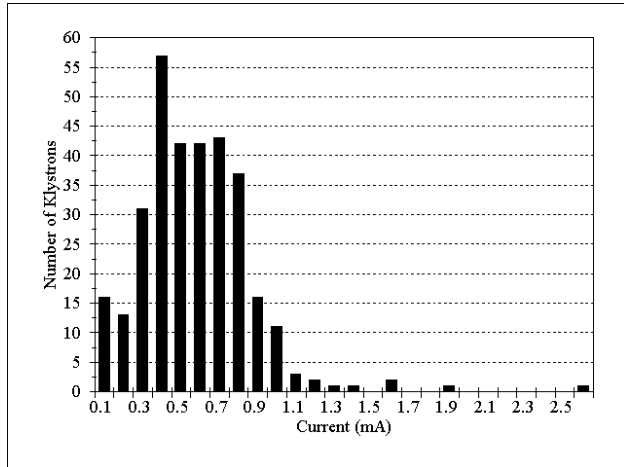
Figure 3 - Mod Anode Current Distribution

Original specs required mod anode intercept to be < 1% of beam current, which equated to <13 mA. Assuming that most of the current intercepted by the modulating anode was dissipated by the metal and ceramic through the potting material, we simulated additional heat on our thermocouple equipped tube by increasing heater power. The temperature reached 250 °C with another 30 watts input. So while 12 mA of intercept would fall within the specs, it would also generate 139 watts of heat. The gun would fracture well before that point. In fact, at least three tubes have suffered that fate, so it's convincing that excessive mod anode current was probably a major contributor to potting failures.

Because mod anode current was found to be a critical measure of the tube's health and an indicator of impending failure, permanent monitoring has been installed on all klystron positions. This parameter is now remotely monitored, and can be logged or trip the power supply if a preset threshold is exceeded.
