DIII-D Safety Program – Incidents and Lessons Learned

By
K. Holtrop
for the DIII-D Team

Presented at the
**DOE Accelerator
Safety Workshop
Thomas Jefferson
National Accelerator
Facility
Newport News, VI**

LN₂ cryogenic leak: Summary

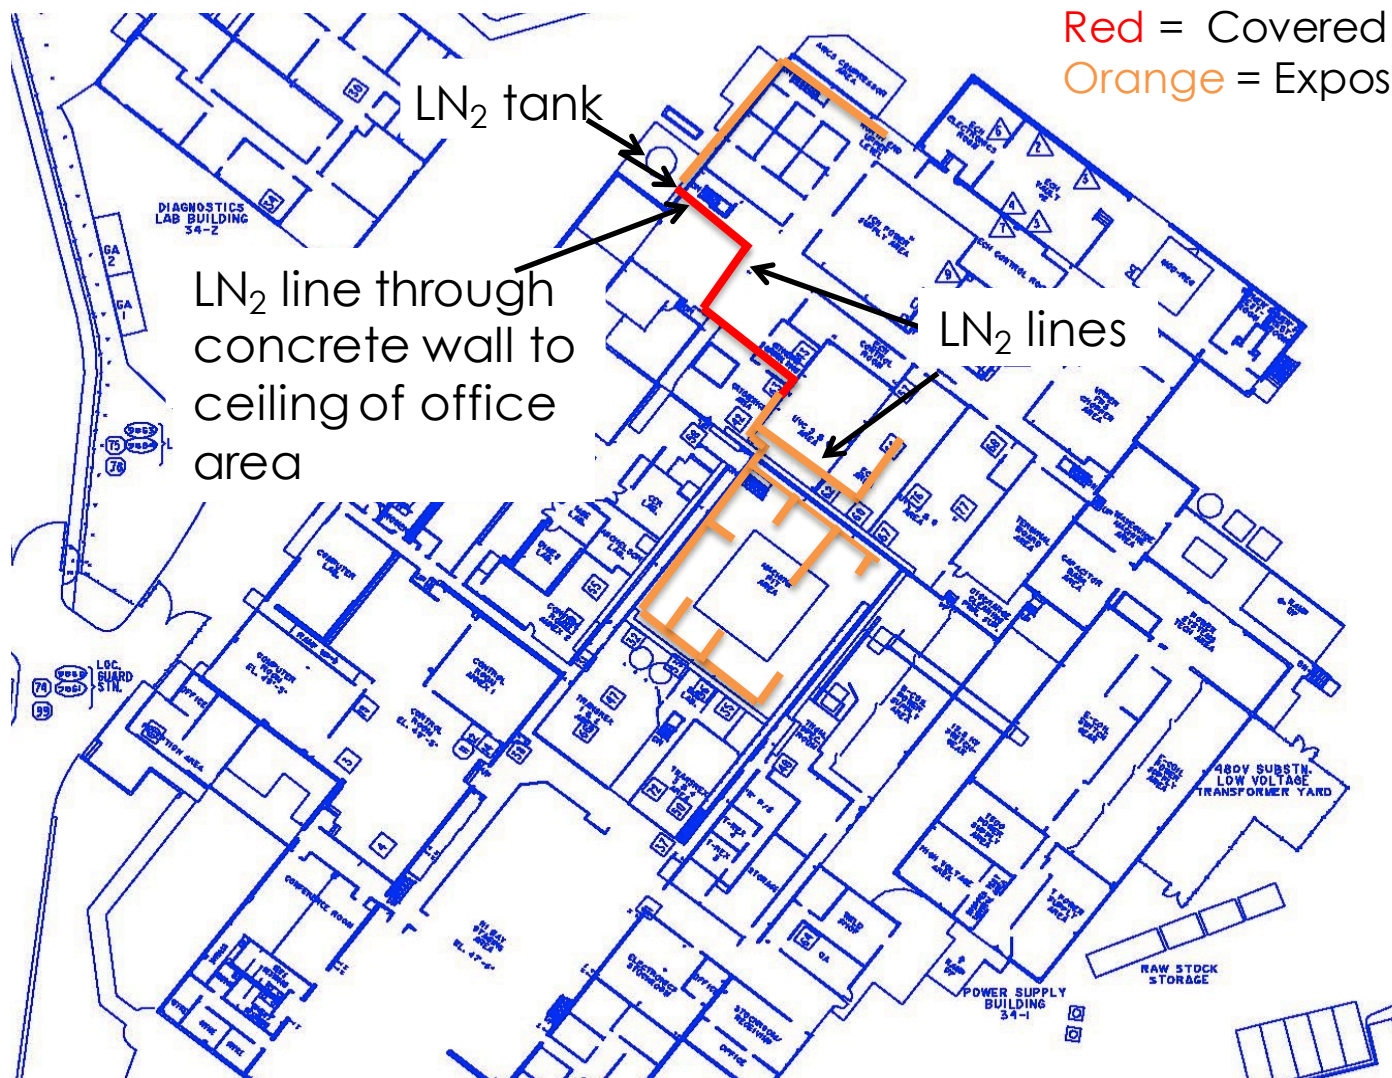
Incident Location

Red = Covered by ceiling
Orange = Exposed

LN₂ tank

LN₂ line through concrete wall to ceiling of office area

LN₂ lines

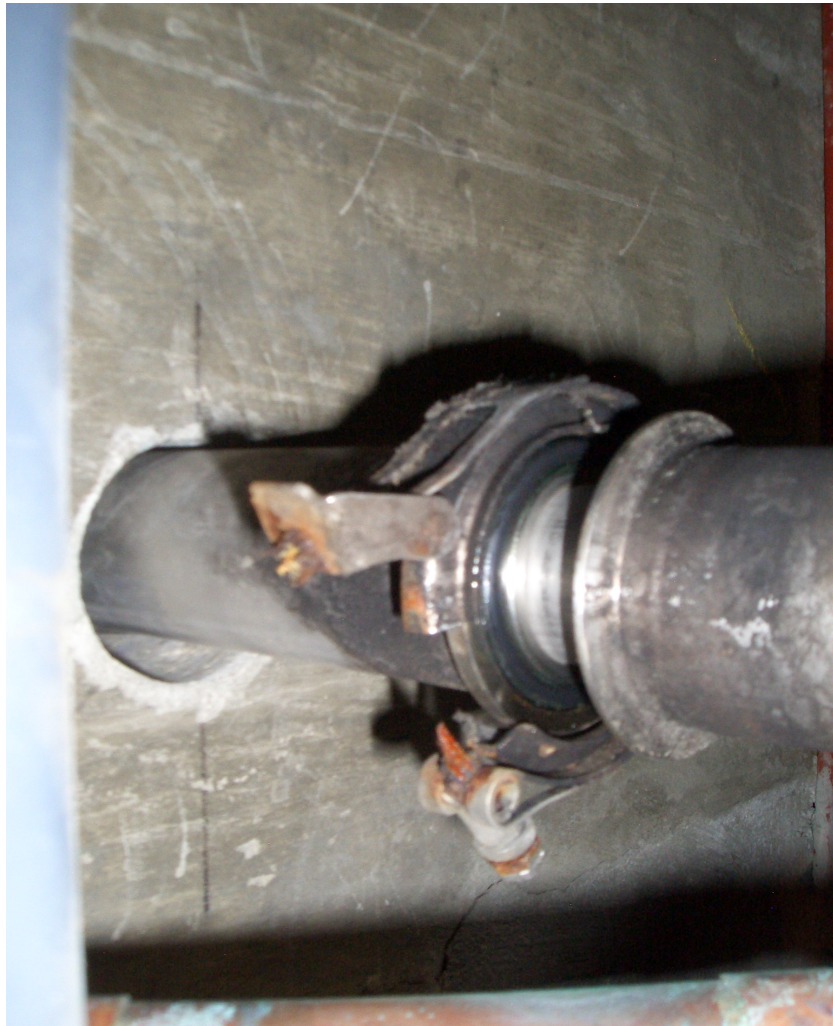
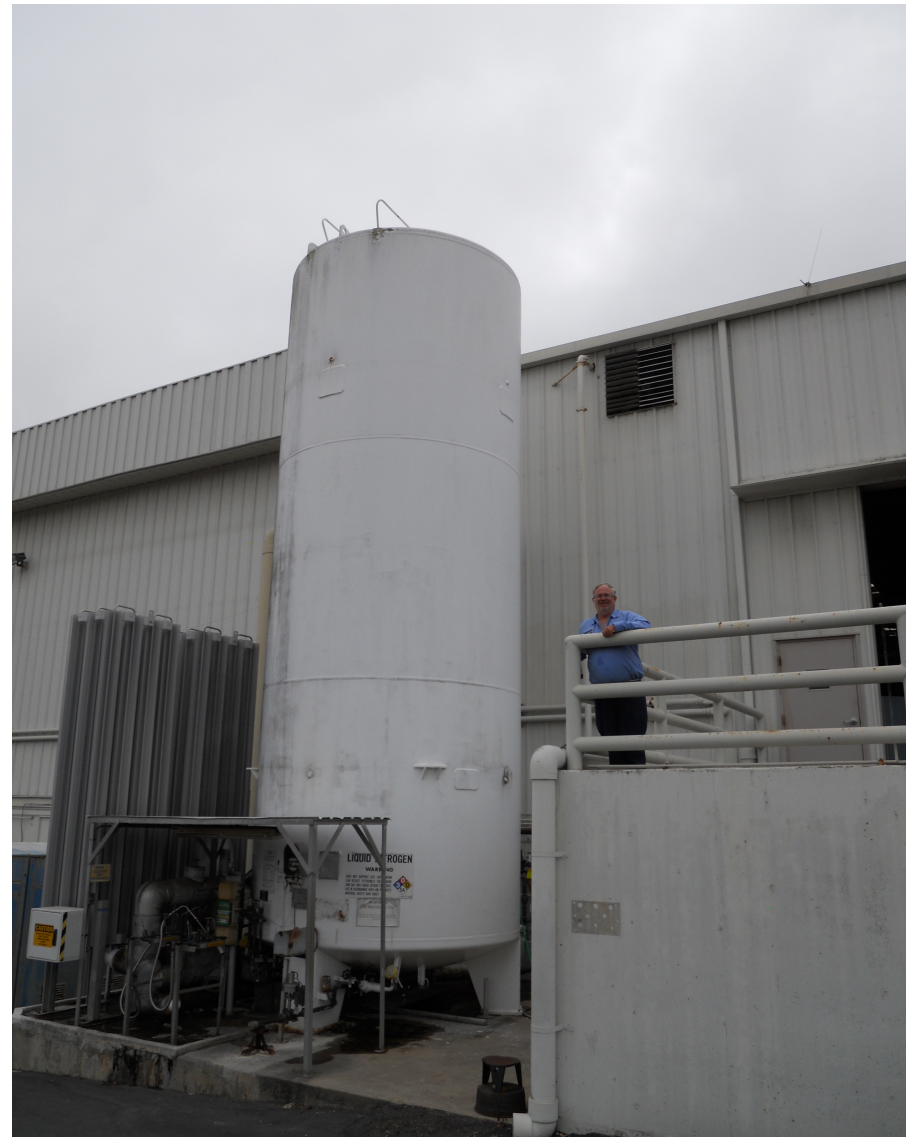
Loose Bayonet Connector

- **Proximate Cause**: Failed carbon steel bolt on clamp for bayonet connector. The bolt that failed was 30 years old, exposed to the outside climate, and not inspected since it was installed in the ceiling. Lines are double jacketed with a vacuum inter-space except at the bayonet connector
- **Severity of Problems**: Exposure to LN₂ could cause extreme cold burns. GN₂ gas a possible asphyxiation hazard
- **Alarms**: There was not an alarm that unambiguously alerted to operators of the failure
- **Response**: Knowledgeable technicians quickly identified the problem. Appropriate actions were taken to eliminate the problem. Safety Training and understanding of the key systems were key in resolving the problem safely

- **Replace failed bolt with stainless steel bolt. Inspect the other bayonet connectors and replace any suspect bolts**
- **Building entrance sealed to keep moisture off bolt**
- **Yearly inspection of all bayonet connectors on LN₂ line has been added to the preventative maintenance schedule. Access panels in the roof have been added to inspect the bayonet connectors**
- **Rate of change alarm of LN₂ tank level added to Cryo Programmable Logic Controller (PLC). Output wired to Alarm System that is monitored by Security Guards**
- **Thermocouples installed at bayonet fittings to detect leaks. Wired to Cryo PLC which will generate an output to the Alarm System**

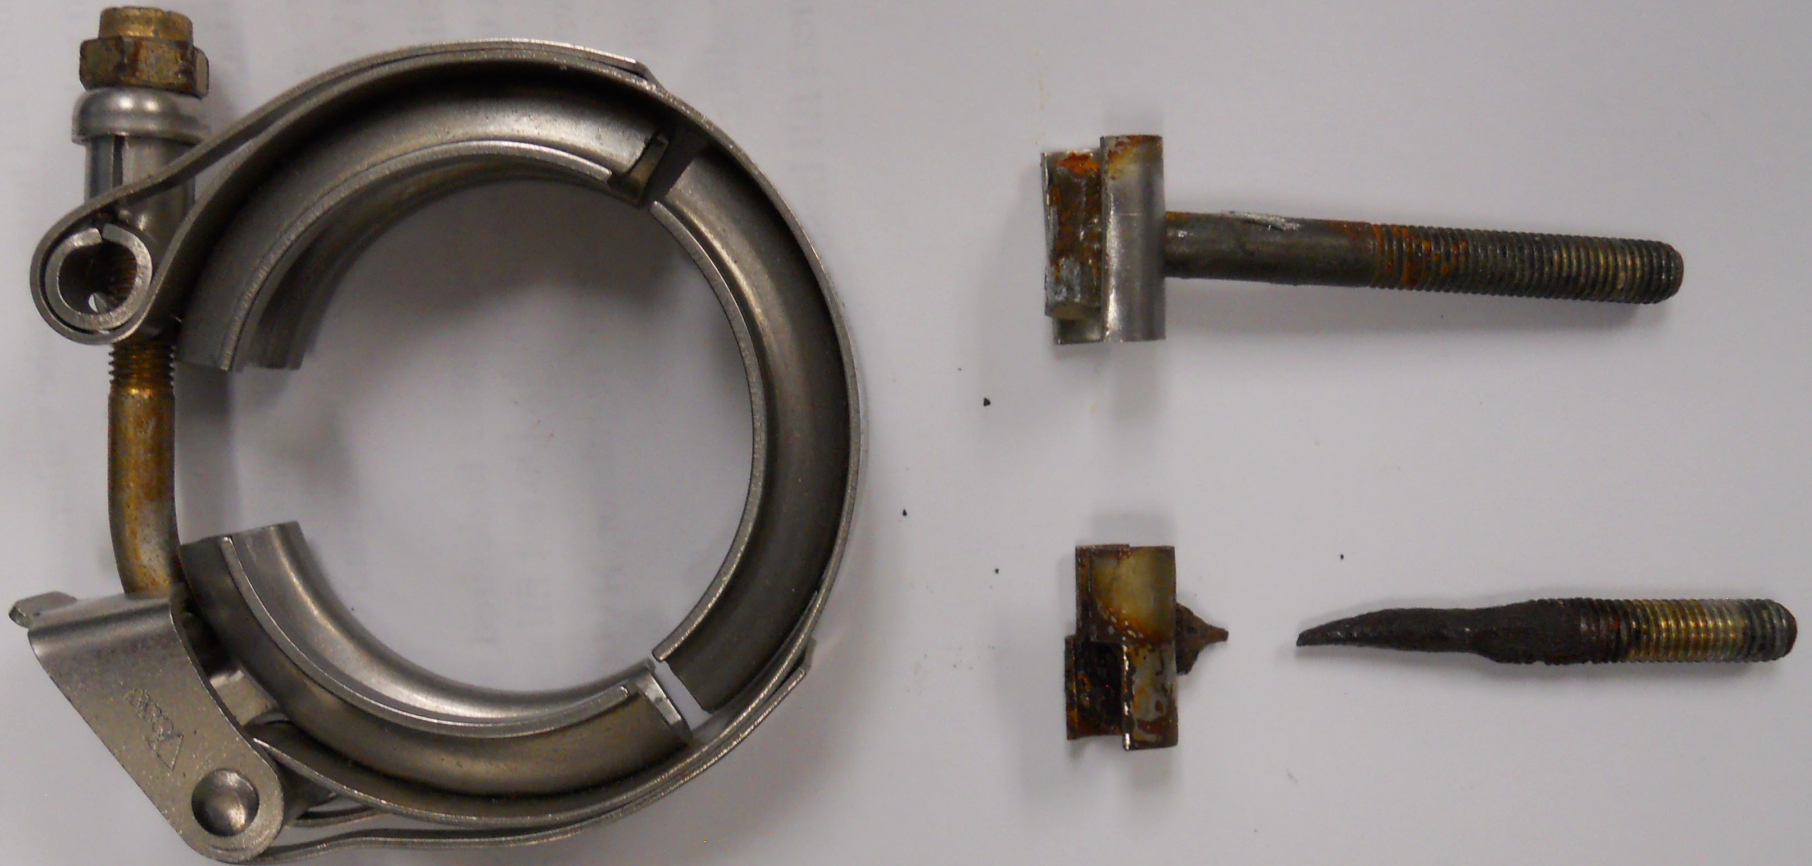
Stainless Steel Clamp with Carbon Steel Bolt
