PROCUREMENT AND COMMISSIONING OF THE CHL REFRIGERATOR AT CEBAF*

W. C. Chronis, D. M. Arenius, B. S. Bevins,
V. Ganni, D. H. Kashy, M. M. Keesee, T. R. Reid,
and J. D. Wilson

Continuous Electron Beam Accelerator Facility
12000 Jefferson Avenue
Newport News, VA 23606-1909 USA

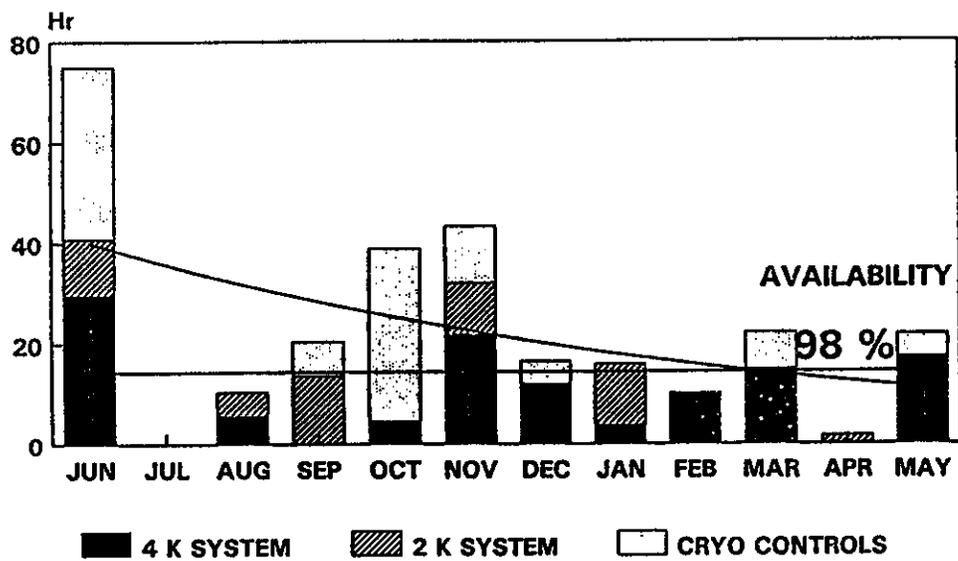
Figure 3. Cryogenic downtime (June 1994 - May 1995)

Cryogenic availability for the previous year has averaged 96.9% and 98.0% for the last six months; the downtime and its causes are shown in figure 3. The causes are split between the 4K system (1.4%), and the 2K system (0.6%), and the cryogenic controls (1.2%). The cryogenic controls category includes cryogenic software and hardware, as well as linac cryogenic instrumentation for the cavities. Not included in the downtime is another 0.8% of nonavailability charged to other sub-systems such as utilities; these included site power, city water, end station errors, and MCC problems.

The primary 4K system downtime was caused by contamination tripping the 25K and 15K turbines; the turbine trip in turn causes a temperature transient, which would trip the cold compressors. Other causes included the warm screw compressor trips and some control valves.

Only one of the 2K system downtimes was associated with the cold compressor hardware; with a valiant 14 hour all-night effort, it was possible to get the magnetic bearing electronics operational again. Six downtimes were due to excursions of the cold compressors out of their stable operating regions, and were not traceable to any equipment failures.

The unreasonably large cryo control downtime was due to three root causes: A) a failure of a supervisory LAN connection and/or board, B) intermittent failures of the linac serial highways which transmit load liquid level information, and C) overloading of memory allocations due to adding the third refrigeration system, ESR, to the network. The first was fixed by replacing several boards and reworking all the terminations, the second problem still remains, and the third has been partially fixed.
