Notable Event Worksheet

Title of Event			
Event Title:	EWB Solenoid Valve Failure		
Date and Time of Occurrence:	02/23/2012 12:10pm	Notable Event Number:	FML-12-0223
Event Location:	Test Lab Rm122	Date Notable Event Report is Due*:	03/23/2012

EBW N2 Valve Fire Alarm Event

Incident: Jefferson Lab – Test Lab – Overheated Coil

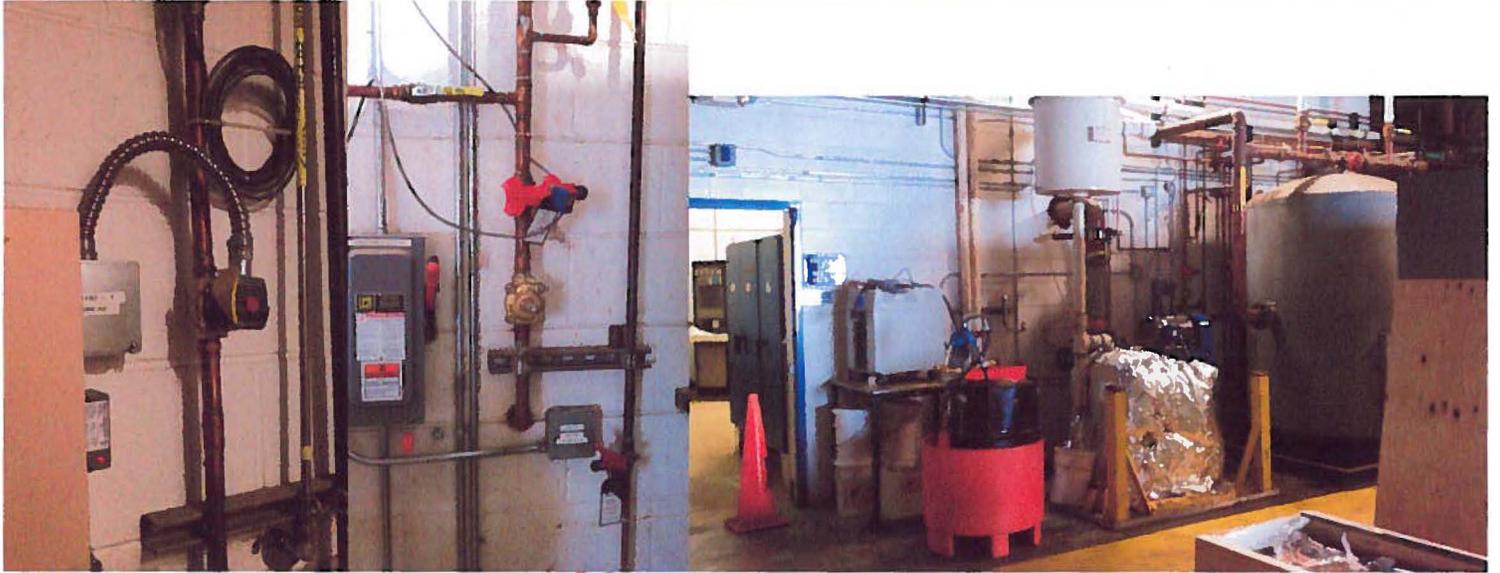
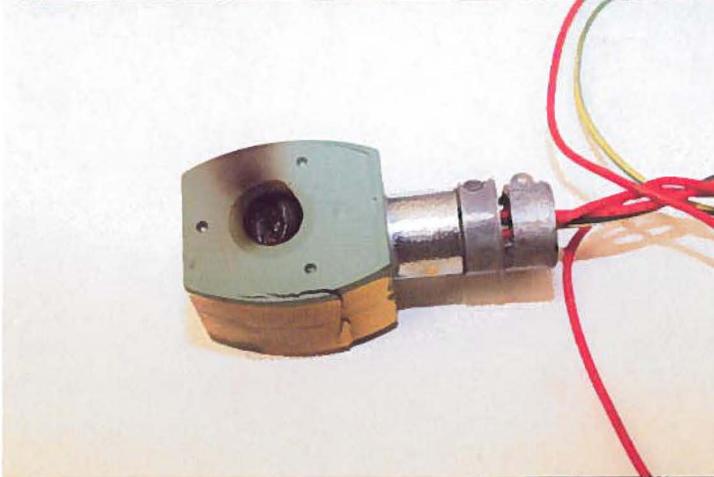
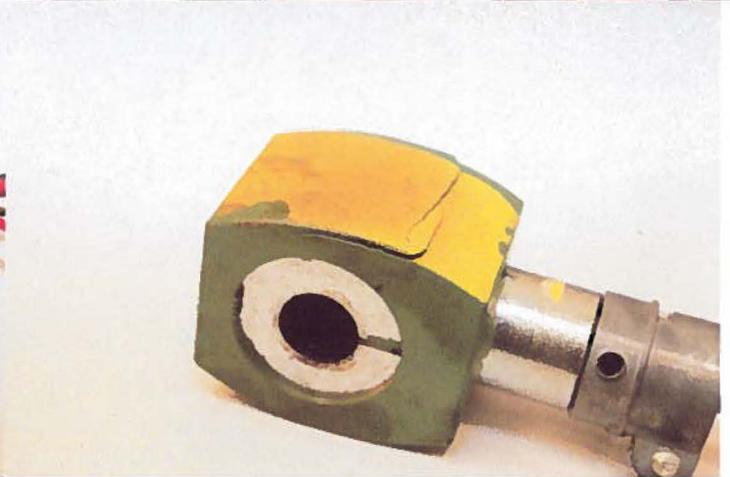
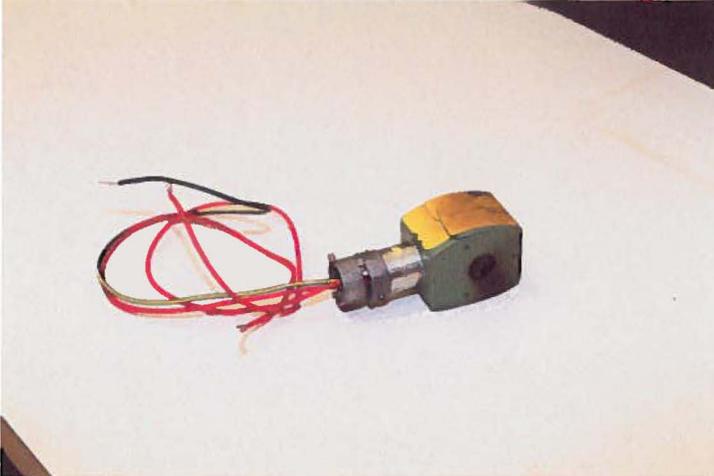
This valve is designed "Fail Safe" in that when electricity is powered to the solenoid, it withdraws the valve stem and opens the line so nitrogen can flow thru the line. In case of power failure, the valve fails shut stopping the flow of nitrogen. It takes a heavy draw of electricity to open the valve but a very small draw of electricity to hold it open. By removing the solenoid and leaving the electricity connected, the valve was continuing to demand a heavy draw of electricity as it was attempting to open the valve which was no longer connected. The valve body was no longer connected to the solenoid so there was no mass to dissipate the heat.

- What led to the problem was the following: During removal of the nitrogen line for the EBW lab in preparation for moving the welder, MRI had removed the solenoid from the valve body and left the solenoid powered up. It is believed that with the loss of the inductive load that the valve body presents, the coil essentially became a short and overheated to the point of failure.

Root Cause:	This was a breakdown in communications. Mechanical contractor was advised to cut the pipe below the valve and plug the pipe. During the job, a telephone conversation took place between the MRI mechanic and Mike Sprouse. MRI was told to plug the line below the valve. Mike was talking about the solenoid valve and MRI thought he was talking about the Ball valve just above it so he removed the solenoid portion of the valve which was still under power and then broke for lunch. He was not aware of the problems with disconnecting the solenoid from a valve while under power.
Contributing Causes: (List as many as apply.)	The solenoid valve body was not removed as a complete unit. The electrical power was not locked out to the solenoid portion of unit prior to its removal. The work was not performed as directed. Either one of these 3 steps would have eliminated this failure.

Extent of Condition Check	Responsible Person(s)	JLab CATS Number	Target Date
Evaluate all similar 120v solenoid valve installations to see if changes to those installations need to be made. If necessary, correct those installations. (This has been completed on 03/15/2012)	Carroll Jones	NE-2012-06	03/15/2012

Corrective Action(s)	JLab CATS Number	Target Date
Train all MRI employees on the problem with removing solenoids with power on.	NE-2012-06	Completed 3/15/2012
For all incidents, make sure the area is undisturbed for investigative purposes.	NE-2012-06	Completed 3/16/2012
Follow the manufacturer's recommendations for all maintenance and alteration work activities.	NE-2012-06	Completed 3/15/2012
Make all pre job briefings clear and insure that all parties understand by having them repeat those directions.	NE-2012-06	Completed 3/16/2012
