Notable Event Worksheet

Title of Event			
Event Title:	Potential Electrical Hazard in Building 36		
Date and Time of Occurrence:	June 20, 2012 Approximately 10:30am	<u>Notable Event Number:</u>	ENG-12-0620
Event Location:	Building 36, Room 102	Date Notable Event Report is Due*:	07/20/2012

Building 36 Electrical Incident Causal Analysis
06/22/2012

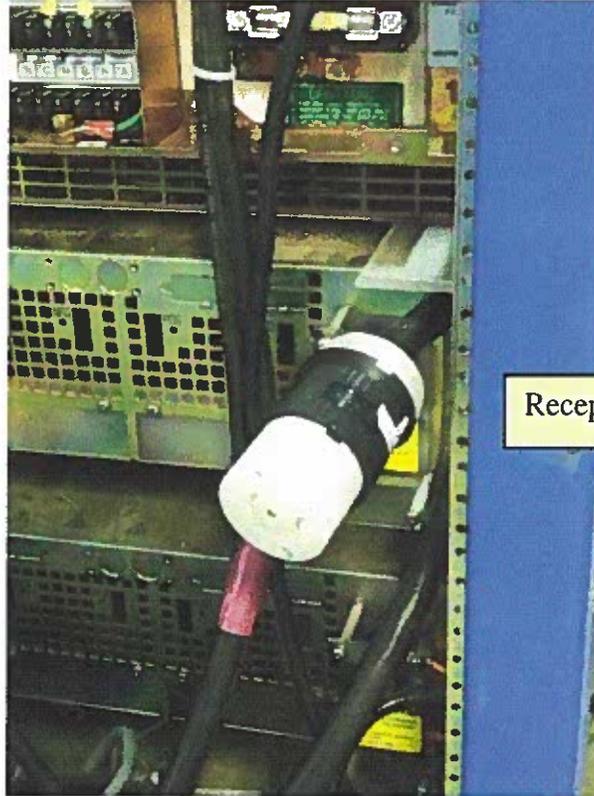
Receptacle 2

Associate Coordinator and Engineer arrive at about 10:25am and install a power supply to test into rack TL05B06.
 Engineer plugs the power supply into another unpowered receptacle (Rec. 2) in rack TL05B06.
 Associate Coordinator energizes the receptacles by turning on the P2 breaker associated with Rec. 1 and Rec. 2.
 P2 breaker immediately tripped. It was later discovered that the upstream breaker (L4/7,9,11) also tripped.
 Upon investigation of the cause the Associate Coordinator and an Electrical Tech II, who was in the area, discovered the practice cable installed in Rec. 1. This cable had an assembled connector on one end but the other end had bare exposed wires, which shorted, causing the fault.
 Engineer attempted to reach for the cable and was stopped by Tech II.
 Associate Coordinator verified the power was off with a volt meter.
 Associate Coordinator removed the cable and the Engineering Support Manager cut the cable, making certain it could not be used again.

On June 20, 2012 at approximately 10:25 the Associate Coordinator and the Engineer installed a power supply into rack TL05B06 for the purpose of testing it. The Engineer went around to the back side of the rack and connected the power supply input power cable to one of the 3 phase 208VAC pigtails. The Associate Coordinator then energized the P2 breaker (15 amp) associated with the power source they connected the power supply to and it immediately tripped. The Associate Coordinator traced out the circuit and noticed a 3 phase 208VAC cable that had open conductors on one end attached to one of the pigtails. The Associate Coordinator removed the cable and tossed it to the side.

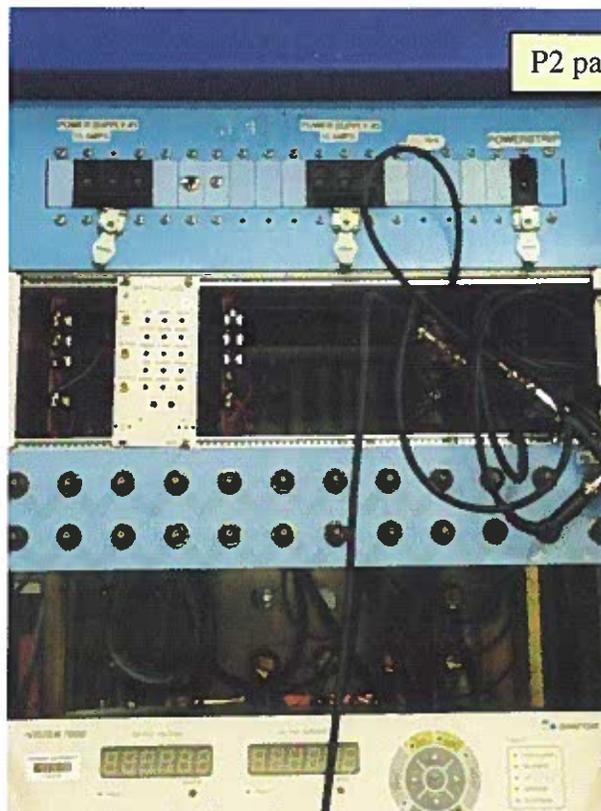
P2 panel

On June 20, 2012 the Engineering Support Manager was alerted to the fact that a P2 breaker in one of his test racks had tripped about 5-10 minutes earlier. The Engineering Support Manager was informed that the cable the Engineer made had been connected to one of the power source cables in rack TL05B06. The Engineering Support Manager said he was upset when he saw the cable and informed the Engineer of the seriousness of what happened. The Engineering Support Manager said that the Engineers explanation of why he had plugged his cable into the rack was unacceptable. The Engineering Support Manager did not state the Engineers exact words only that he didn't say much. The Engineering Support Manager doesn't believe the Engineer has a grasp of how serious this is.

At approximately 10:00 am the following morning, an operator turned on the power supply, and the exposed wires arced and shorted, opening the breaker to the power supply and the electrical panel that fed it.

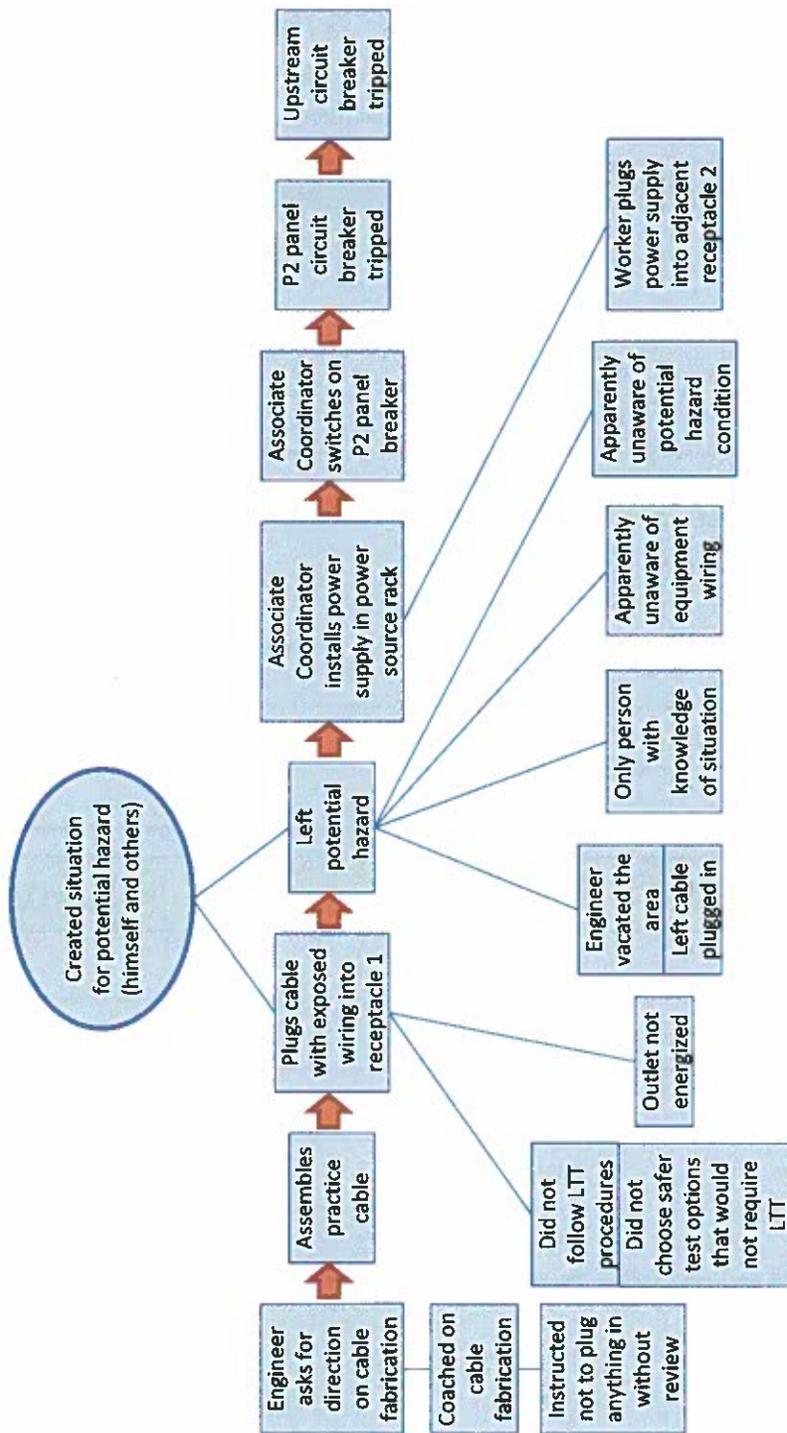
Root Cause(s):	Employee plugged exposed wiring device into outlet Employee left a potential hazard
Contributing Causes: (List as many as apply.)	Employee did not follow LT&T procedures Employee vacated the area and left exposed wiring device plugged in Employee only person with knowledge of situation Employee apparently unaware of equipment wiring Employee apparently unaware of potential hazard condition

Corrective Action(s)	JLab CATS Number	Target Date
Engineer must re-qualify as an Electrical Worker	NE-2012-15-01	8/31/2012
