Notable Events 71634

Event Title: ENG-17-1012 CHL1 C6 Starter Fire
Response Owner: Will Oren (oren)
Category: Fire / Explosion
Date of Occurrence: 10/12/2017
Event Location: CHL1, building 8
Date Notable Event Report is Due: 11/13/2017

PROJECT: CHL Fire Investigation **PROJECT #:** HN.00386

SUBJECT: Fire Investigation

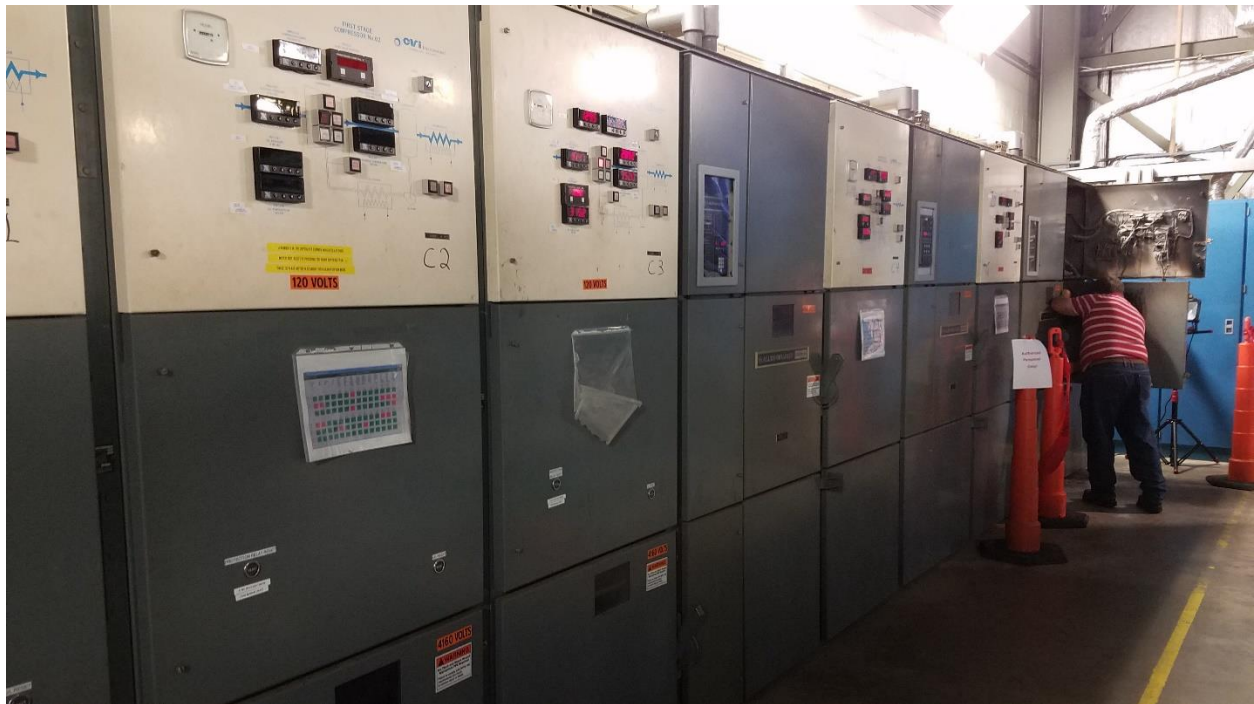
1. The Compressor #6 starter is the right-most set of cabinets in a row of MCC cabinets for three of the six main compressors in this building. See Figure 1, Figure 2.

Figure 1 The entire bank of motor control center starters for the 2250HP compressors in the building

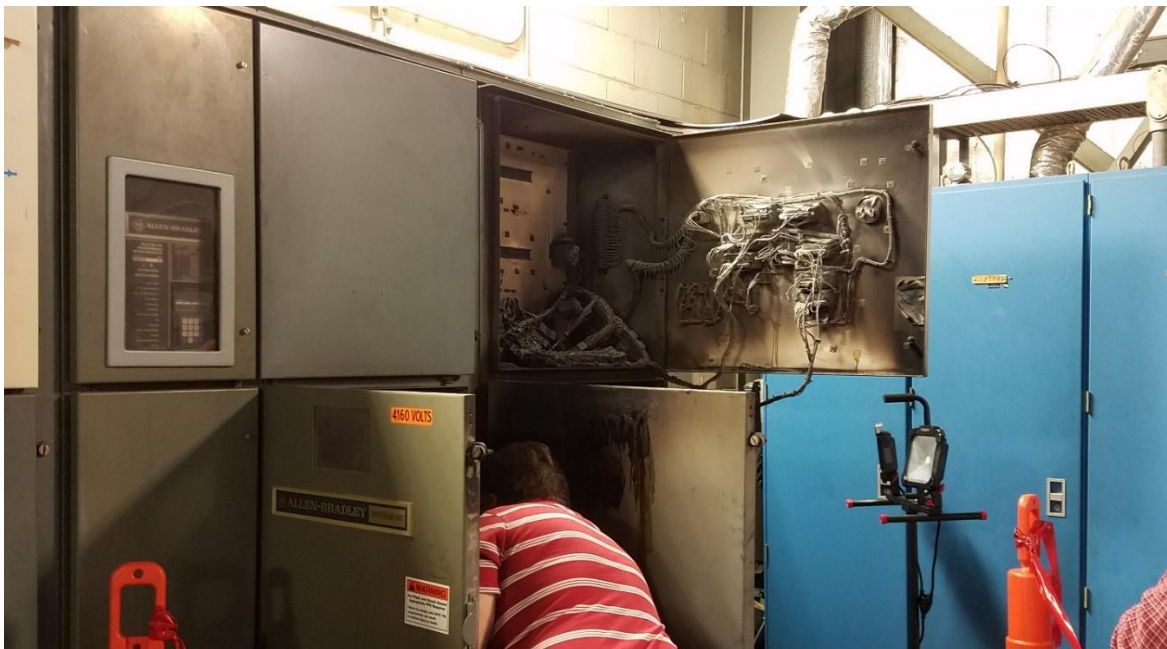
Figure 2 - Compressor 6 MCC – cabinets left to right, PMP, contactor/fuse, and autotransformer.

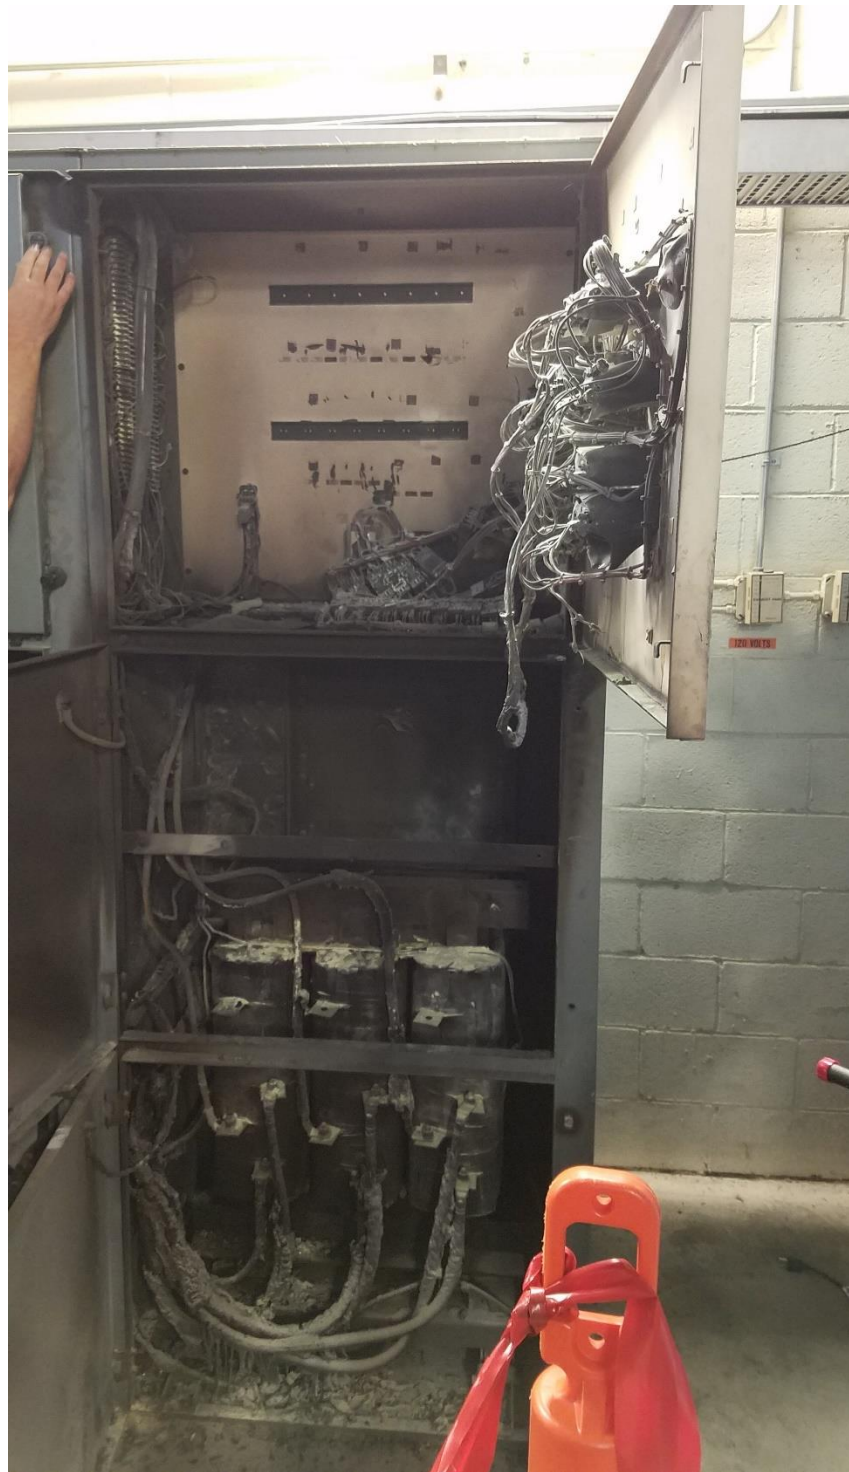
2. The damage was primarily located in the right-most of three vertical sections. This section houses the autotransformer and external control relays. See Figure 3.

7. The control equipment in the compartment above the autotransformer was heavily damaged, likely from heat and fire below.

Figure 3 - Fire damage in autotransformer/ external control enclosure.

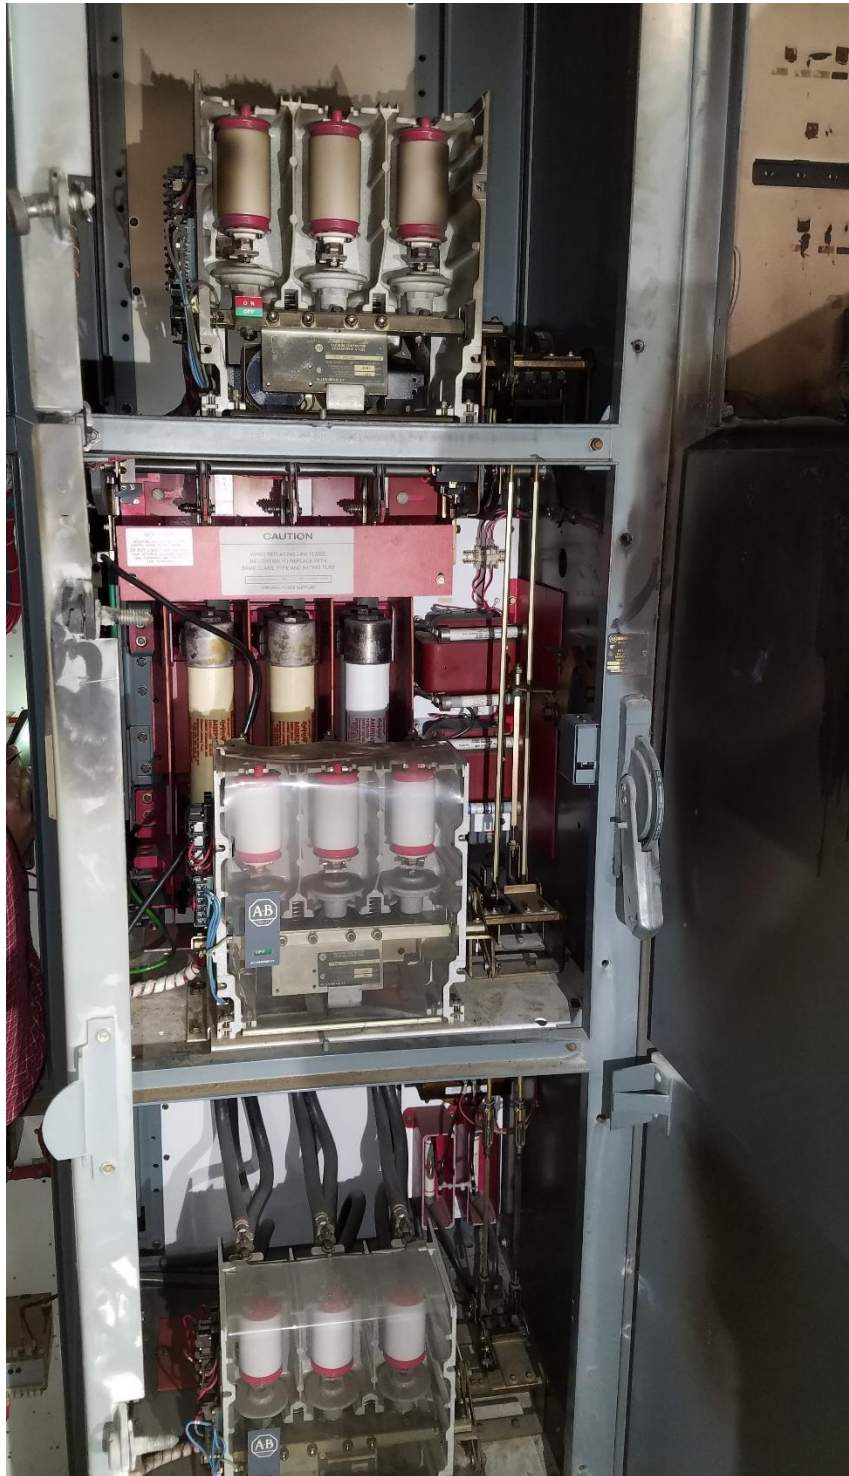
3. There was some indication of limited smoke damage in the top center compartment. Otherwise the center compartment seemed undamaged. This compartment houses the main fuses and contactors. See Figure 4.

Figure 4 - Interior of the contactor/fuse enclosure.

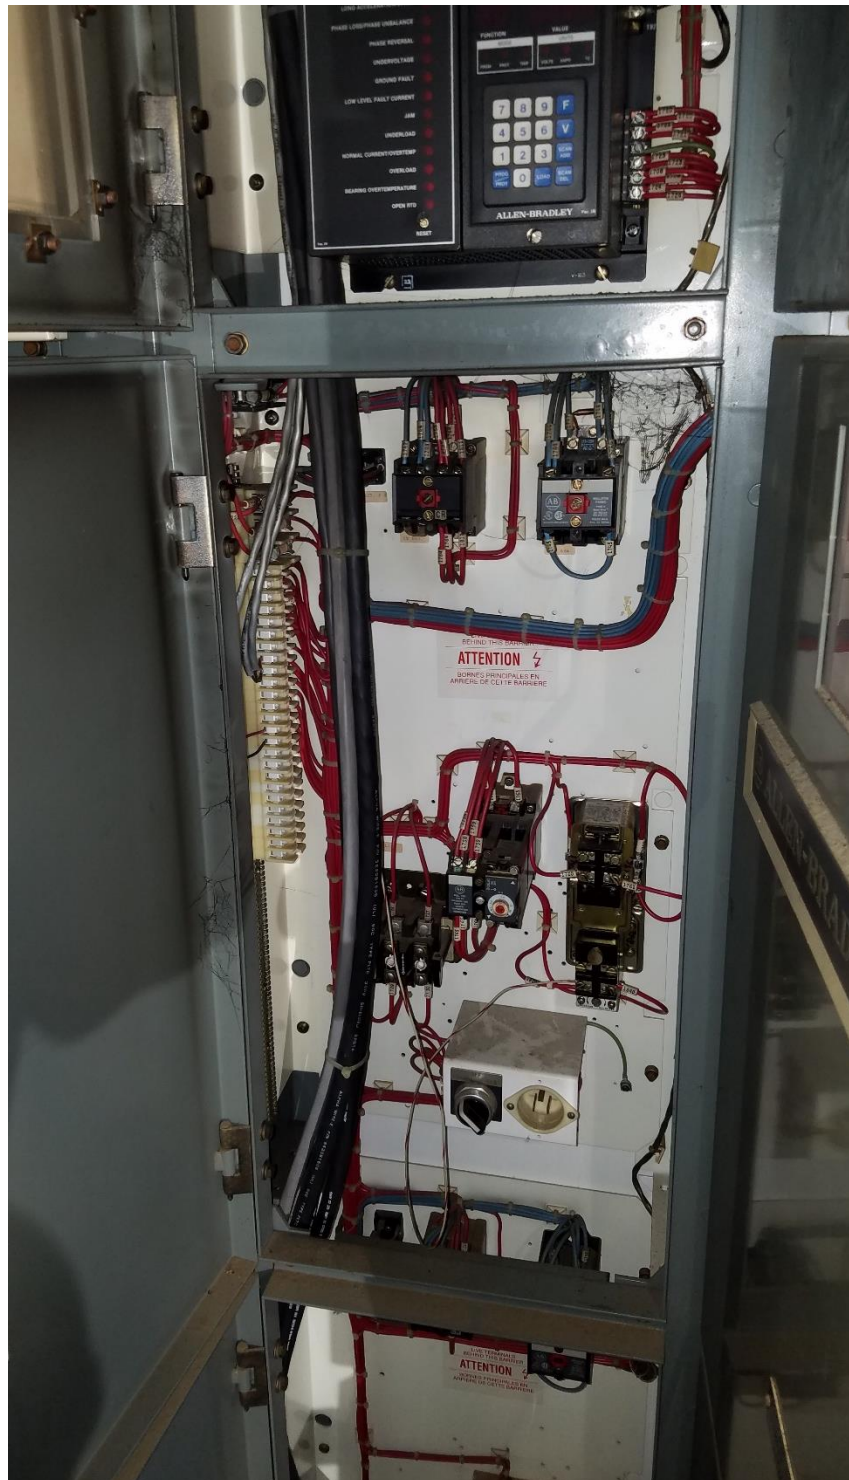
4. The left-most compartment appeared undamaged. This compartment houses control relays for the operation of the contactors in the center section as well as an Allen-Bradley 1406-P16 Series B programmable motor protector (PMP). See Figure 5. Earlier reports from responding firefighters of fire in the underground conduit from the MCC to the compressor appear to have been erroneous, this is supported by visual observation of the underground conduit and megger testing by facility personnel.

Figure 5 - Interior of the PMP enclosure.

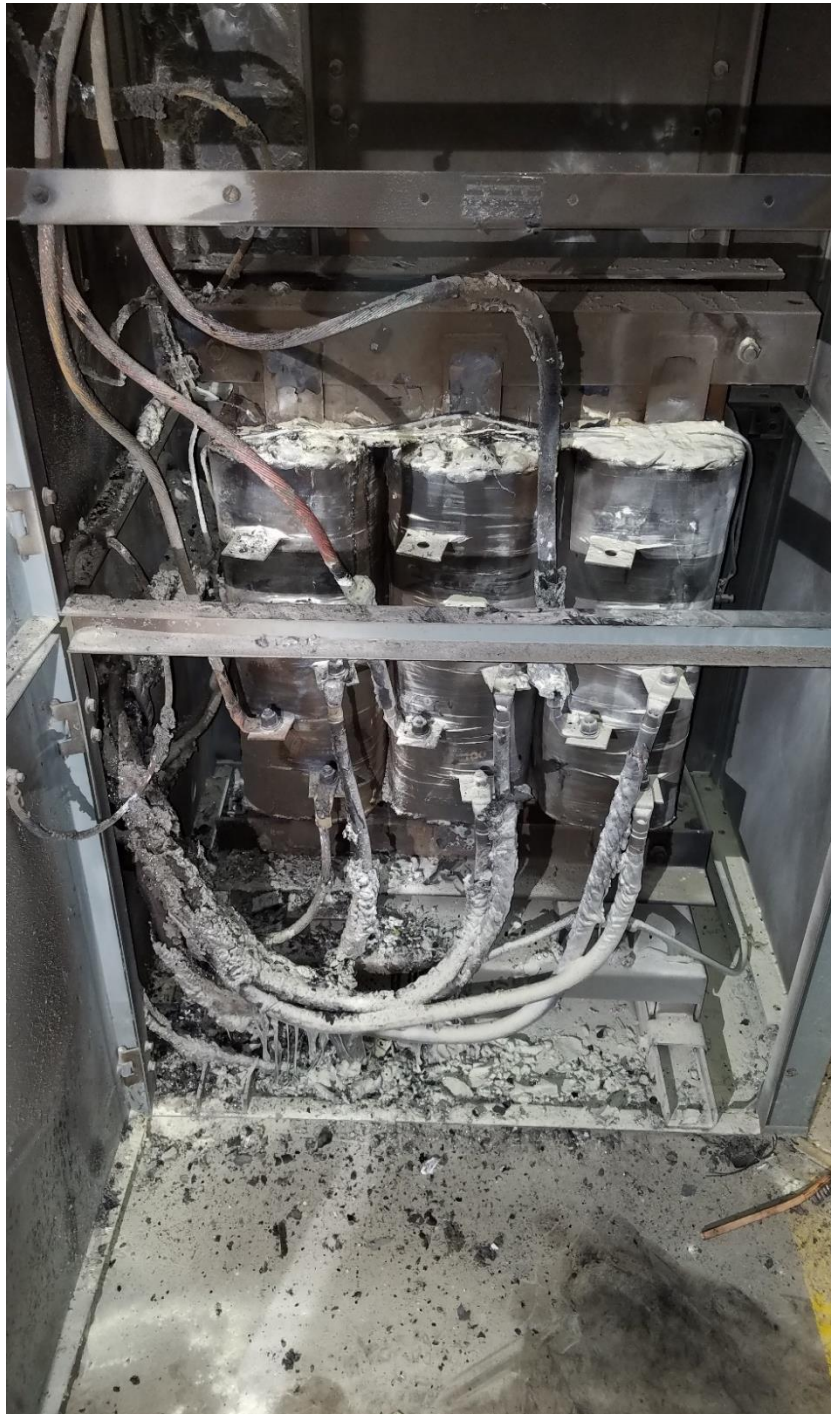
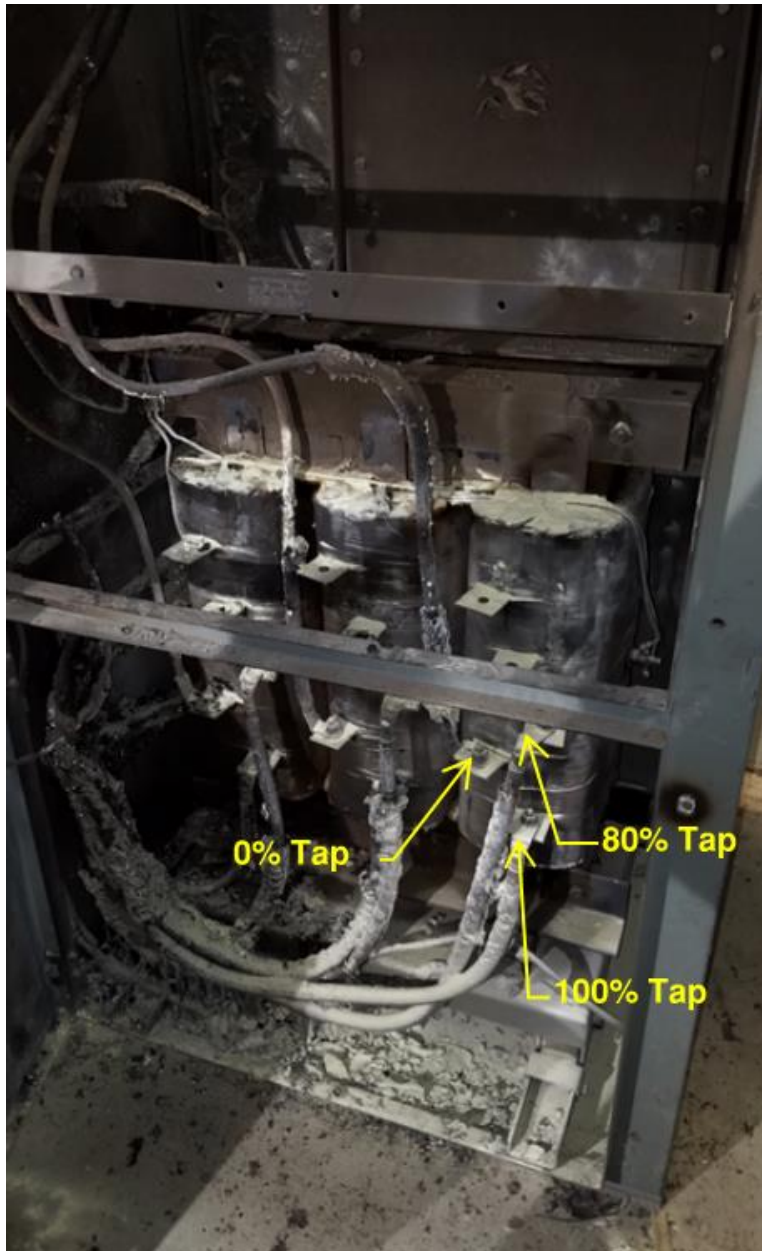
5. Most of the damage was concentrated on the left side of the autotransformer compartment, and more specifically the 0% tab on A-phase of the autotransformer. See Figure 6, Figure 7. This tab was noticeably looser than all the others. All bolted connections appeared tight. There is a bonding jumper for the door in close proximity to the 0% tab on A-phase of the autotransformer. See Figure 8.

6. The 0% tap conductors were routed above the autotransformer and sustained the most damage, all effectively losing all their insulation. Other conductors routed lower generally showed no signs of damage or were covered in melted insulation.

The autotransformer did not appear to be the source of the fire. Instead, the conductor on A-phase of the autotransformer 0% tap appears to have ignited and burned all combustible material close by. There are several possible reasons for the failure in this starter:

Figure 6 - Autotransformer – left to right, Phase “A,” “B,” and “C.”

Figure 7 - Autotransformer – 0% tap conductors routed up, 80% and 100% tap conductors routed down.

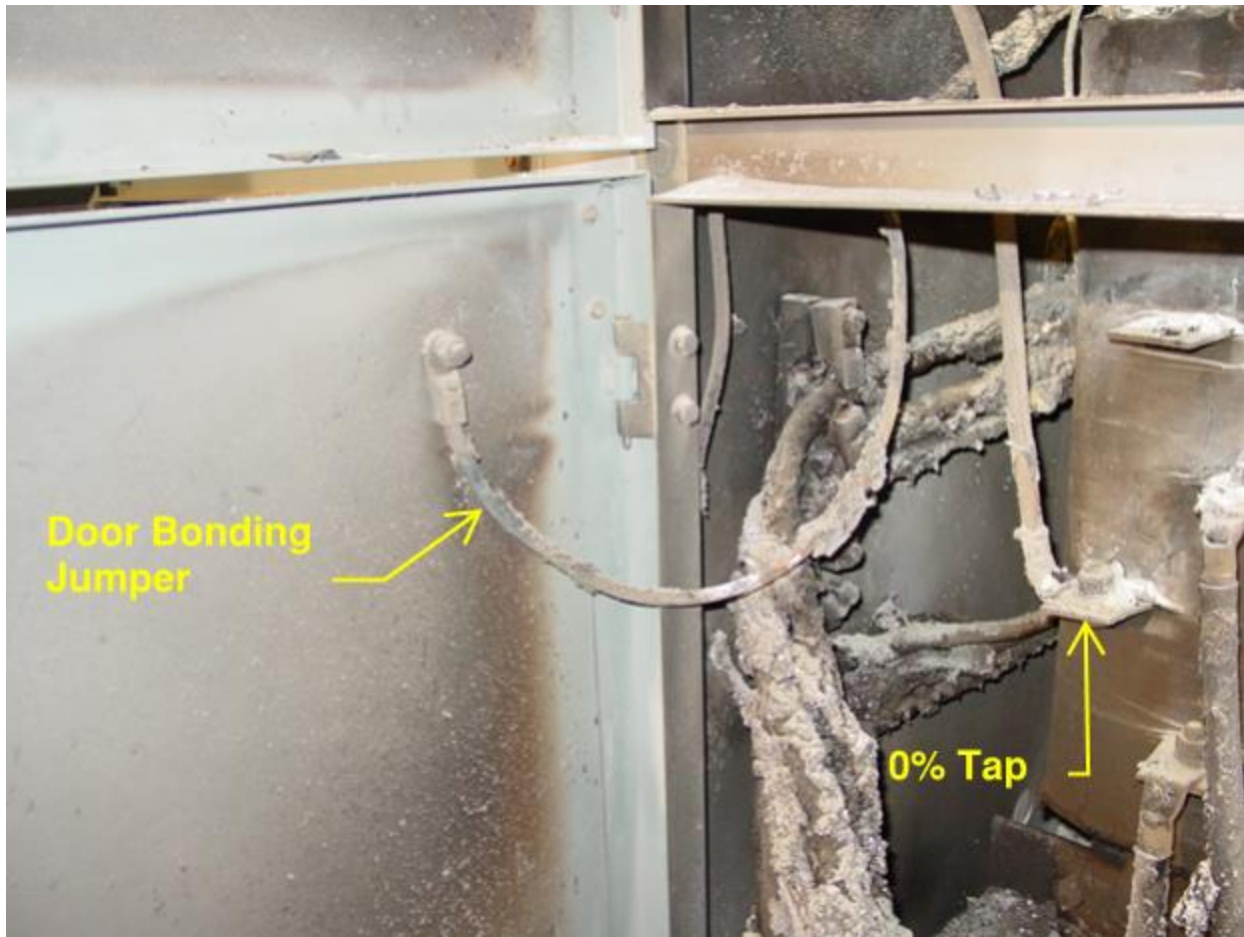
3. Zero tap to ground voltage strike. There is a bonding jumper for the door located directly above the 0% tap on the A-phase of the autotransformer and it is possible an arc occurred between the tap and the bonding jumper or the door. No obvious arcing damage was observed but damage to the conductors may hide this. Both the A-phase 0% tap conductor and bonding jumper had complete insulation failure in this area and often the ground conductor insulation is rated 600V, rather than system voltage.

Figure 8 - Door bonding jumper and 0% Phase A tap.

3. Reroute all grounding conductors away from transformer taps and other exposed connections as much as practical.
4. Replace the motor control center. The existing motor control center is approaching 30 years of age. It is not clear what temperature extremes to which the equipment has been exposed but the plant ambient conditions do not appear to be tightly controlled. Temperature extremes will have an adverse effect on equipment life. Consideration should be given to using newer technologies, such as soft starts and logic controllers, for better control.
