Notable Event Report

Title of Event			
Event Title:	Unexpected Energy Discovery		
Date and Time of Occurrence:	15 December 2016; 10am	Notable Event Number:	ACC-16-1215
Event Location:	Test Lab – Room 1019/1021 Tech Shop	Date Notable Event Report is Due*:	15-JAN-2017

**ORPS/NTS Determination: ACC-16-1215 Unexpected Discovery of Hazardous Energy While troubleshooting a 450 Ton Press** 12/20/2016

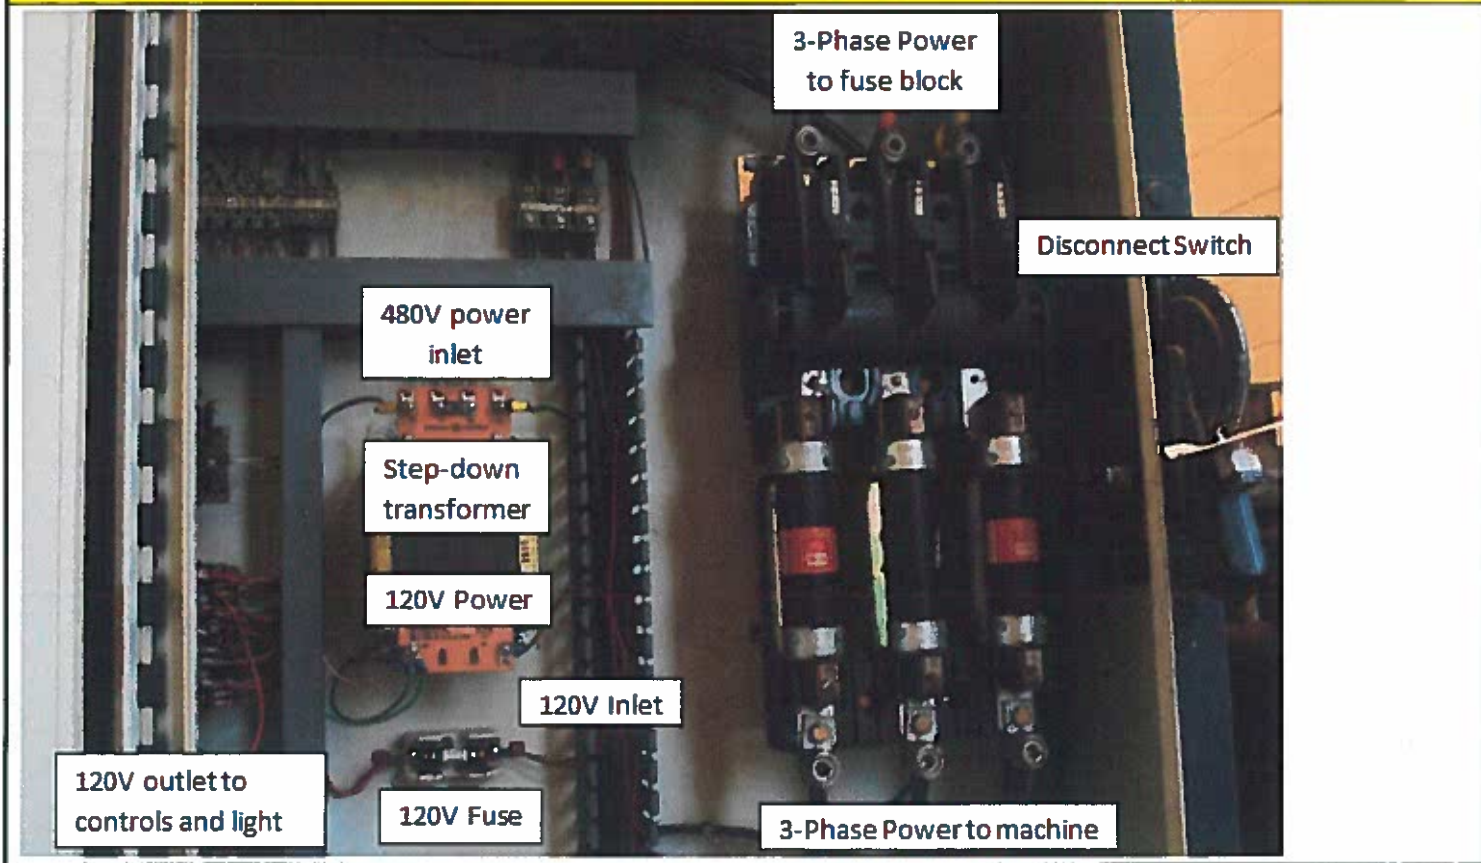
The technicians stopped what they were doing and verified zero power at the main 480 V terminals. However, they discovered power on the output (left) side of the 120 V fuse terminal.

After further safing out of the machine, an electrician was brought in to investigate the source of the unexpected power at the fuse terminal and traced wiring back to a light fixture mounted on the machine. This light fixture was found to be fed from an external source with a wall switch not directly associated to the press system. However an additional power feed was found connected through the light, directly feeding the downstream side of the 120 V fuse terminal.

During the rewire of the light, the wiring for the light was disconnected from the original 120 V power line from the stepdown transformer and the light was fed from an external power source through an external wall switch. However, during that rewiring, a dedicated power line, not connected to the wall switch, was connected to the original 120 V power feed from the output side of the 120 V fuse terminal. This essentially fed continuous 120 V power to the downstream side of the fuse terminal and into the controls. When 480 V was applied to the 450 Ton Press, power fed through the stepdown transformer to the input side of the 120V fuse and led to the fuse opening due to the dual delivery of power from both input and output sides of the fuse.

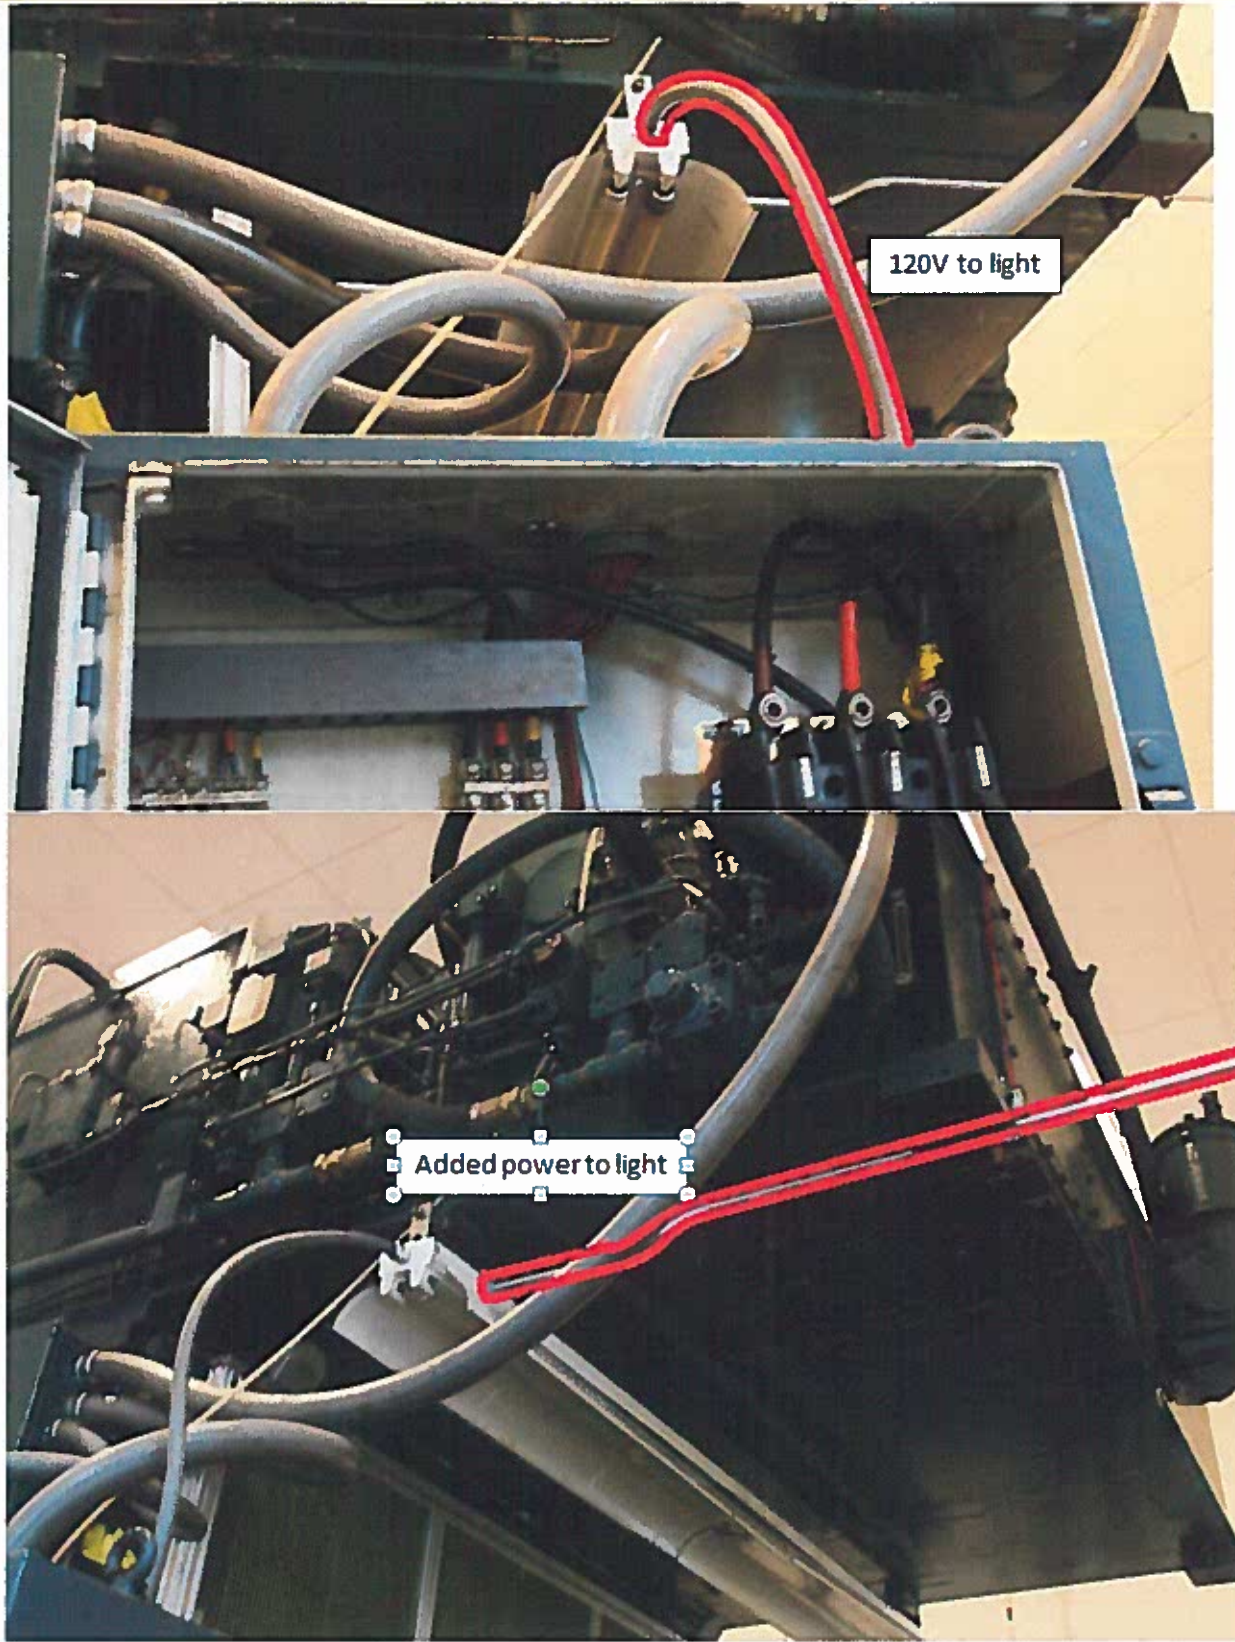
Upon further investigation it was determined the light fixture had always been internally fed from the downstream side of the 120 V fuse terminal which also feeds the controls of the press. In the original electrical scheme, when the machine's 480 V was powered on, a stepdown transformer would provide 120 V power to the controls and the light, while the 480 V powered the press' hardware. The light would provide improved visibility under the press during operation. When the 480 V power was secured to the tool, the press hardware fed from the 480 V and the controls and light fed from the 120 V side of the transformer would become inactive.
