**Notable Event Report**

Title of Event			
<b>Event Title:</b>	Refrigerant Detections System Disabled Following Discovery of a small leak- Interim Mitigations were Less than adequate (LTA)		
<b>Date and Time of Occurrence:</b>	11/29/2016	<b>Notable Event Number:</b>	FML-16-1130
<b>Event Location:</b>	Building 60 –CUP	<b>Date Notable Event Report is Due*:</b>	12/30/2016

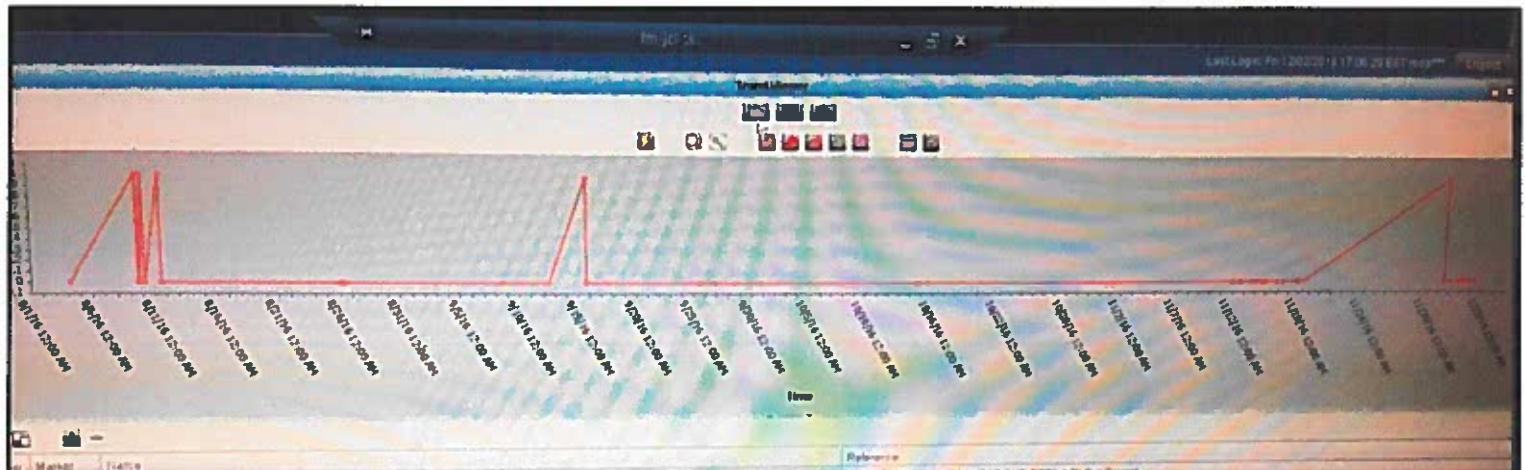
The monitor has been switched on/off on multiple occasions (with undetermined duration) during this specific time frame, trend data supports the recollection of the events - see below. The monitor was OFF for electrical outages, control modifications, construction activities such as pipe painting, cleaning and some chiller evaluation work, but the monitor was ON / active to alarm on 11/14/16. This would suggest our length of potential exposure is less than originally determined.
