Title of Event			
Event Title:	Experimental RF Cavity Vacuum Window Failure		
Date and Time of Occurrence:	11-July-2012/~3pm	Notable Event Number:	ACC-12-0711
Event Location:	Room 115, Test Lab North Extension (Vacuum Lab)	Date Notable Event Report is Due*:	12-August-2012

Addendum: Notable Event Report – ACC-12-0711 Experimental Cavity Vacuum Window Failure

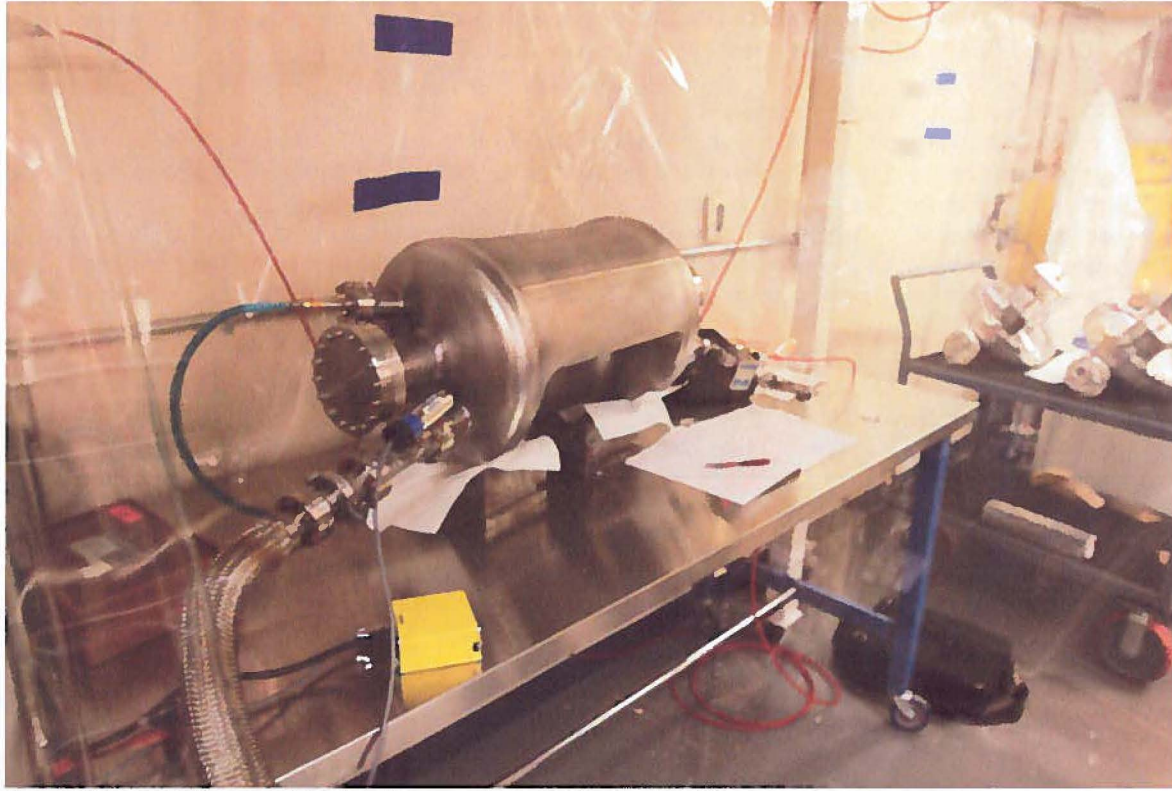
Scene Picture (taken outside the clean work area plastic sheeting)

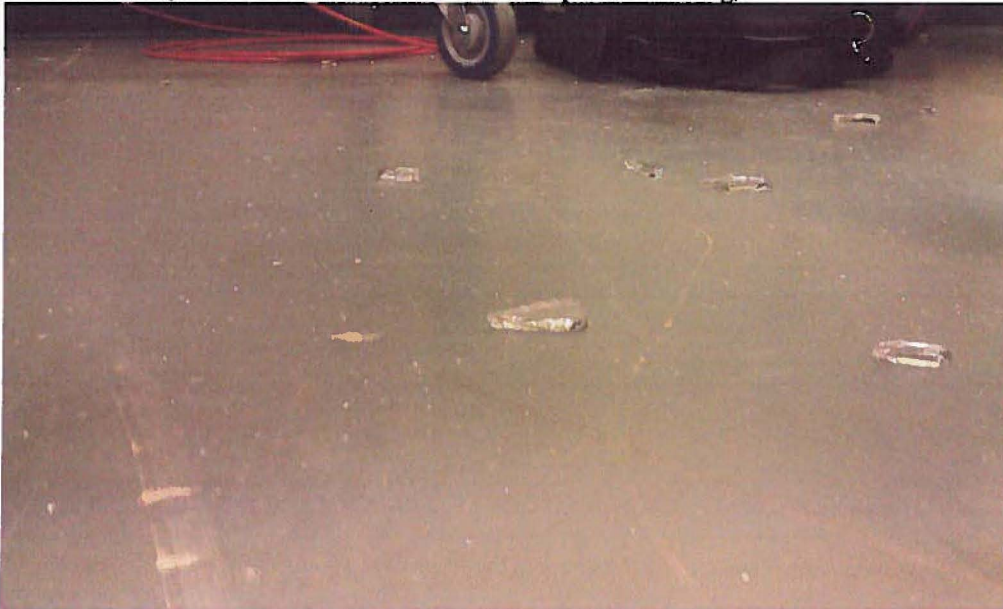
Fragments of Glass on Floor (taken within the clean work area)

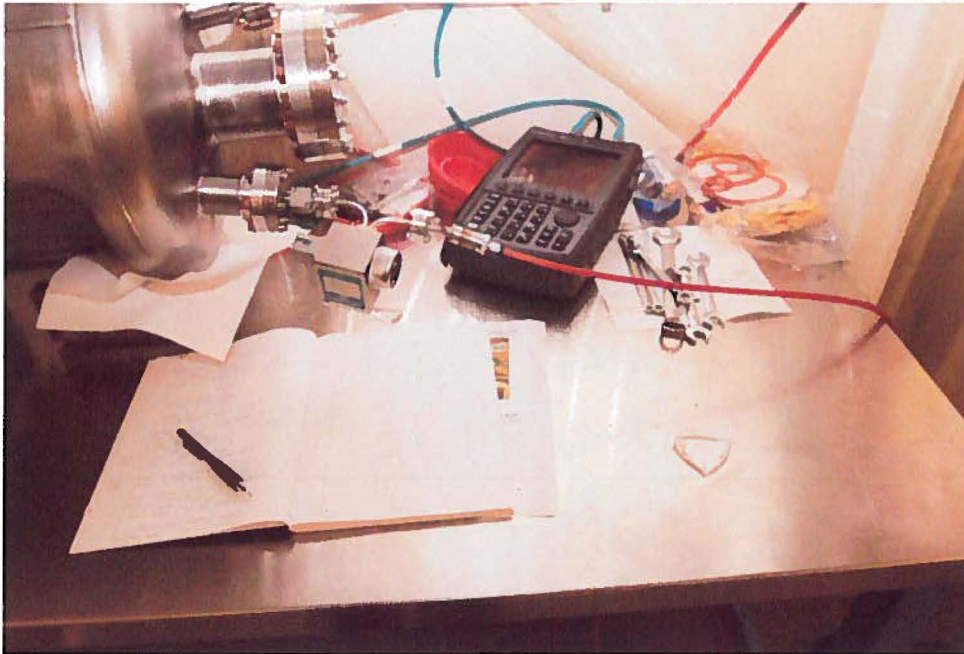
Student Work Area w/ Large and Small Glass Fragments (ruptured flange window seen in upper left)

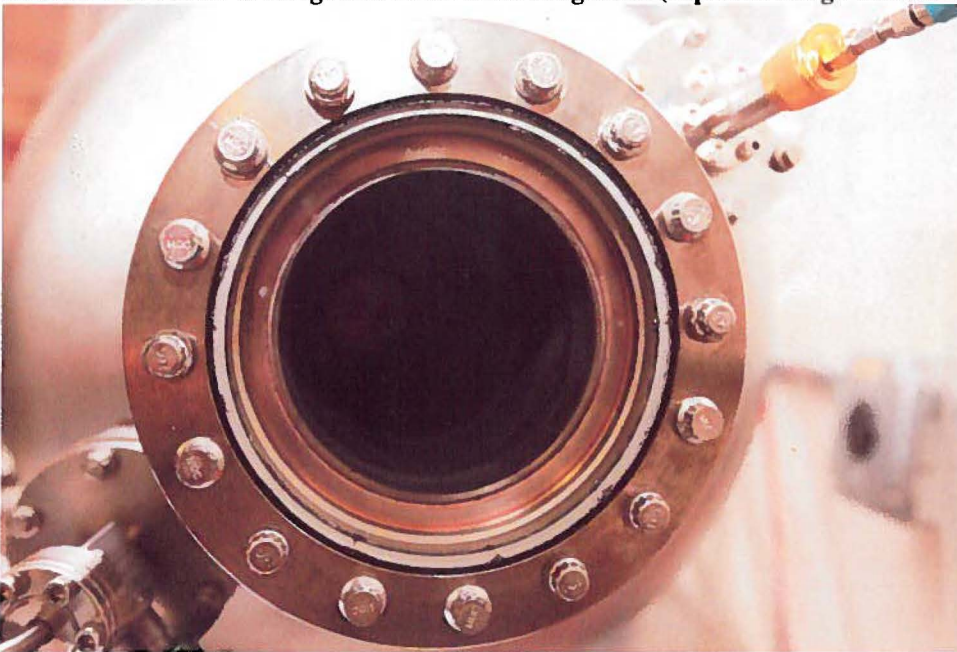
15:00 – The glass Varian viewport window ruptured at what was believed to be 200 Torr of pressure (below 1 atm) as observed and recorded by the student just before the rupture.

15:00 – Glass fragments forcefully propel from the cavity's viewport end and continue into the adjacent clean work area. No glass fragments are within the cavity.

- 2.) There was no need for a visual inspection of the inside of the cavity during the experiment and the viewport was therefore not needed for the setup. The viewport could have been replaced by a regular 6" Conflat blank flange to seal the cavity.

- 3.) There was no pressure relief in the vacuum setup to prevent over pressurization during purge stages of the experiment. If one was installed on the setup at the entrance of the Nitrogen purge to the cavity, the overpressure should not have occurred.

View of Flanged "Window" Where Glass was Ejected

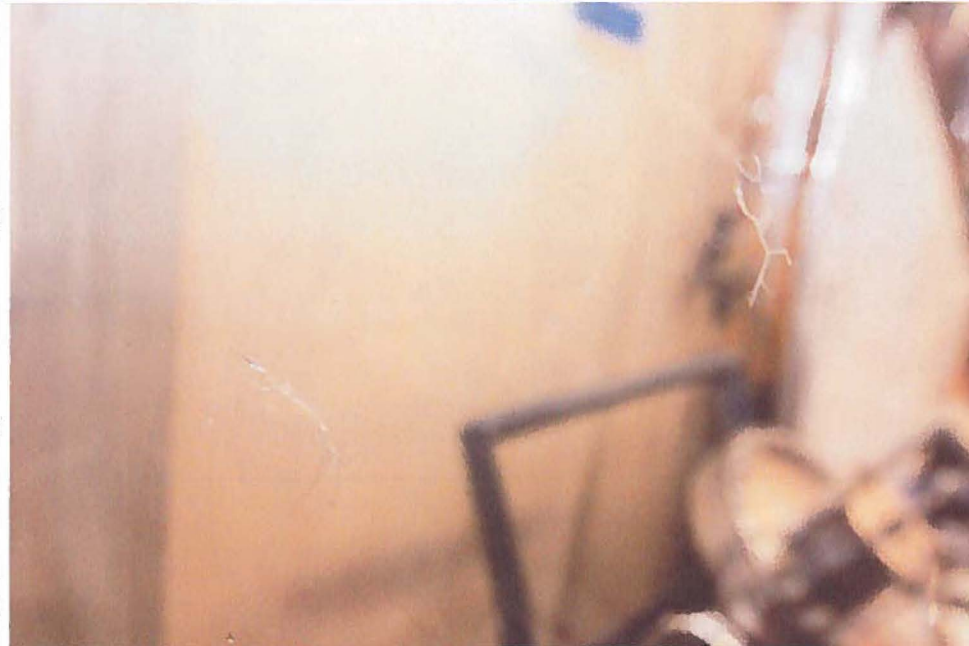
View of Double Walled Plastic Clean Area(s) Sheeting w/ Holes from Projected Glass

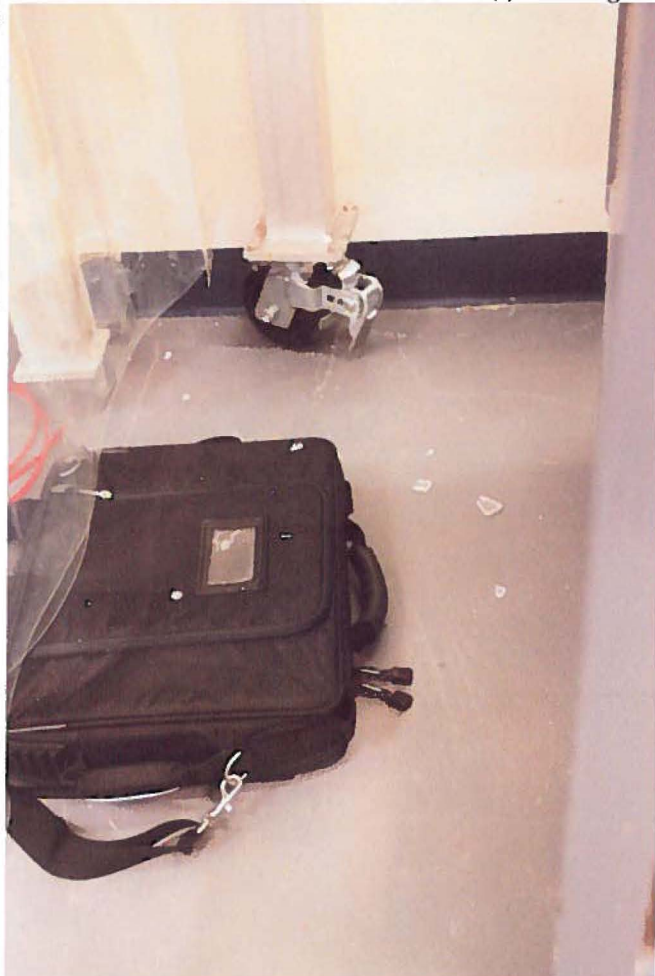
Glass in Second Clean Area Adjacent to Student Work Area (left of white pillar)

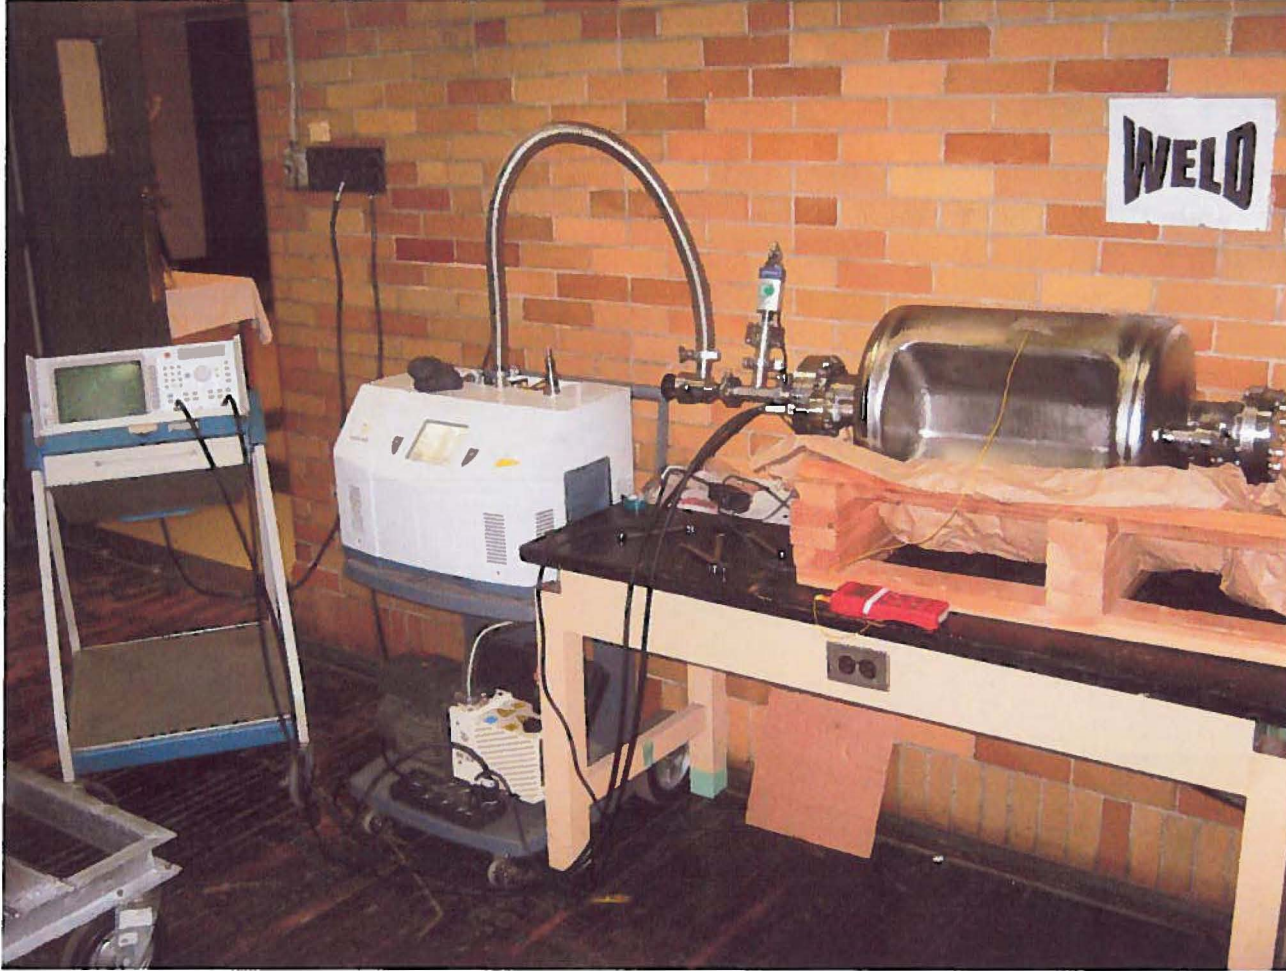
Assembly of the cavity setup with parts obtained earlier from within the vacuum lab is conducted mainly by the student. The student assembled the vacuum system to match a similar setup at the cavity manufacturer's lab (Niowave, INC.) which did not include a Nitrogen purge line.

Picture of Cavity and Setup at the Manufacturer – Niowave, INC. (this photo was used by the student as an assembly guide.)
