Notable Event Worksheet

Event Title: Electrical Conduit Breach by Drill Bit

Notable Event Number: FML-12-0501

Event Location: Jefferson Lab; Technical Engineering & Development (TED) Building 55 Lobby

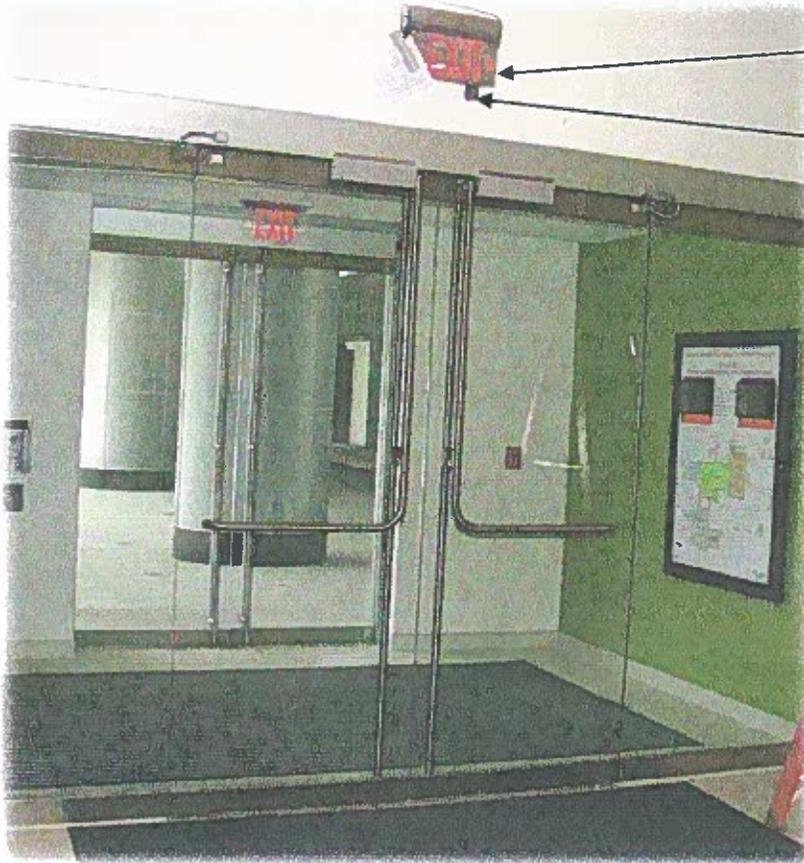
Exit sign

Motion sensor junction box

The rough-in of the electrical exit sign junction box and the motion sensor junction box were not well coordinated. The motion sensor j-box was not centered over the door opening. The work to be accomplished involved relocating the motion sensor to a position just under the installed exit sign and centered over the door. A PVC plastic panel was to be installed behind the motion sensor to cover the abandoned single gang rough-in.

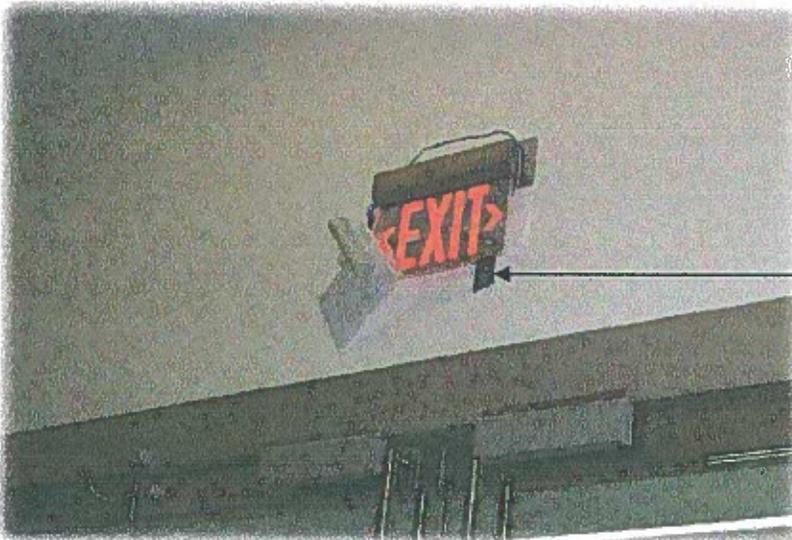
The motion sensor j-box was roughed in off center with respect to the door opening and partially behind the exit sign.

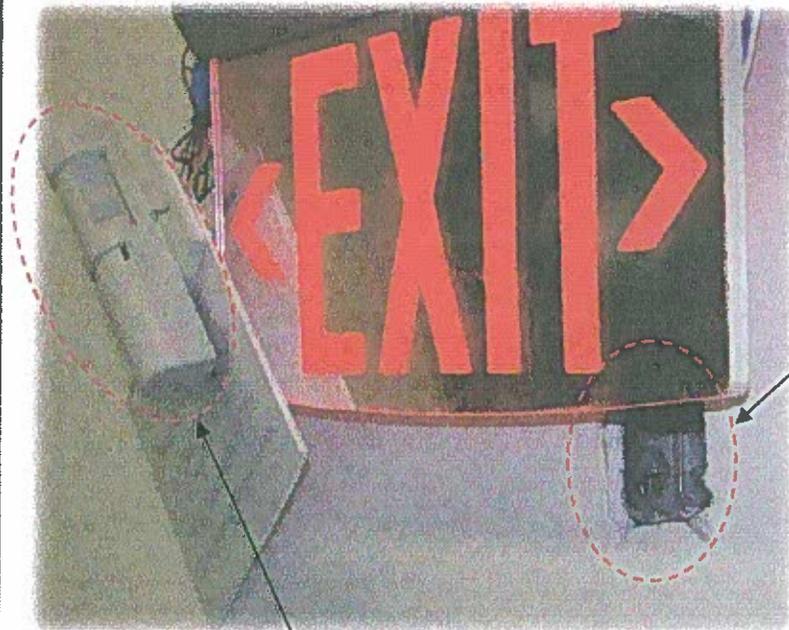
A closer look at the low voltage motion sensor junction box.

This is the motion sensor that will be relocated to a position directly below the center of the exit sign.

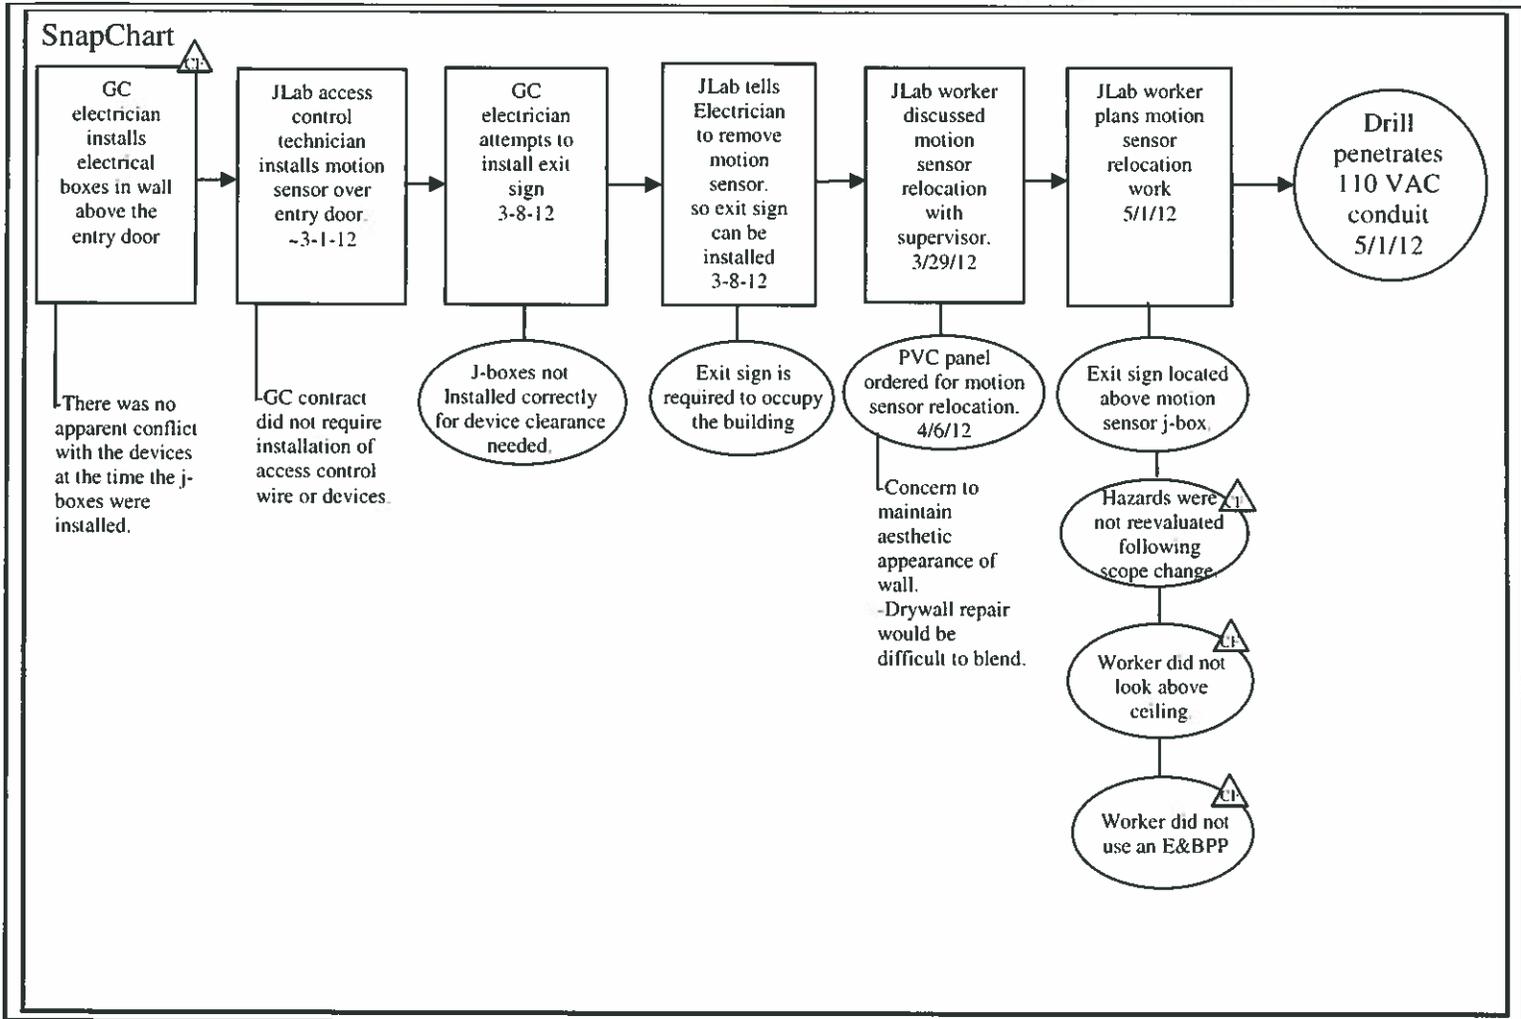
Two team members have received some training in the TapRoot method of accident investigation. The TapRoot Cause Tree was used to evaluate this event.

| Causal Analysis: (Use attachment as necessary) | |
|---|---|
| Root Cause: | The work package was less than adequate. The employee changed the scope of the task and failed to reanalyze the hazards and develop and implement the appropriate hazard controls. This included failing to complete a visual inspection of the ceiling and wall prior to completing the task as well, and, completing the Excavations and Blind Penetrations into Walls & Floors Permit. |
| Contributing Causes: (List as many as apply.) | <p>The construction drawings available for subcontractors and employees to use need improvement. The drawing package did not contain enough detail to coordinate the installation of the exit sign and the motions sensor. No institutional mechanisms exist to help guide a design team on this minor level of detail.</p> <p>Discussion: The drawing package for the TED construction does not contain an interior elevation detail to coordinate the installation of the exit sign selected for this building and an access control motion sensor which both needed to be installed centered over the glass wall door opening. A wall mounted exit sign typically installs centered over the electrical box that is installed in the drywall. The exit signs specified for this installation hangs well below the electrical box installed in the drywall and partially covered the junction box installed below the exit sign for a motion sensor. The installation was not apparently deficient until an attempt was made to install both the exit sign and the motion sensor.</p> |

| Corrective Action(s) | <u>JLab CATS Number</u> | Target Date |
|---|---|---|
| The JLab Excavations and Blind Penetrations into Walls & Floors Permit was not used for this job, however, during the investigation, it was determined that the permit is not strict enough and it allows a technician latitude to avoid using the permit. The JLab permit is also confusing because it includes both digging activities and wall/floor penetration activities. These two activities will seldom if ever be accomplished on the same job. A separate permit for each of these activities will simplify each permit. Sperlazza | NE-2012-14-01 | 12/01/2012 |
| Consider making blind penetration permits mandatory for all situations. Use Los Alamos' blind penetration permit as guidance. This permit is mandatory for all instances of wall and floor penetration but also allows simpler approval for the picture hanging type of penetration. The practical check list of this permit forces the technician planning the work to either thoroughly investigate the wall cavity or lie about the investigation. The investigation team believes that when a JLab technician is faced with a check box the JLab culture and work ethic would result in a thorough investigation prior to the penetration. Sperlazza | NE-2012-14-01 | 12/01/2012 |
| Once the Excavation and Blind Penetration Permit has been revised, retrain the personnel that will be required to use them. Sperlazza | NE-2012-14-01 | 03/31/2013 |
