Notable Event Report

Title of Event			
Event Title:	Electrical Spark and Power Loss Caused by Leak During Magnet Power Supply Cooling System Flush		
Date and Time of Occurrence:	1/3/2017 ~ 6:30am	Notable Event Number:	ENG-17-0103
Event Location:	North Access – Building #67	Date Notable Event Report is Due*:	2/2/2017

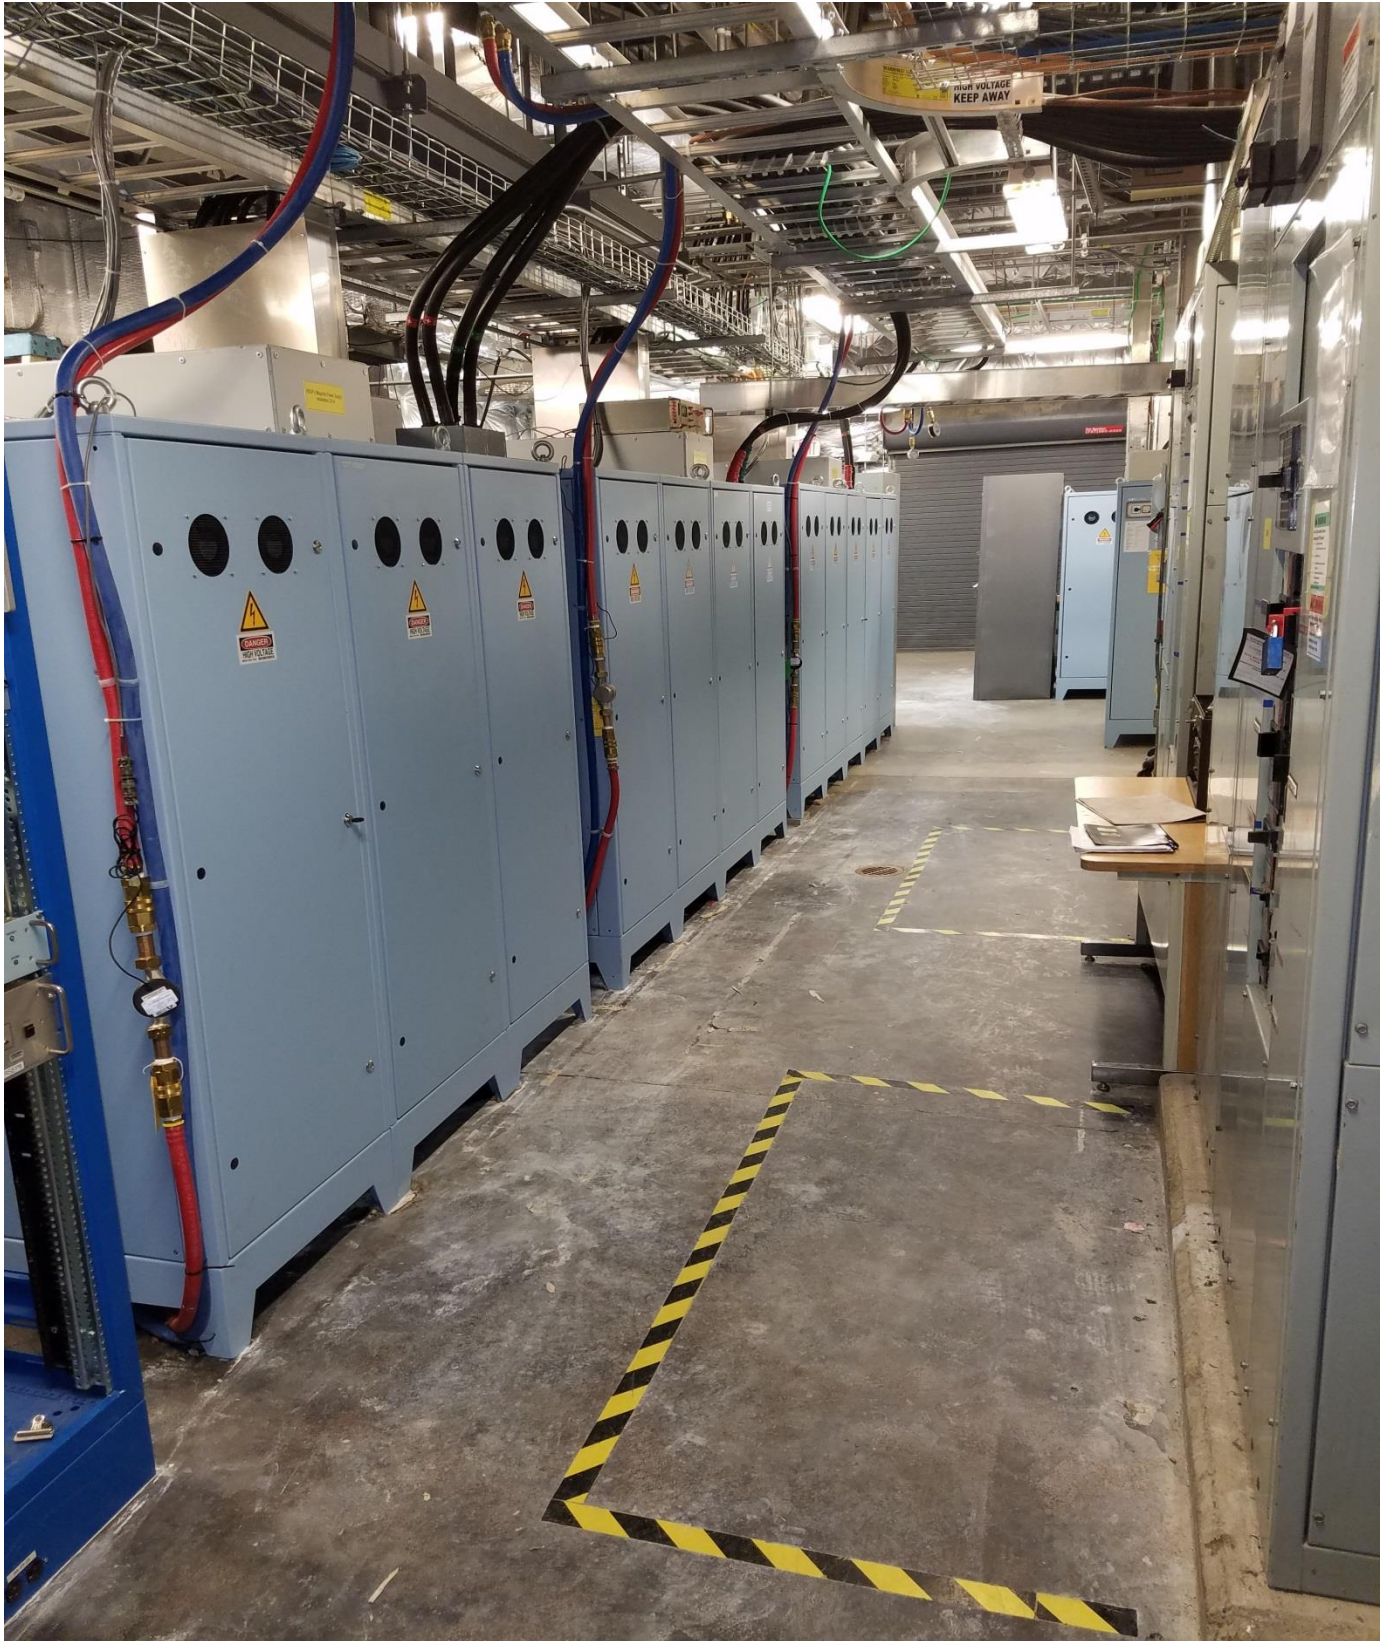
Figure 1

- 1) Power supplies being acid flushed (left) – Switchboard NA2 (right).
- 2) Blue hose connection point for acid flush machine (in ceiling)-red hose connection point at floor level beyond flow meter (see figure one); blue hose connection was the one discovered to be leaking.

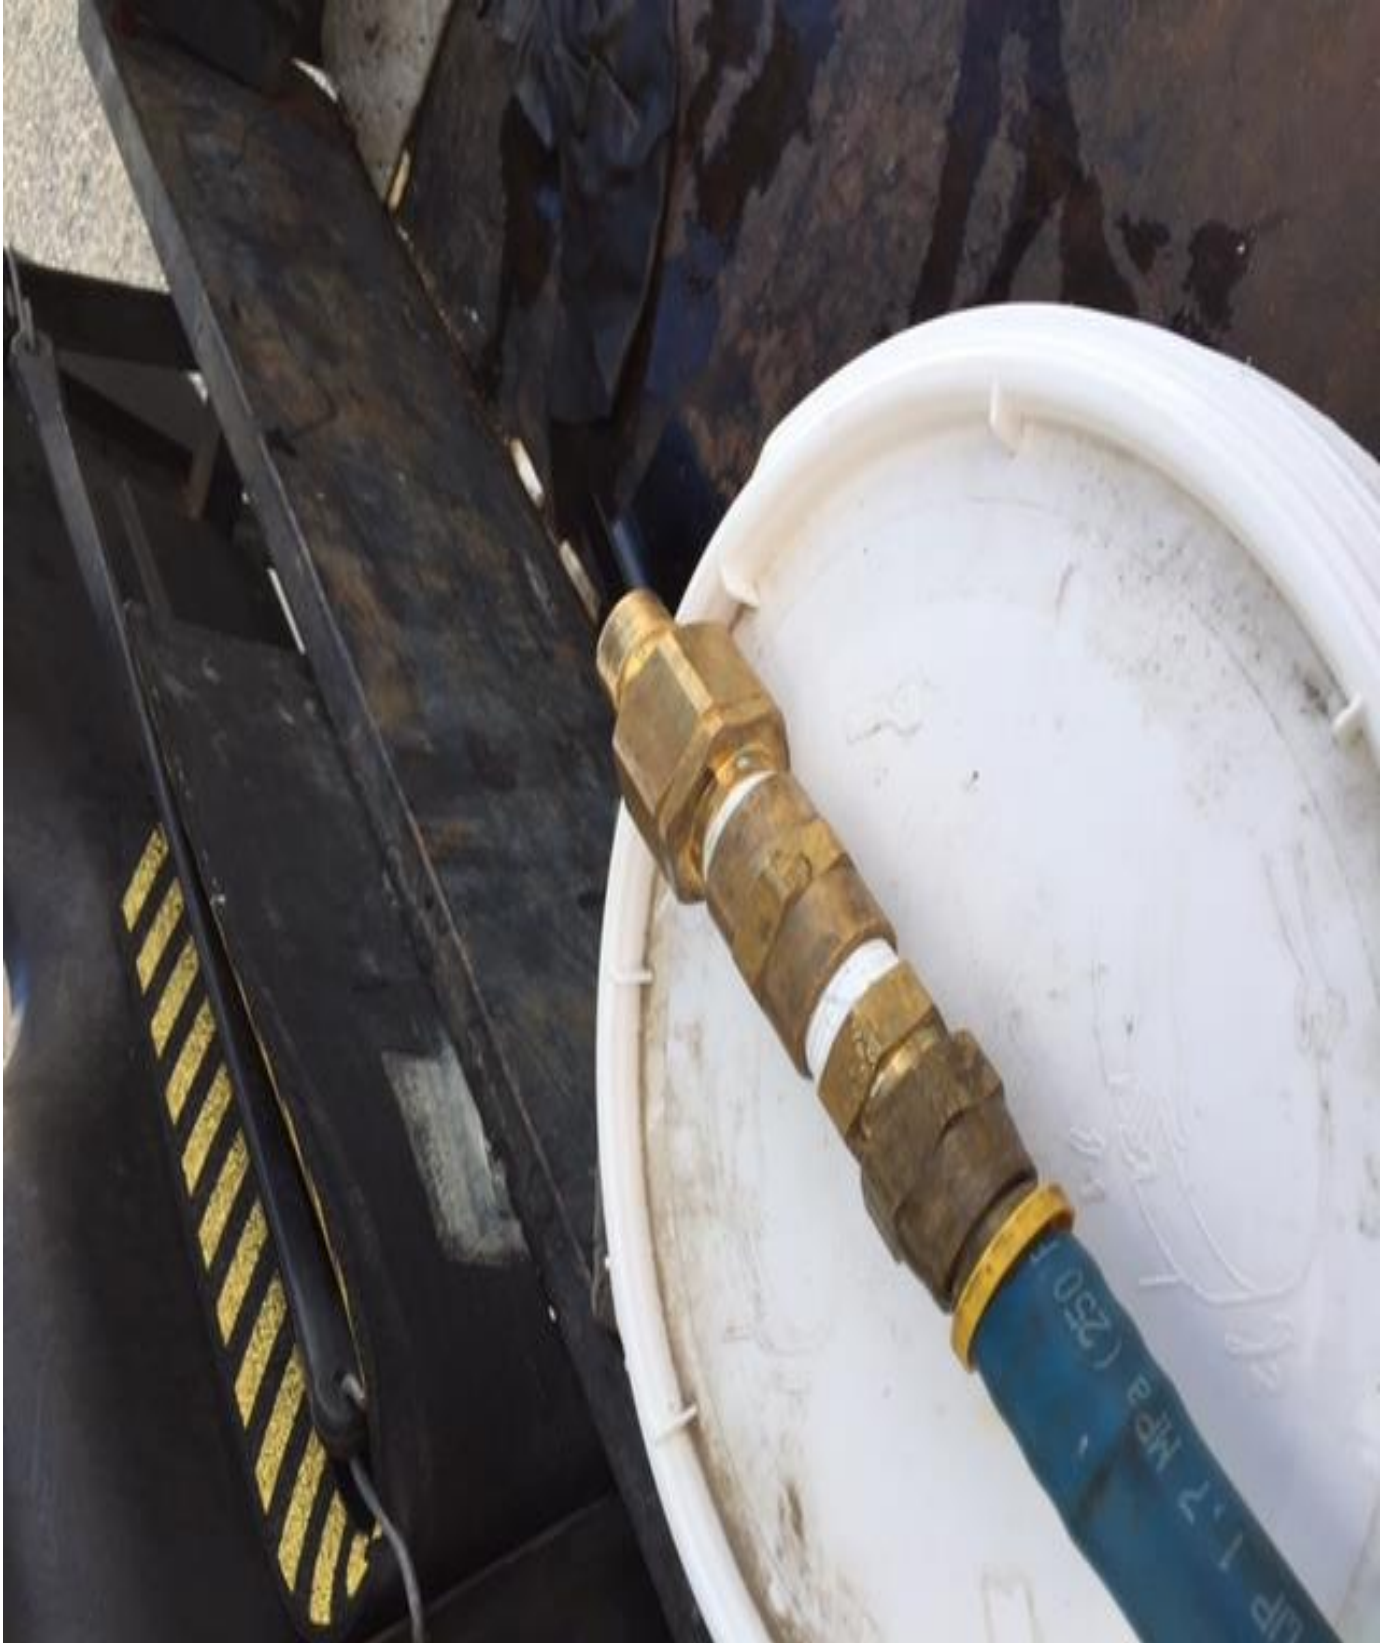
Figure 3

- 3) Fittings where leak was discovered.
- 4) SKM snapshot of switchboard NA2 arc flash analysis (1.1 cal/cm² incident energy and a 17 inch arc flash boundary).

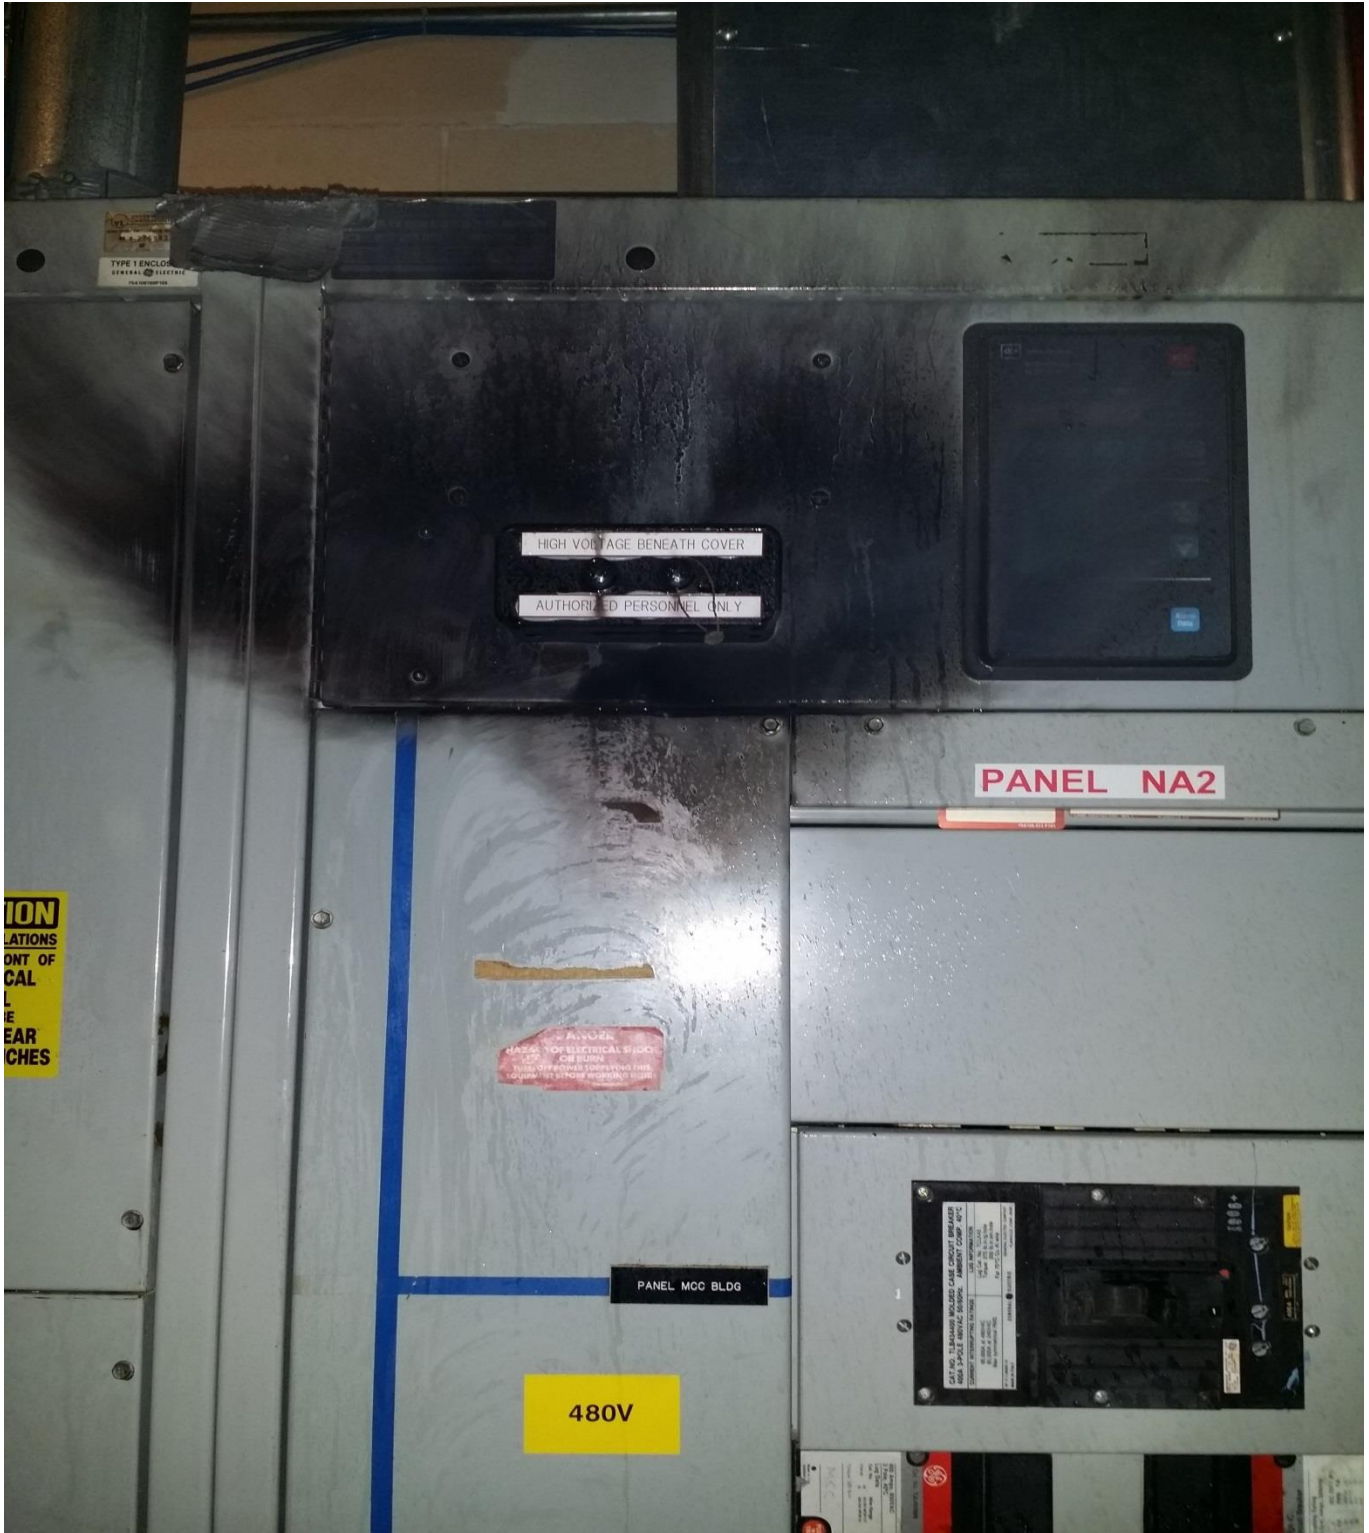
Figure 5

- 5) Scene preservation less than adequate. Scene preservation aids in the investigation process. The FM&L electricians were allowed to clean and affect repairs of the NA-2 panel without considerations of the investigative process. At a minimum, photos of the equipment and surrounding affected area should have been taken prior to making repairs.

- 5) Switchboard after 2nd flash - **No picture taken after 1st flash.**
- 6) Switchboard after repair was made to the instrumentation/metering compartment. Yellow circle around the General Electric test block, type PK-2, is where the short circuit is assumed to have taken place when the acid spray reached the live contacts on the test block. The type PK-2 test blocks are used to test switchboard mounted instruments, meters, and relays when in an electric circuit or by the use of a separate source of power. They are back connected and their contacts have live-line contact.

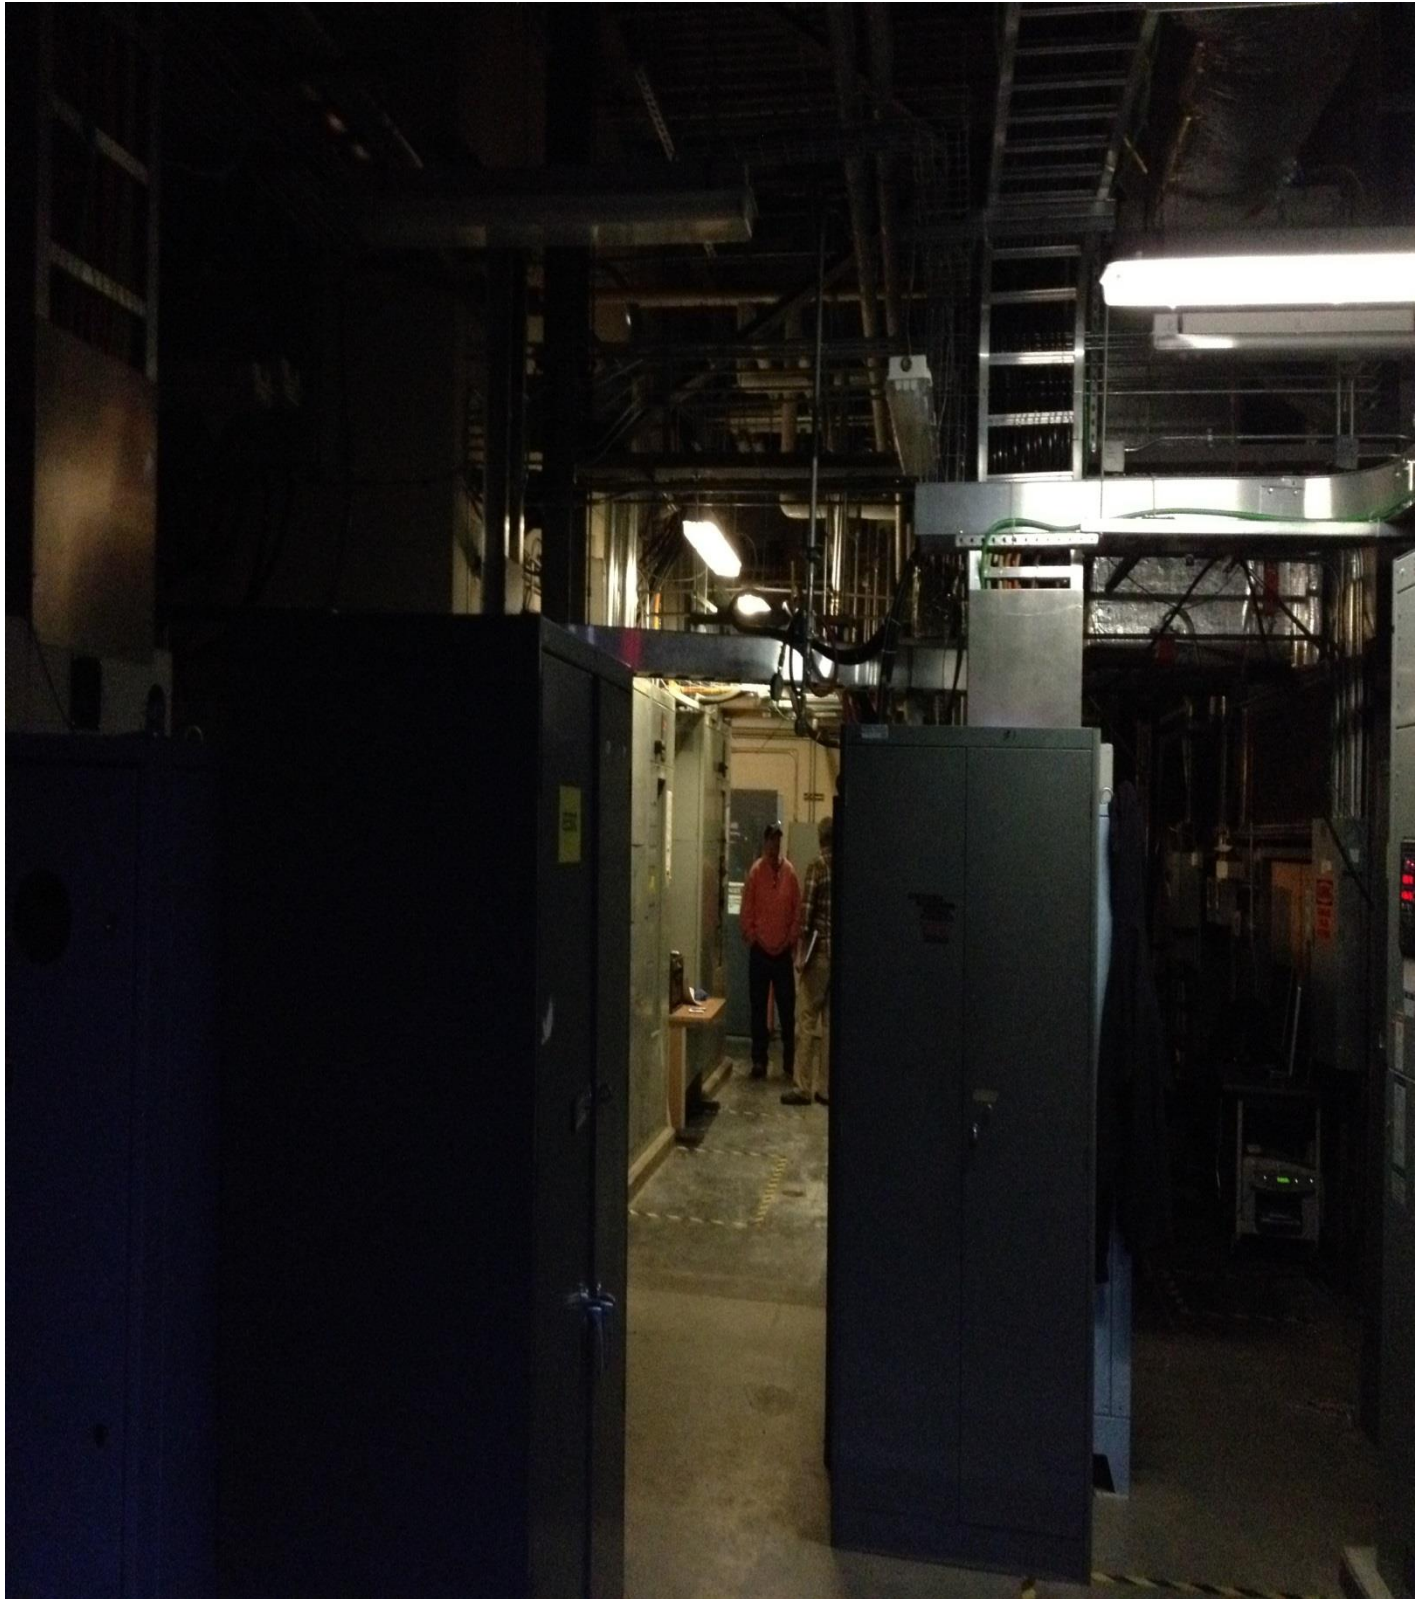
Figure 7

- 7) Emergency lighting present in the North Access building during the power outage; looking back at the switchboard location.
- 8) Outside Main Circuit Breaker (MCB) that feeds switchboard NA2 (breaker that tripped off).

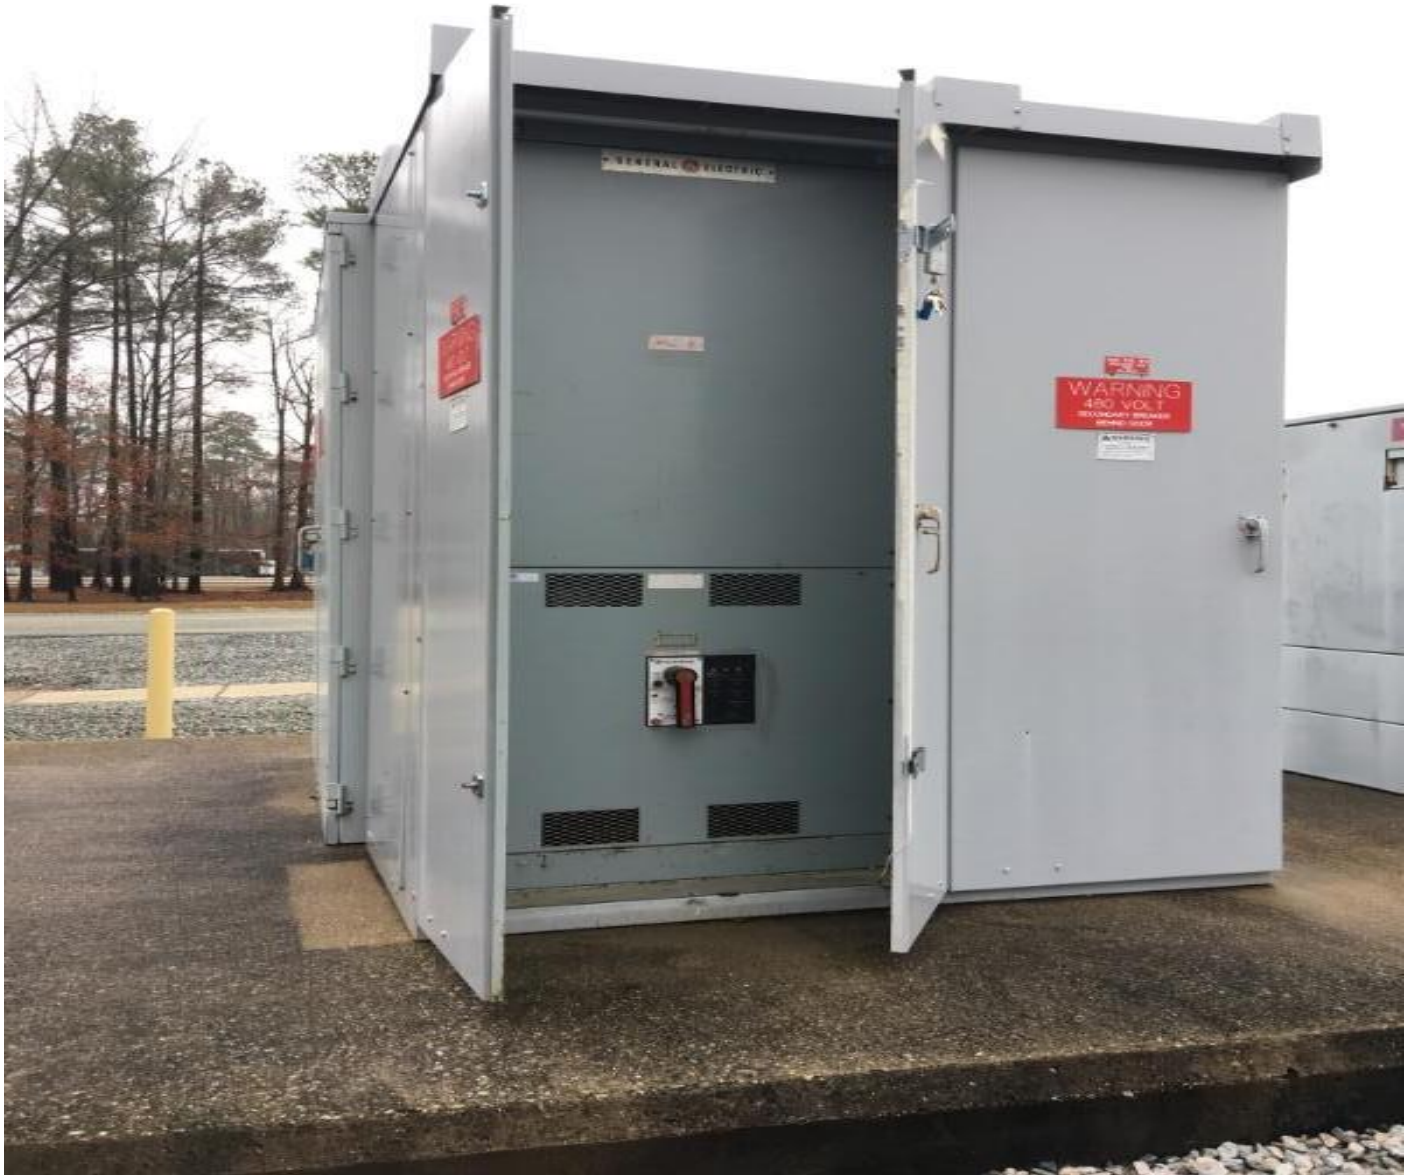
Figure 8

The FMENG donned appropriate PPE, turned off the breakers on the NA-2 panel (the FMENG is trained for this task), and then left the NAB to check the main circuit breaker (MCB) located outdoors. The FMENG determined that the MCB tripped and turned it off. The EMENG did not evaluate the indicator flags on the MCB to help identify why it had tripped. At this point the scene inside the NAB was left uncontrolled. While the FMENG was outside the NAB, the ACC and a DC Power technician (DCP) reported to the NAB, unaware that the FMENG had reported to the scene. The ACC and the DCP were standing approximately three feet away from the NA-2 panel and were engaged in a discussion on what systems were fed by NA-2 when the FMENG switched the MCB back on. The ACC and DCP observed visible flash from the area of a metering device at the top of the switchboard, which coincided with the location the EMENG previously identified minor smoke discoloration. The FMENG was unaware that there were 2 people in the vicinity of the panel as he was trying to reset the breaker. The ACC assigned TECH3 to guard the area.
