Notable Event Worksheet

Title of Event			
Event Title:	Hall A Right Septum Electrical Short		
Date and Time of Occurrence:	Saturday, March 17, 2012 9:16 AM	Notable Event Number:	PHY-12-0317
Event Location:	Building 101 - Hall A	Date Notable Event Report is Due*:	04-17-2012

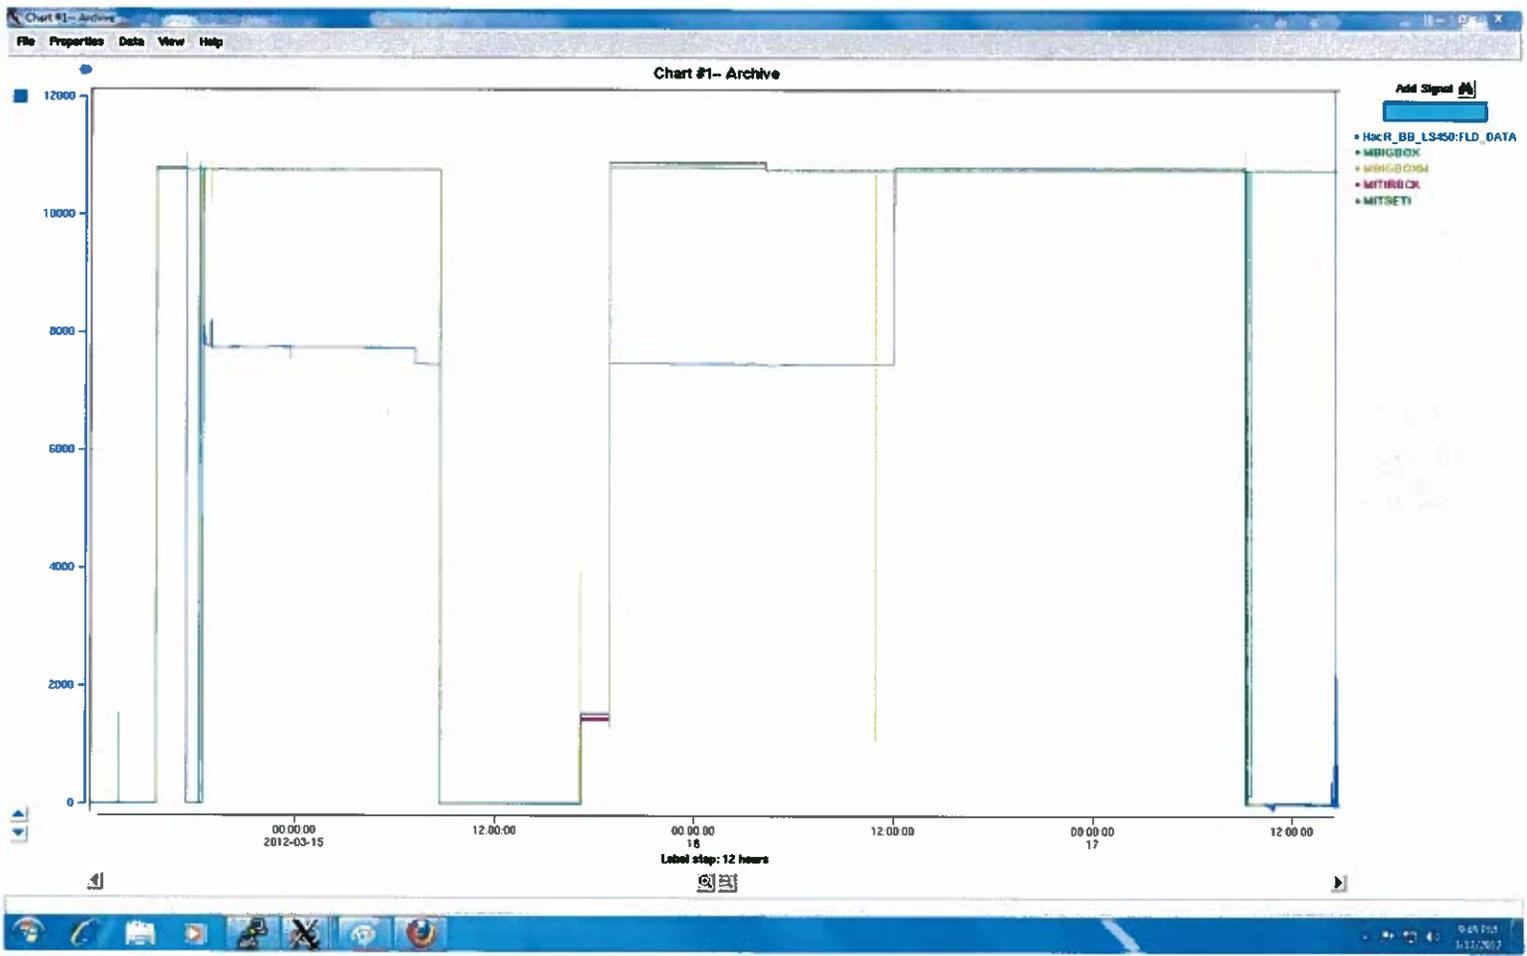
Below is an EPICS Archiver plot of the Right Septum magnet current (green) vs the hall probe readout at the rear of the magnet (blue). While the current stays at roughly 750 amps, the field reading drops and remains low for quite a while. This is an indication the current was not following the correct path. This is included to give a general idea of how long the problem was developing.

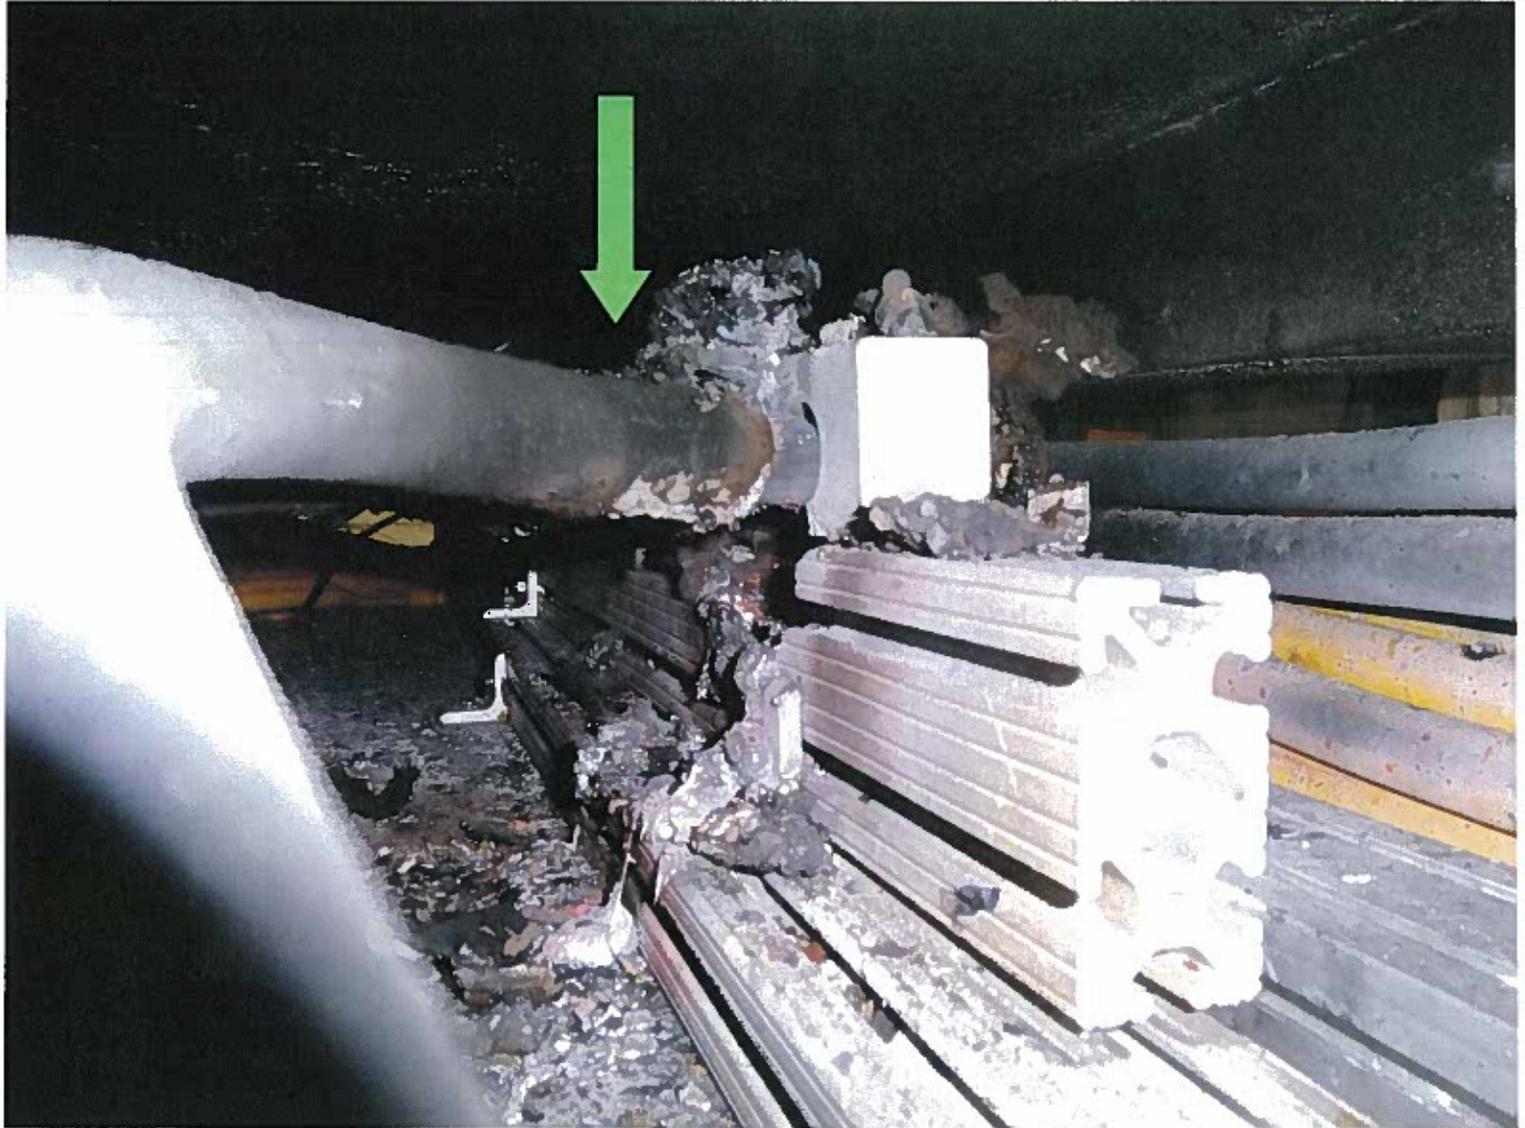
A picture is of the damaged 535.3 MCM copper cable and aluminum splice box as was found after the event.

Root Causes:	<p>1. Less than adequate connection in the electrical cable splice box</p> <p>Integrated Safety Management Core Function 2 - Analyze the Hazard and Core Function 3 - Develop and Implement Hazard Controls</p> <p>2. Ground fault (at some point) and no ground fault detection interlock.</p> <p>The damage that resulted from the overheated connection and very likely the damage to the coils (melting and leaking water), would have been much less if the GFI had been installed. It is highly probable that the fault would have showed up early (when the coil field and current discrepancy showed up) had the GFI been operational. Very likely that the magnet current was bypassing the coils through the dual faults (Coil GF and melted terminal block GF) for some time. Whichever ground fault occurred first would have shut the supply off. The melted cable connection may still have occurred however the rest of the magnet damage may have been much less dramatic.</p> <p>Integrated Safety Management Core Function 2 - Analyze the Hazard and Core Function 3 - Develop and Implement Hazard Controls</p>

Contributing Causes: (List as many as apply.)	<p>1. A copper electrical cable used in an aluminum splice block</p> <p>Integrated Safety Management Core Function 2 - Analyze the Hazard and Core Function 3 - Develop and Implement Hazard Controls</p>

Corrective Action(s)	<u>JLab CATS Number</u>	Target Date
Install ground fault interrupter on septum power supply. Also on the FZ magnets.	Not applicable	March 27, 2012
Install Klaxons on cable connectors	Not applicable	March 27, 2012
Replace the damaged aluminum block connections, to include use of no oxide electrical grease, torque the connections to manufacturer's specification, and develop a procedure to re	Not applicable	March 27, 2012

Corrective Action(s)	JLab CATS Number	Target Date
torque periodically.		
Measure voltages at several locations, specifically on the weak coils	Not applicable	March 27, 2012
After repair of the septa magnet, high potential test (Hi pot) to 400 volts, and run the magnet for at least an hour to verify all is in proper working order.	Not applicable	March 27, 2012

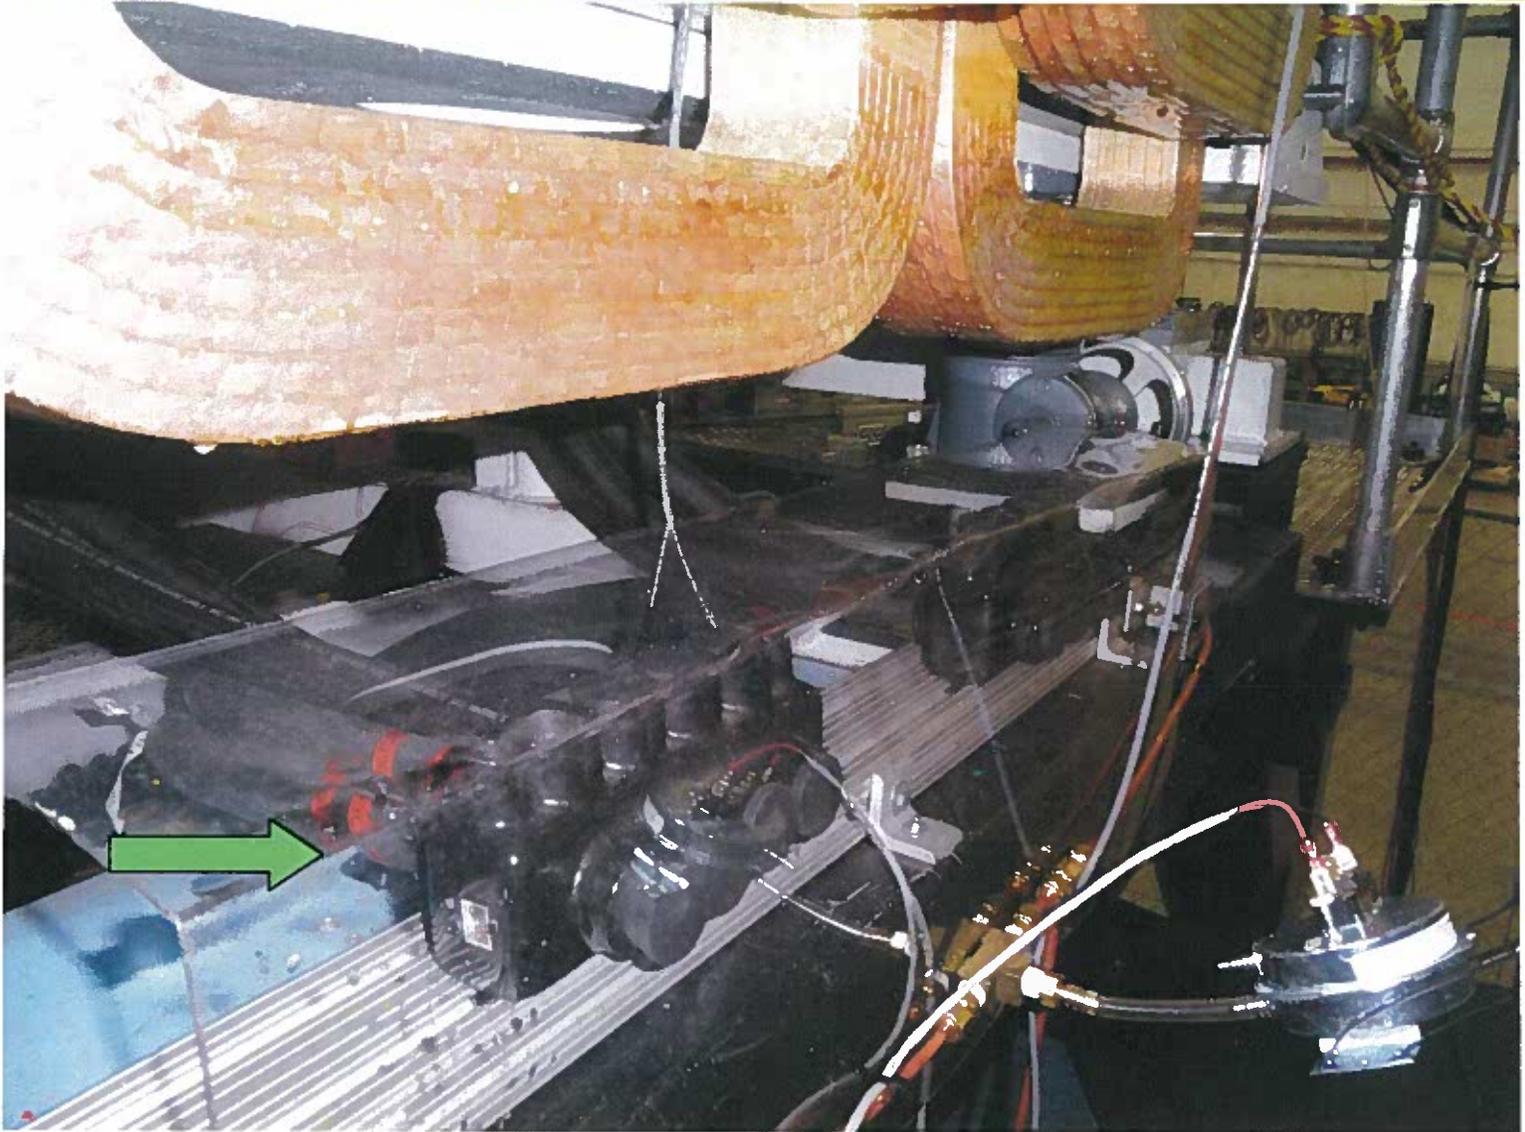
A picture of an undamaged copper cable and an aluminum splice box.

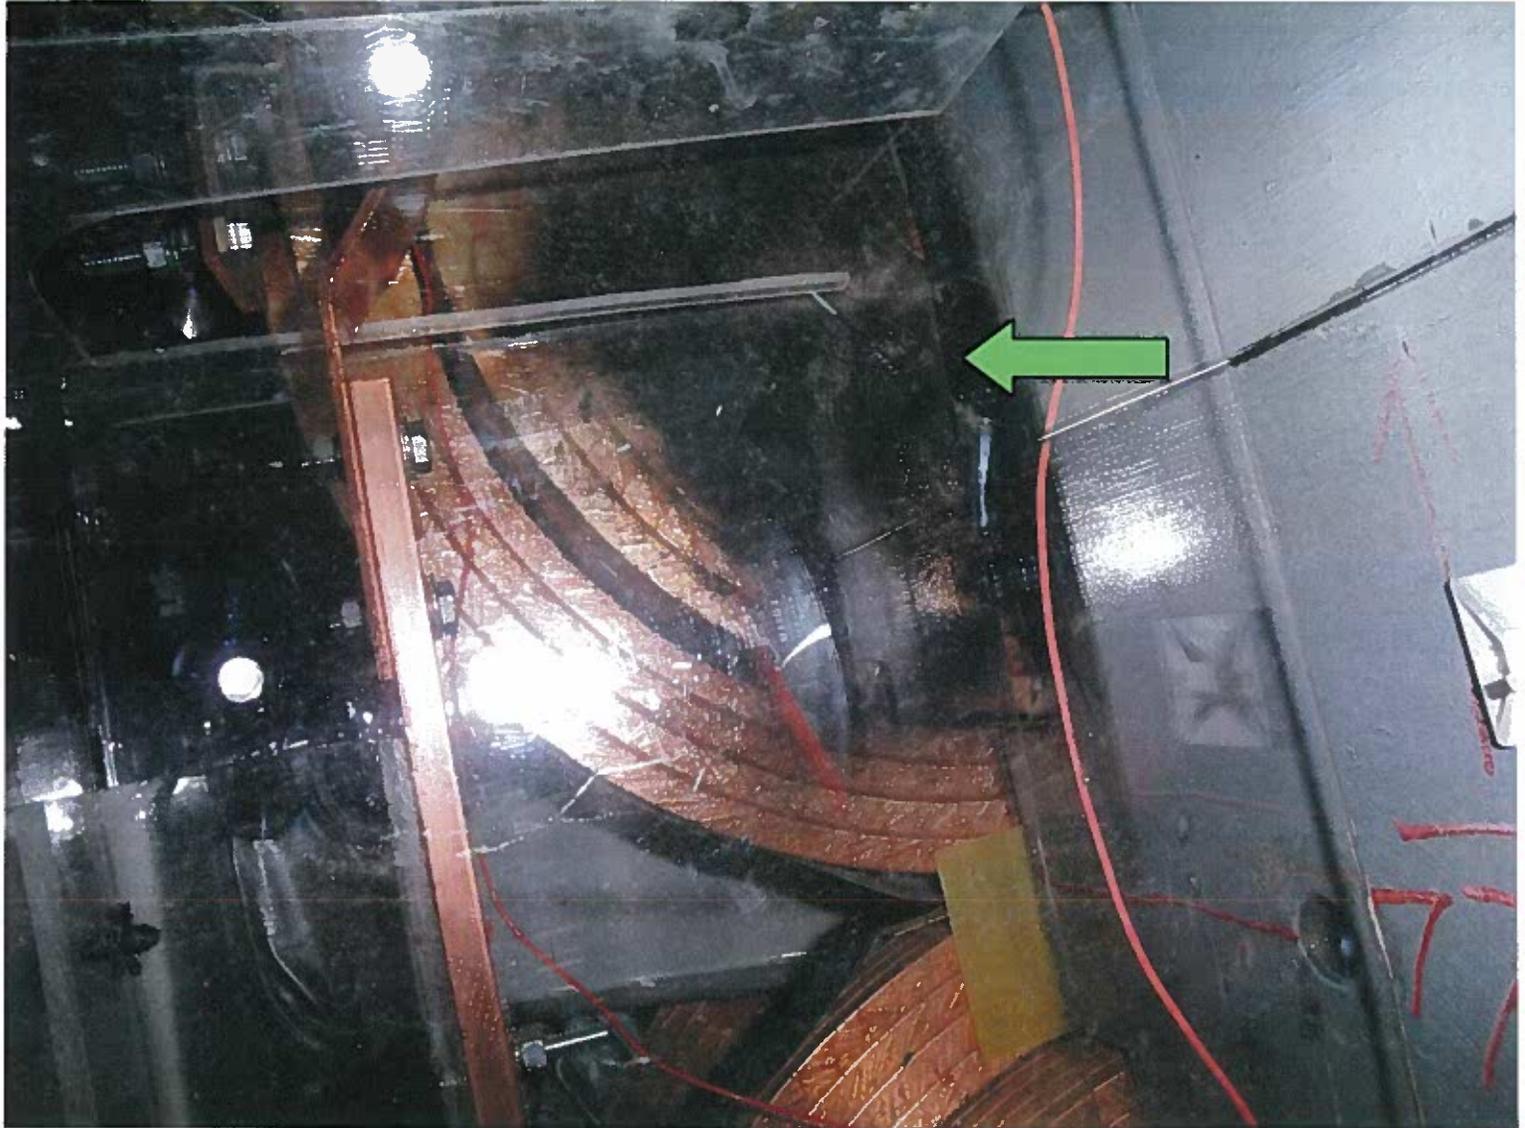
1. Three layers out of 28 layers were disabled on the right septum coil
2. One aluminum block cable connection was damaged
3. Approximately ten feet (4 cables x ~2.5') 535.3 MCM, 1313 strands, extra flexible copper cable were damaged

A picture is of the damage to the septum magnet coil as first found.
