**Notable Event Report**

Title of Event			
<b>Event Title:</b>	Employee Shocked While Using a JLG Manlift- No Injuries		
<b>Date and Time of Occurrence:</b>	08/29/2016 ~ 10:00AM	<b>Notable Event Number:</b>	PHY-16-0829
<b>Event Location:</b>	Hall A	<b>Date Notable Event Report is Due*:</b>	09/29/2016

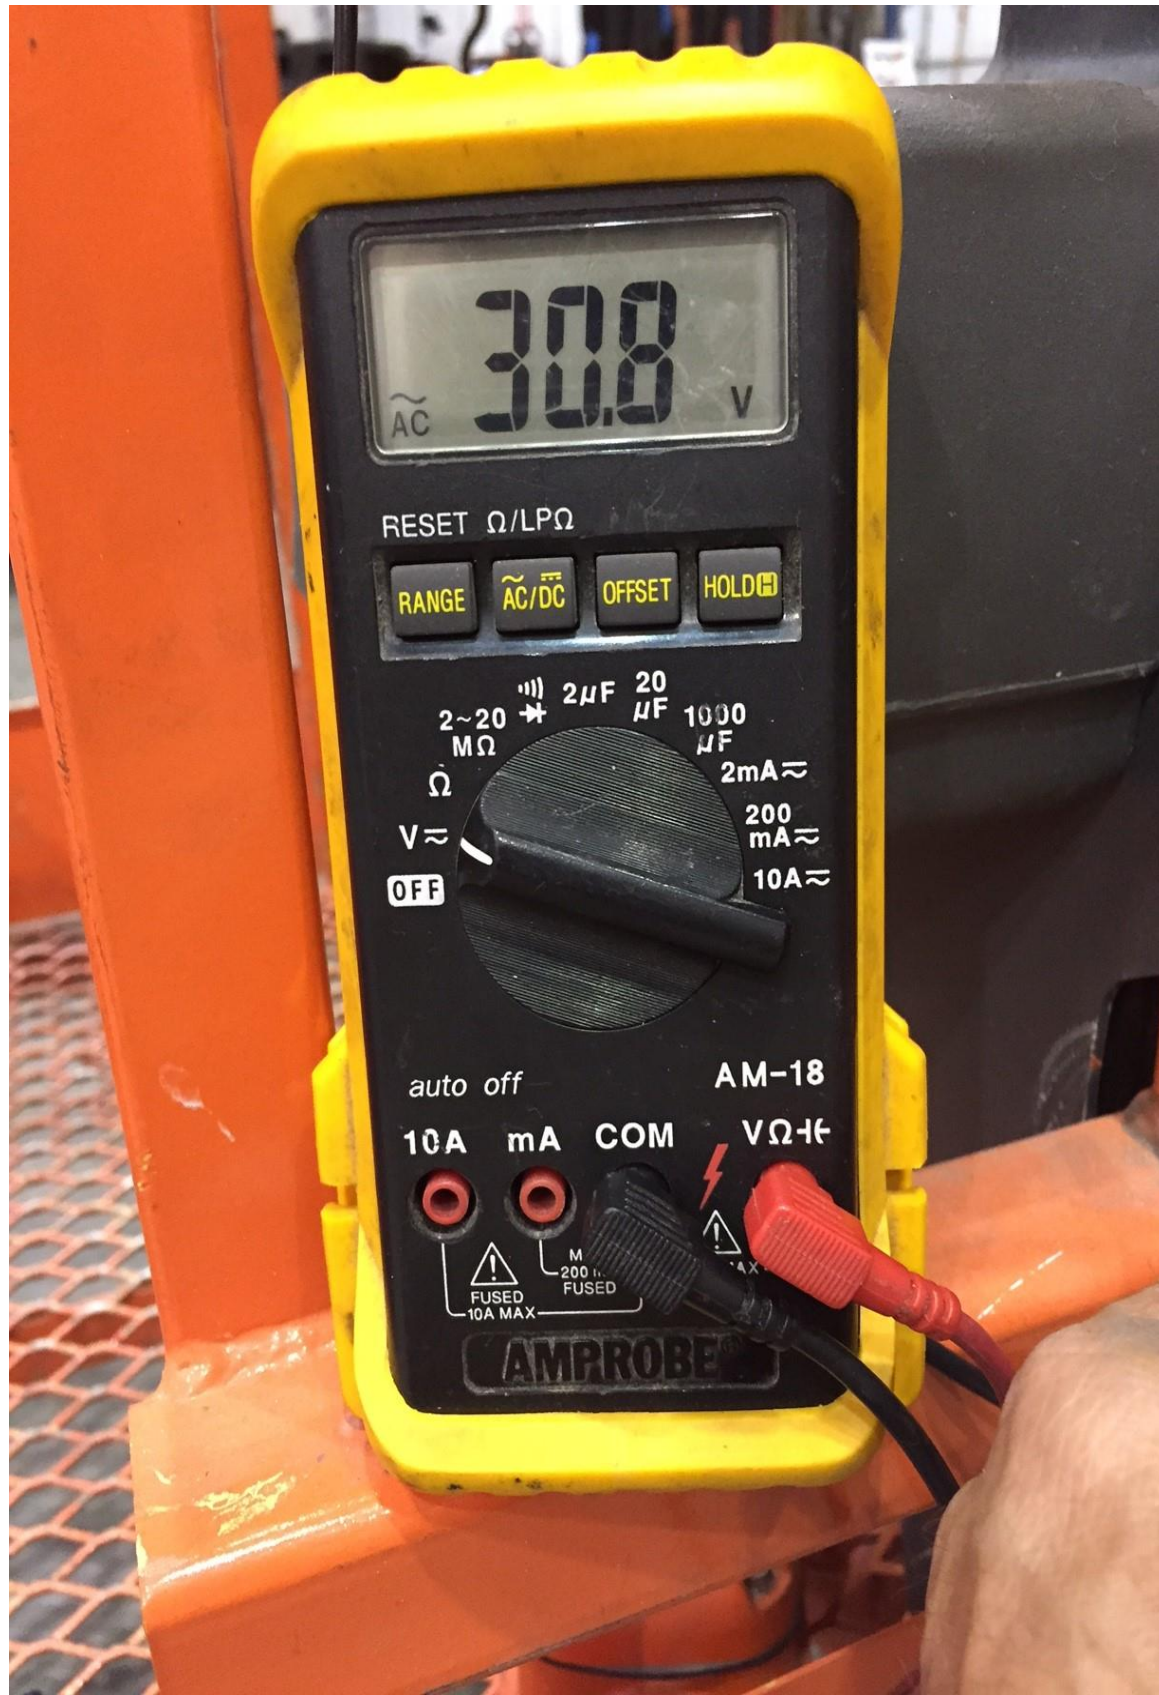
The final disposition is the ~30 VAC being measured is a “Ghost” voltage that is capacitively coupled from the energized internal power cord and that was being recorded with a high input impedance multimeter. Since the “Ghost” voltage is a physical phenomenon involving very small values of capacitance, it cannot energize a load or cause physiological damage to a person.

Measurement taken from JLG manlift to earth ground without the Fluke SV225 “Stray Voltage Eliminator” adapter (30.8 VAC / Ghost voltage)

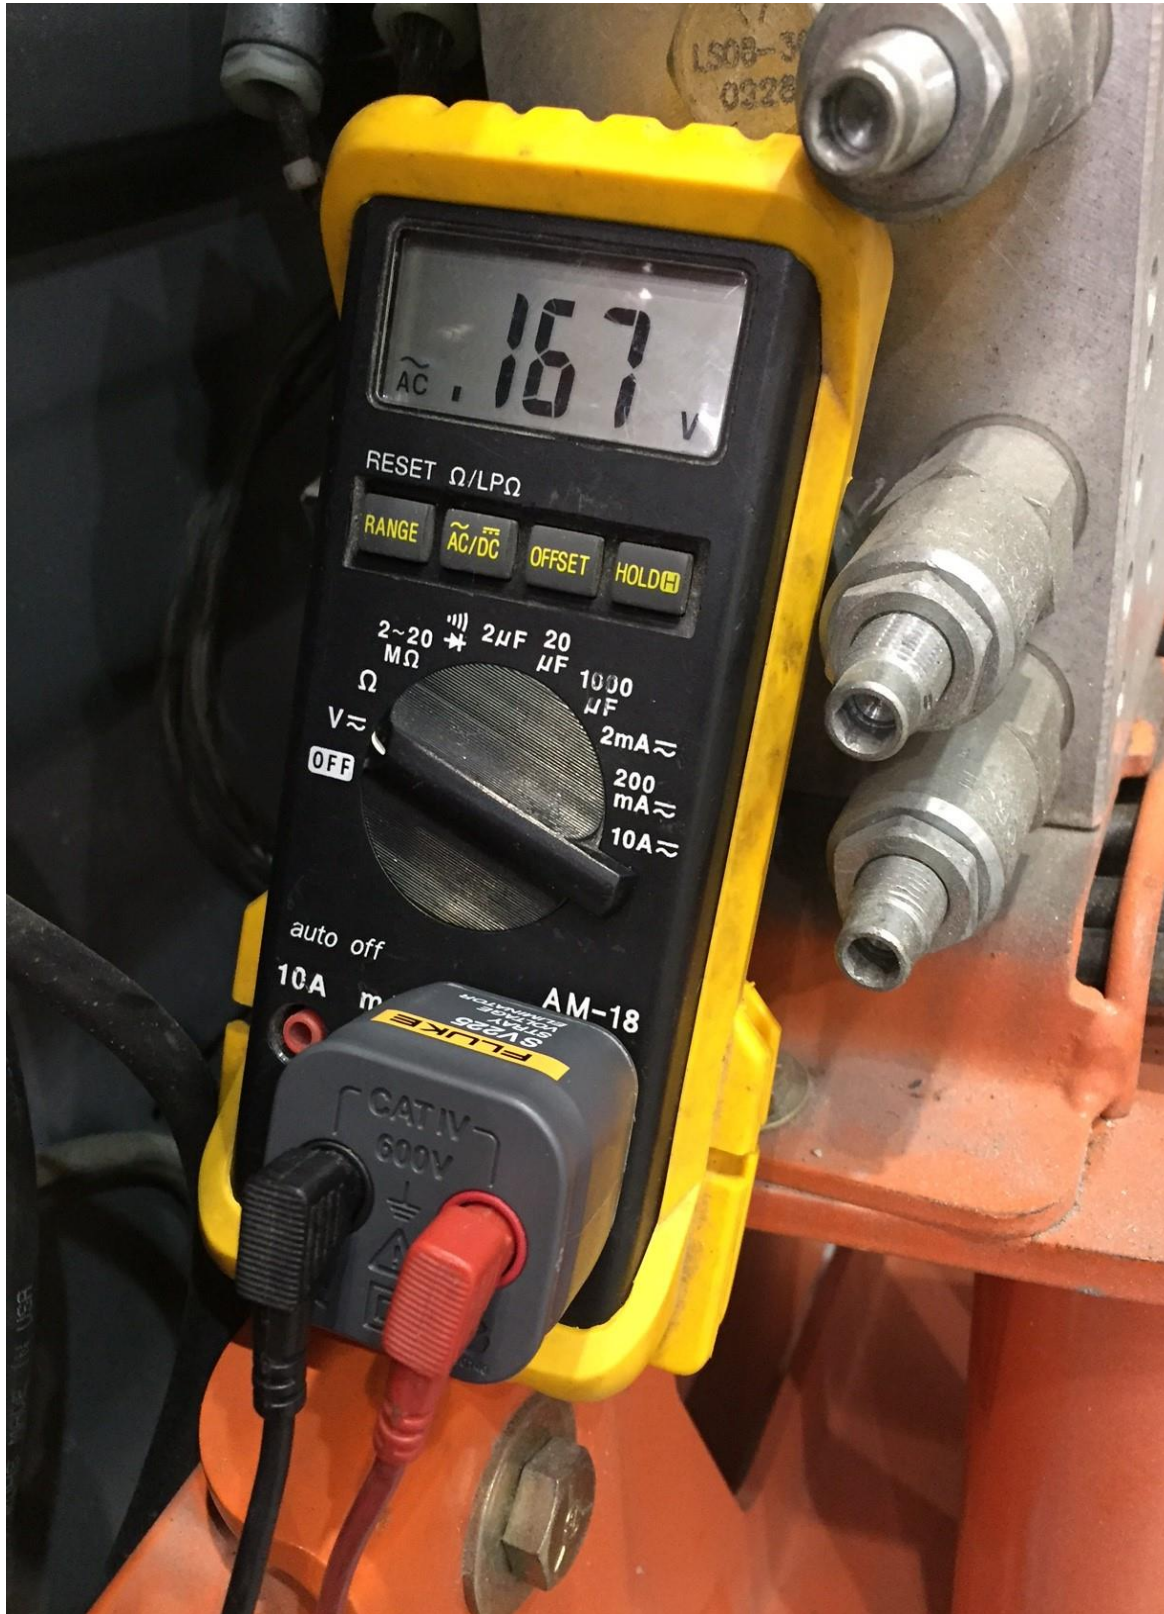
\*Measurement taken from JLG manlift to earth ground with the Fluke SV225 “Stray Voltage Eliminator” adapter (0.167 VAC / True voltage).
