Notable Event

Event Title: PHY-21-0721-Student Receives two 120V shocks - No injury

Date Submitted: 08/02/2021 02:01:05 PM

Event Location: 90_1.109

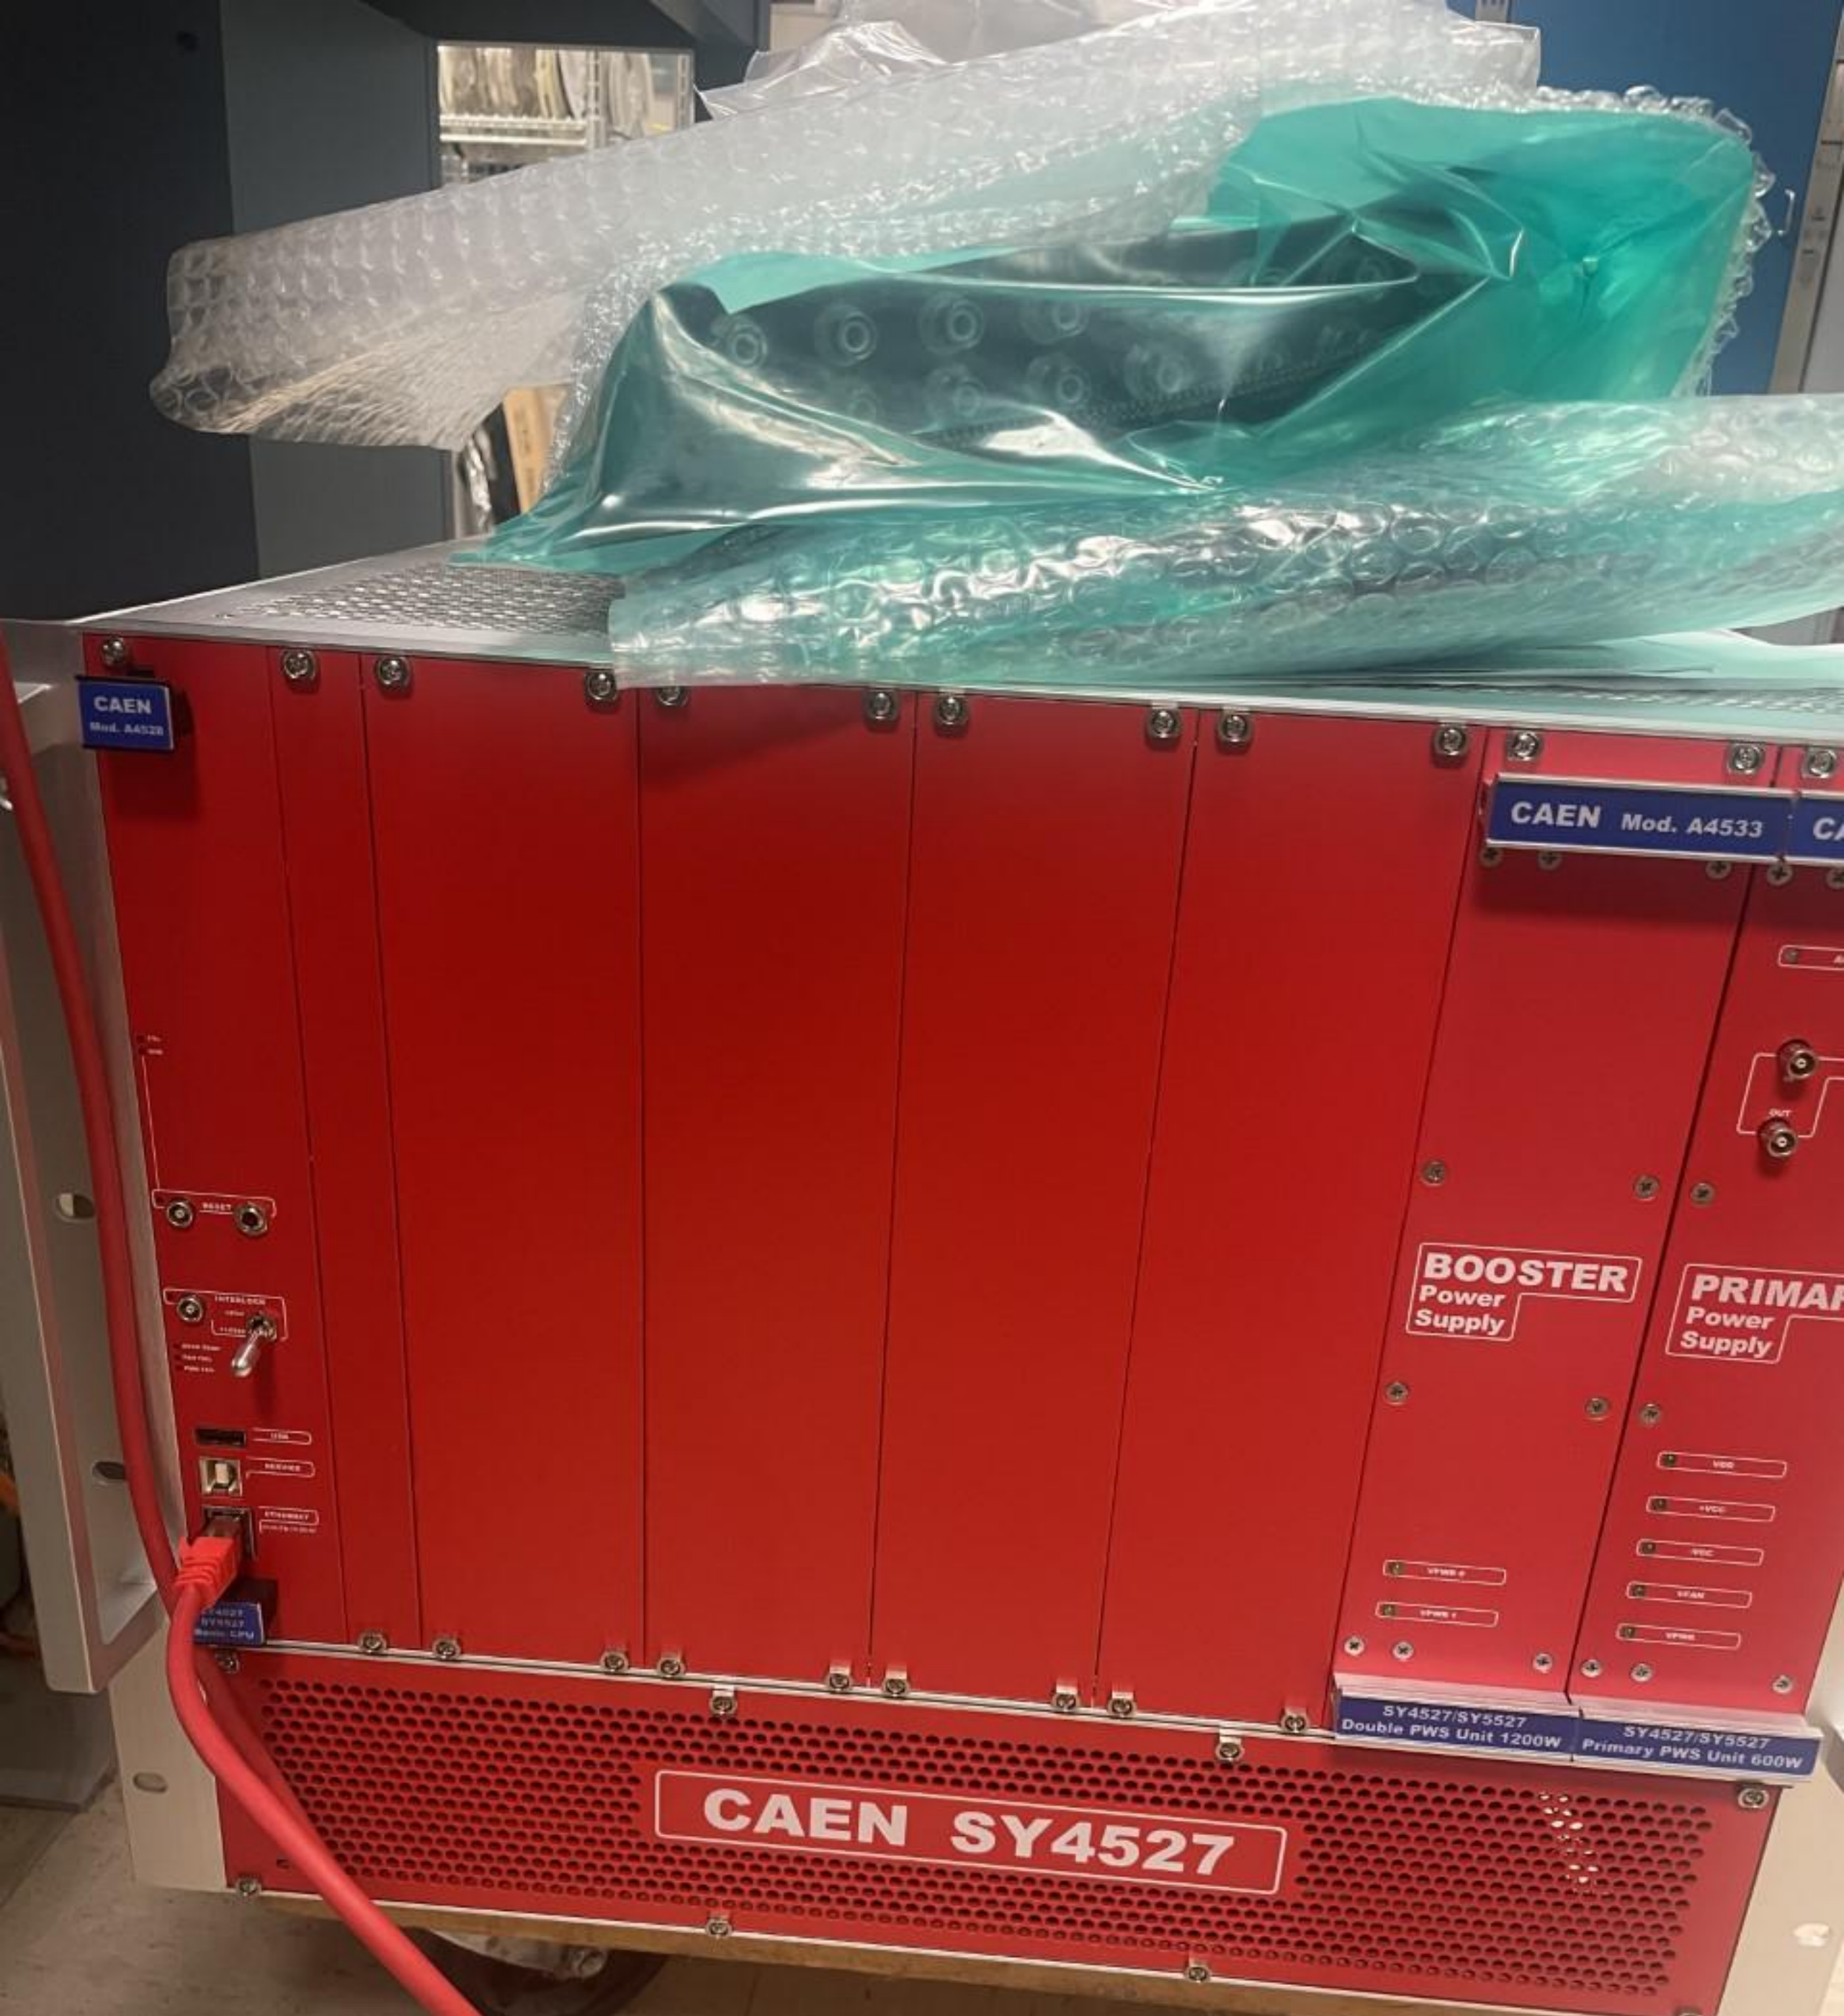
EEL109 LAB
MAINFRAME SUPPORTED ON WOODEN DOLLY
FRONT PANEL OF MAINFRAME

REAR PANEL

VOLTAGE RANGE:	100 - 240 V ~
FREQUENCY:	50 - 60 Hz
INPUT CURRENT:	25A MAX

120V INPUT CONNECTOR

GROUNDING POST

3 PIN FEMALE
SOCKET CONNECTOR
THREADS TO CHASSIS MALE PINS

3 PIN 120V PLUG

120V AC power cord connector
Mates with SY4527 CAEN mainframe

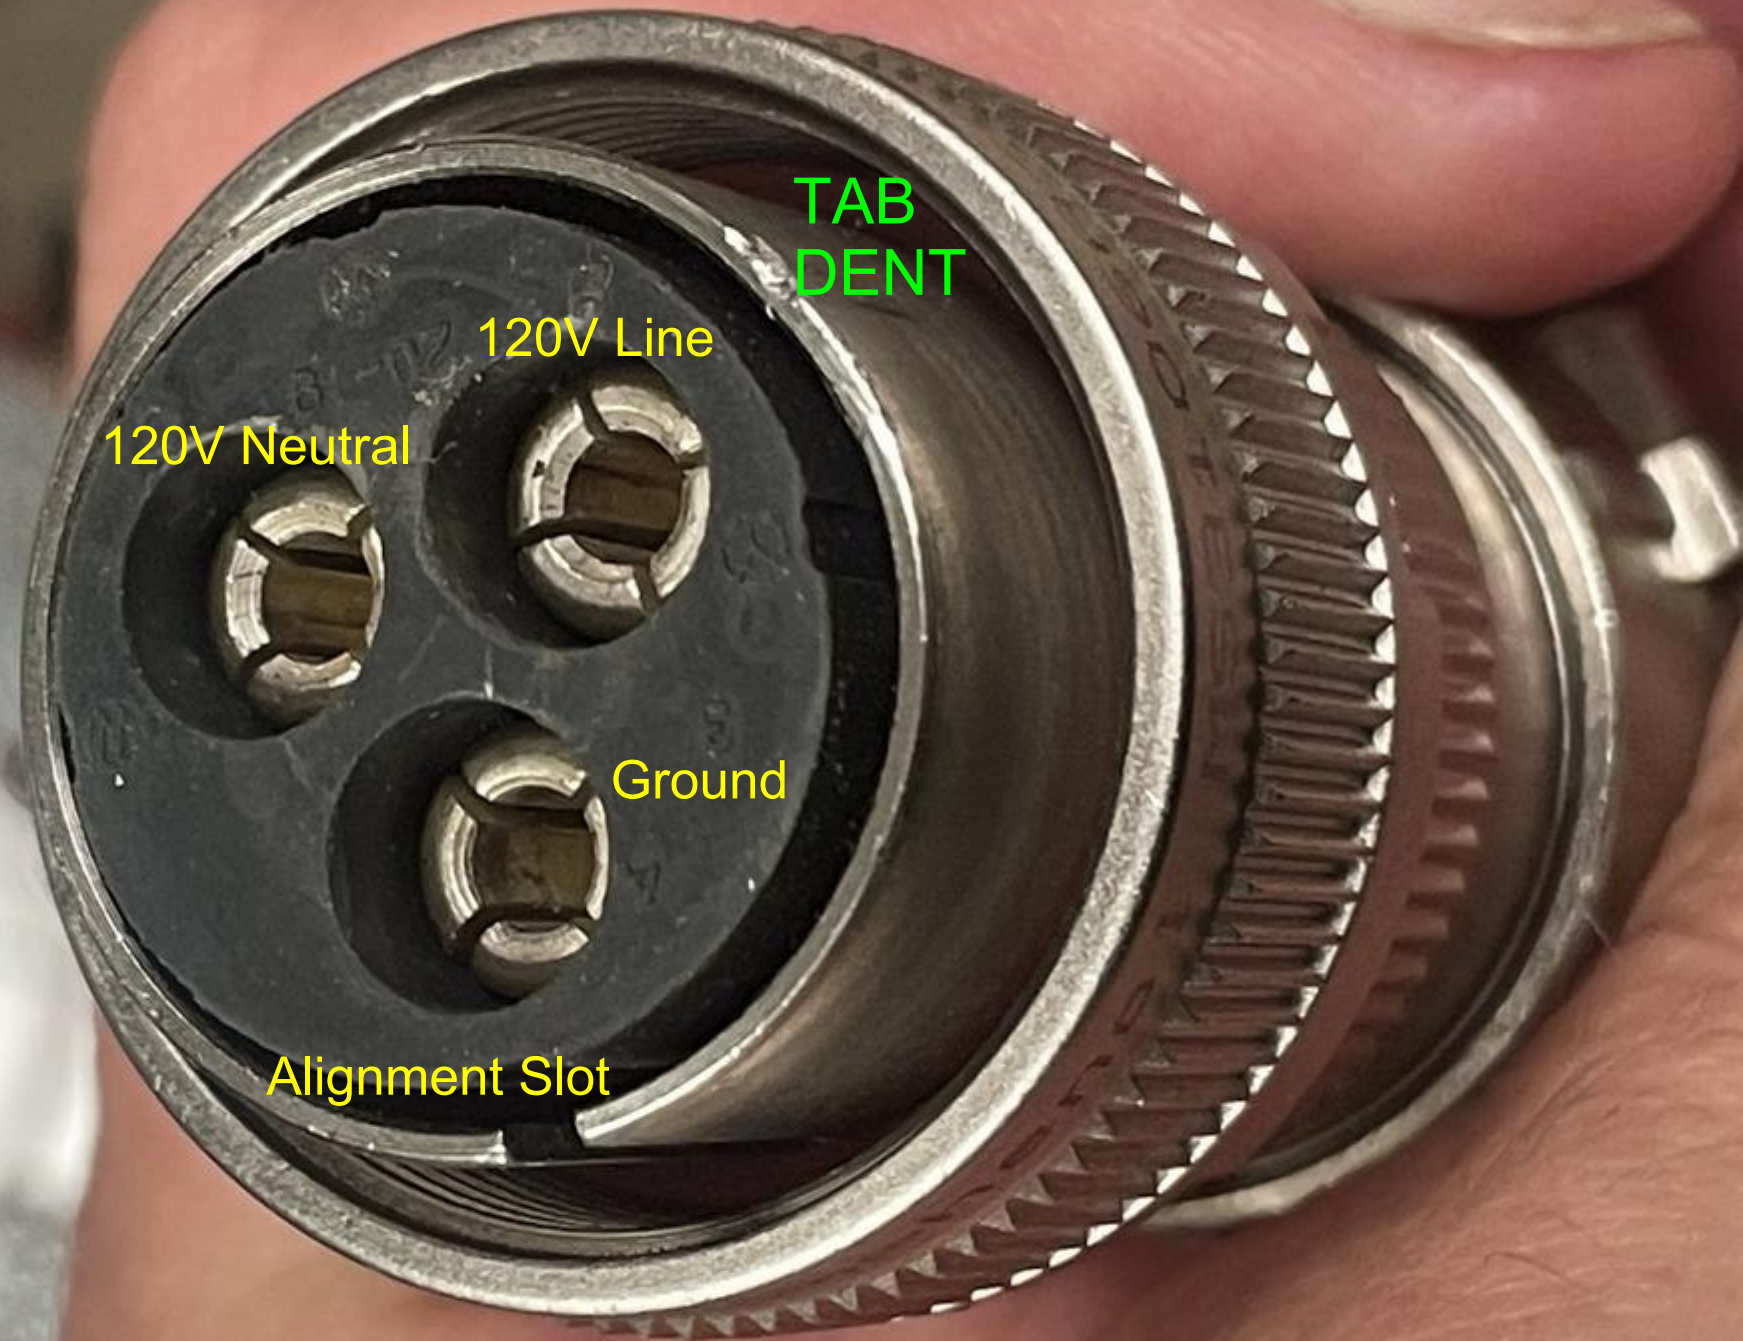
Rear Panel of SY4527 Mainframe
Input AC power connector

TAB
DENT

120V Line

120V Neutral

Ground

Alignment Slot

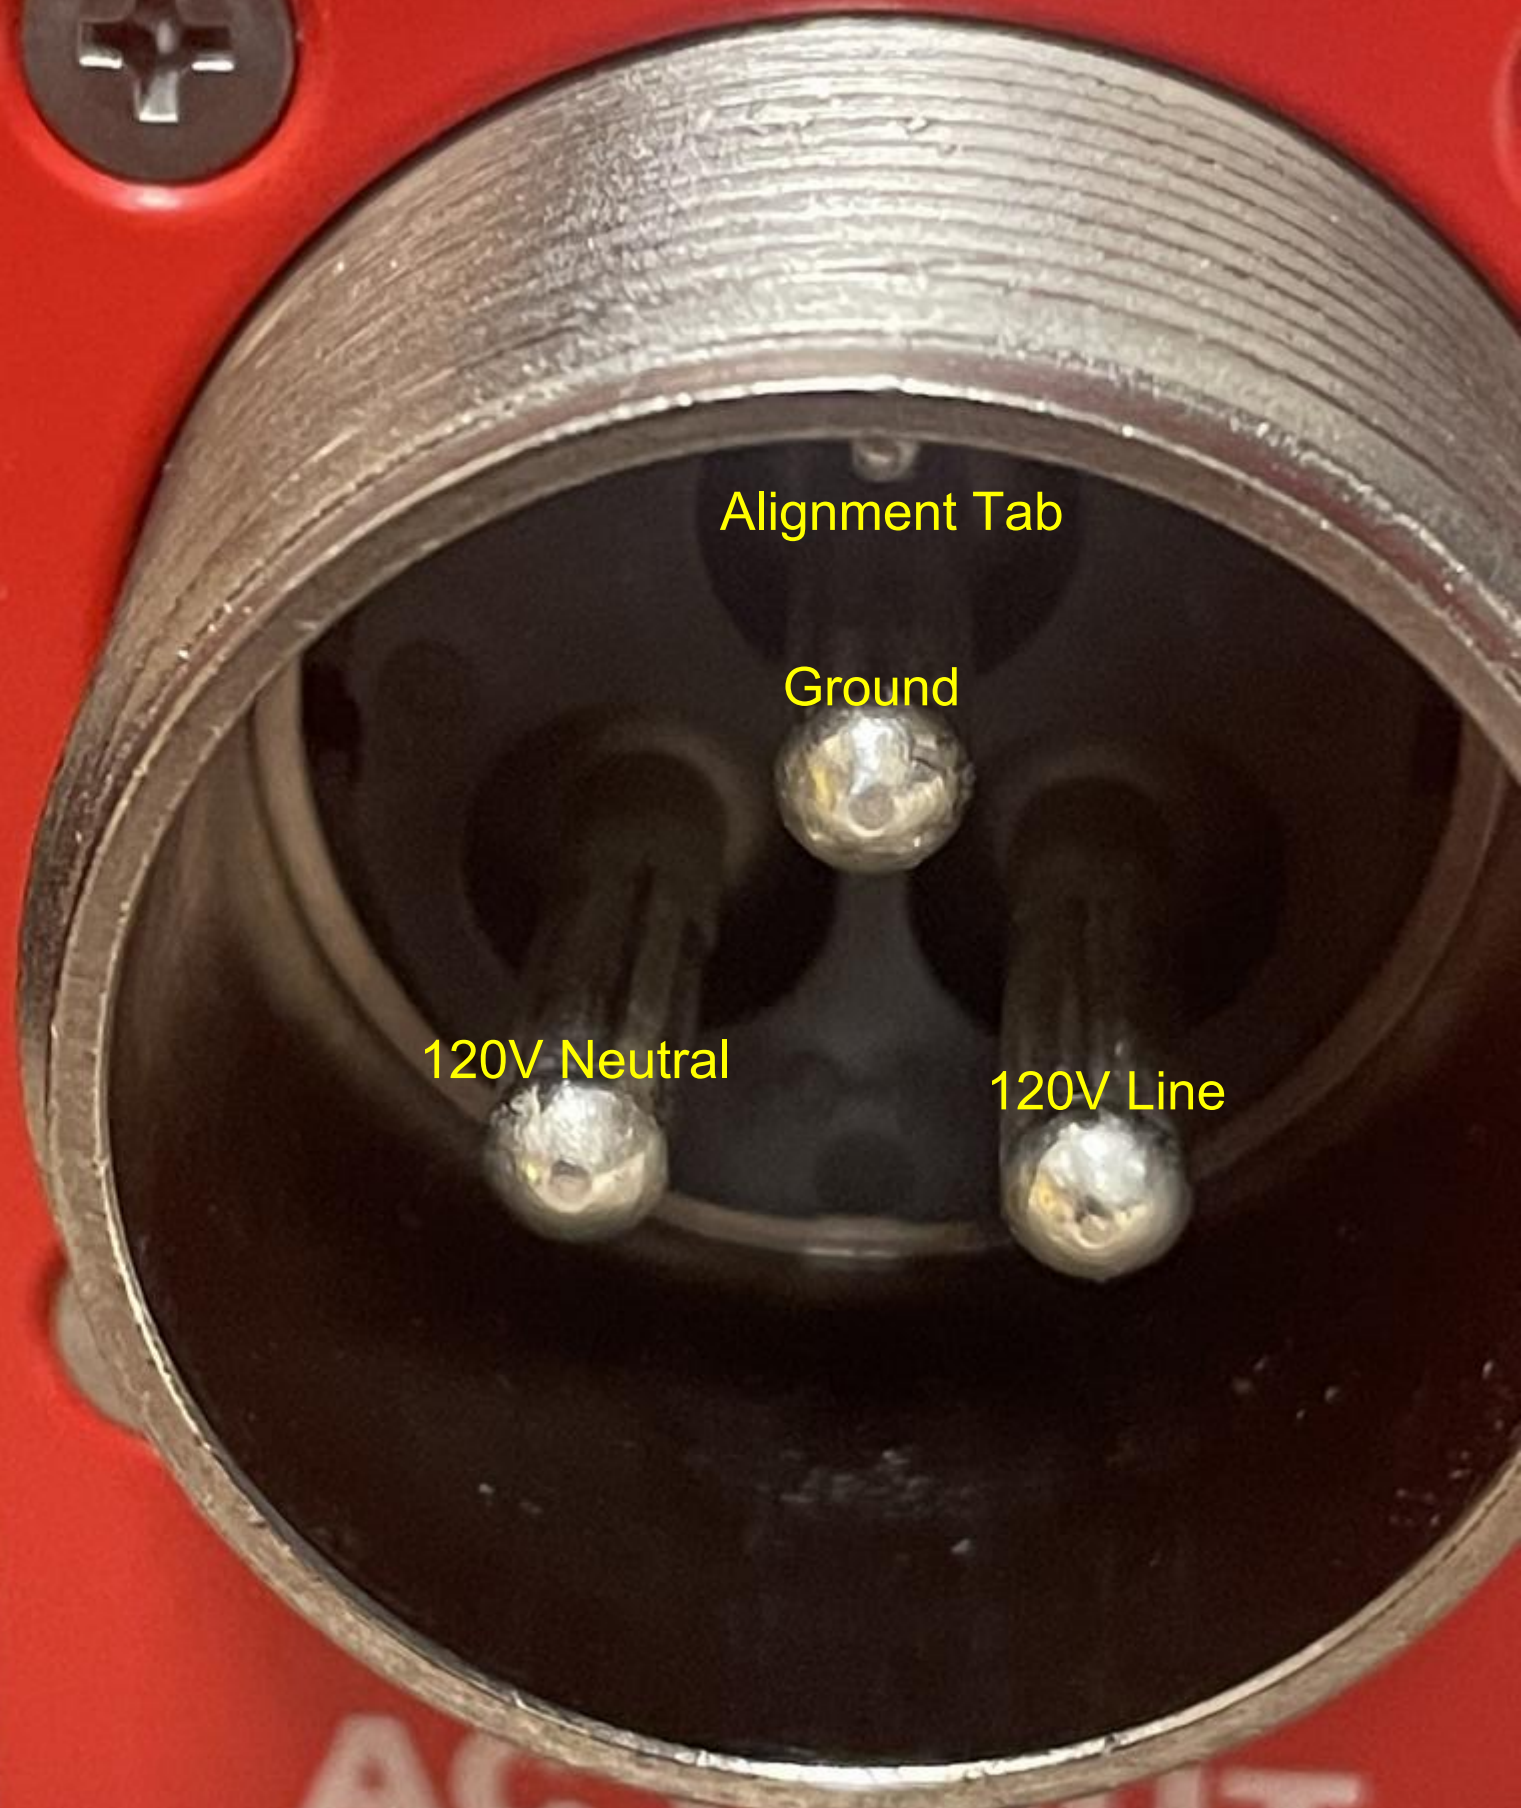
AC INPUT

Alignment Tab

Ground

120V Neutral

120V Line

SY4527 SIDE PANEL CHASSIS
CLOSE UP VIEW OF INTERNAL WIRING
ON BREAKER.
BROWN, BLUE, STRIPED GREEN/YELLOW AC WIRING

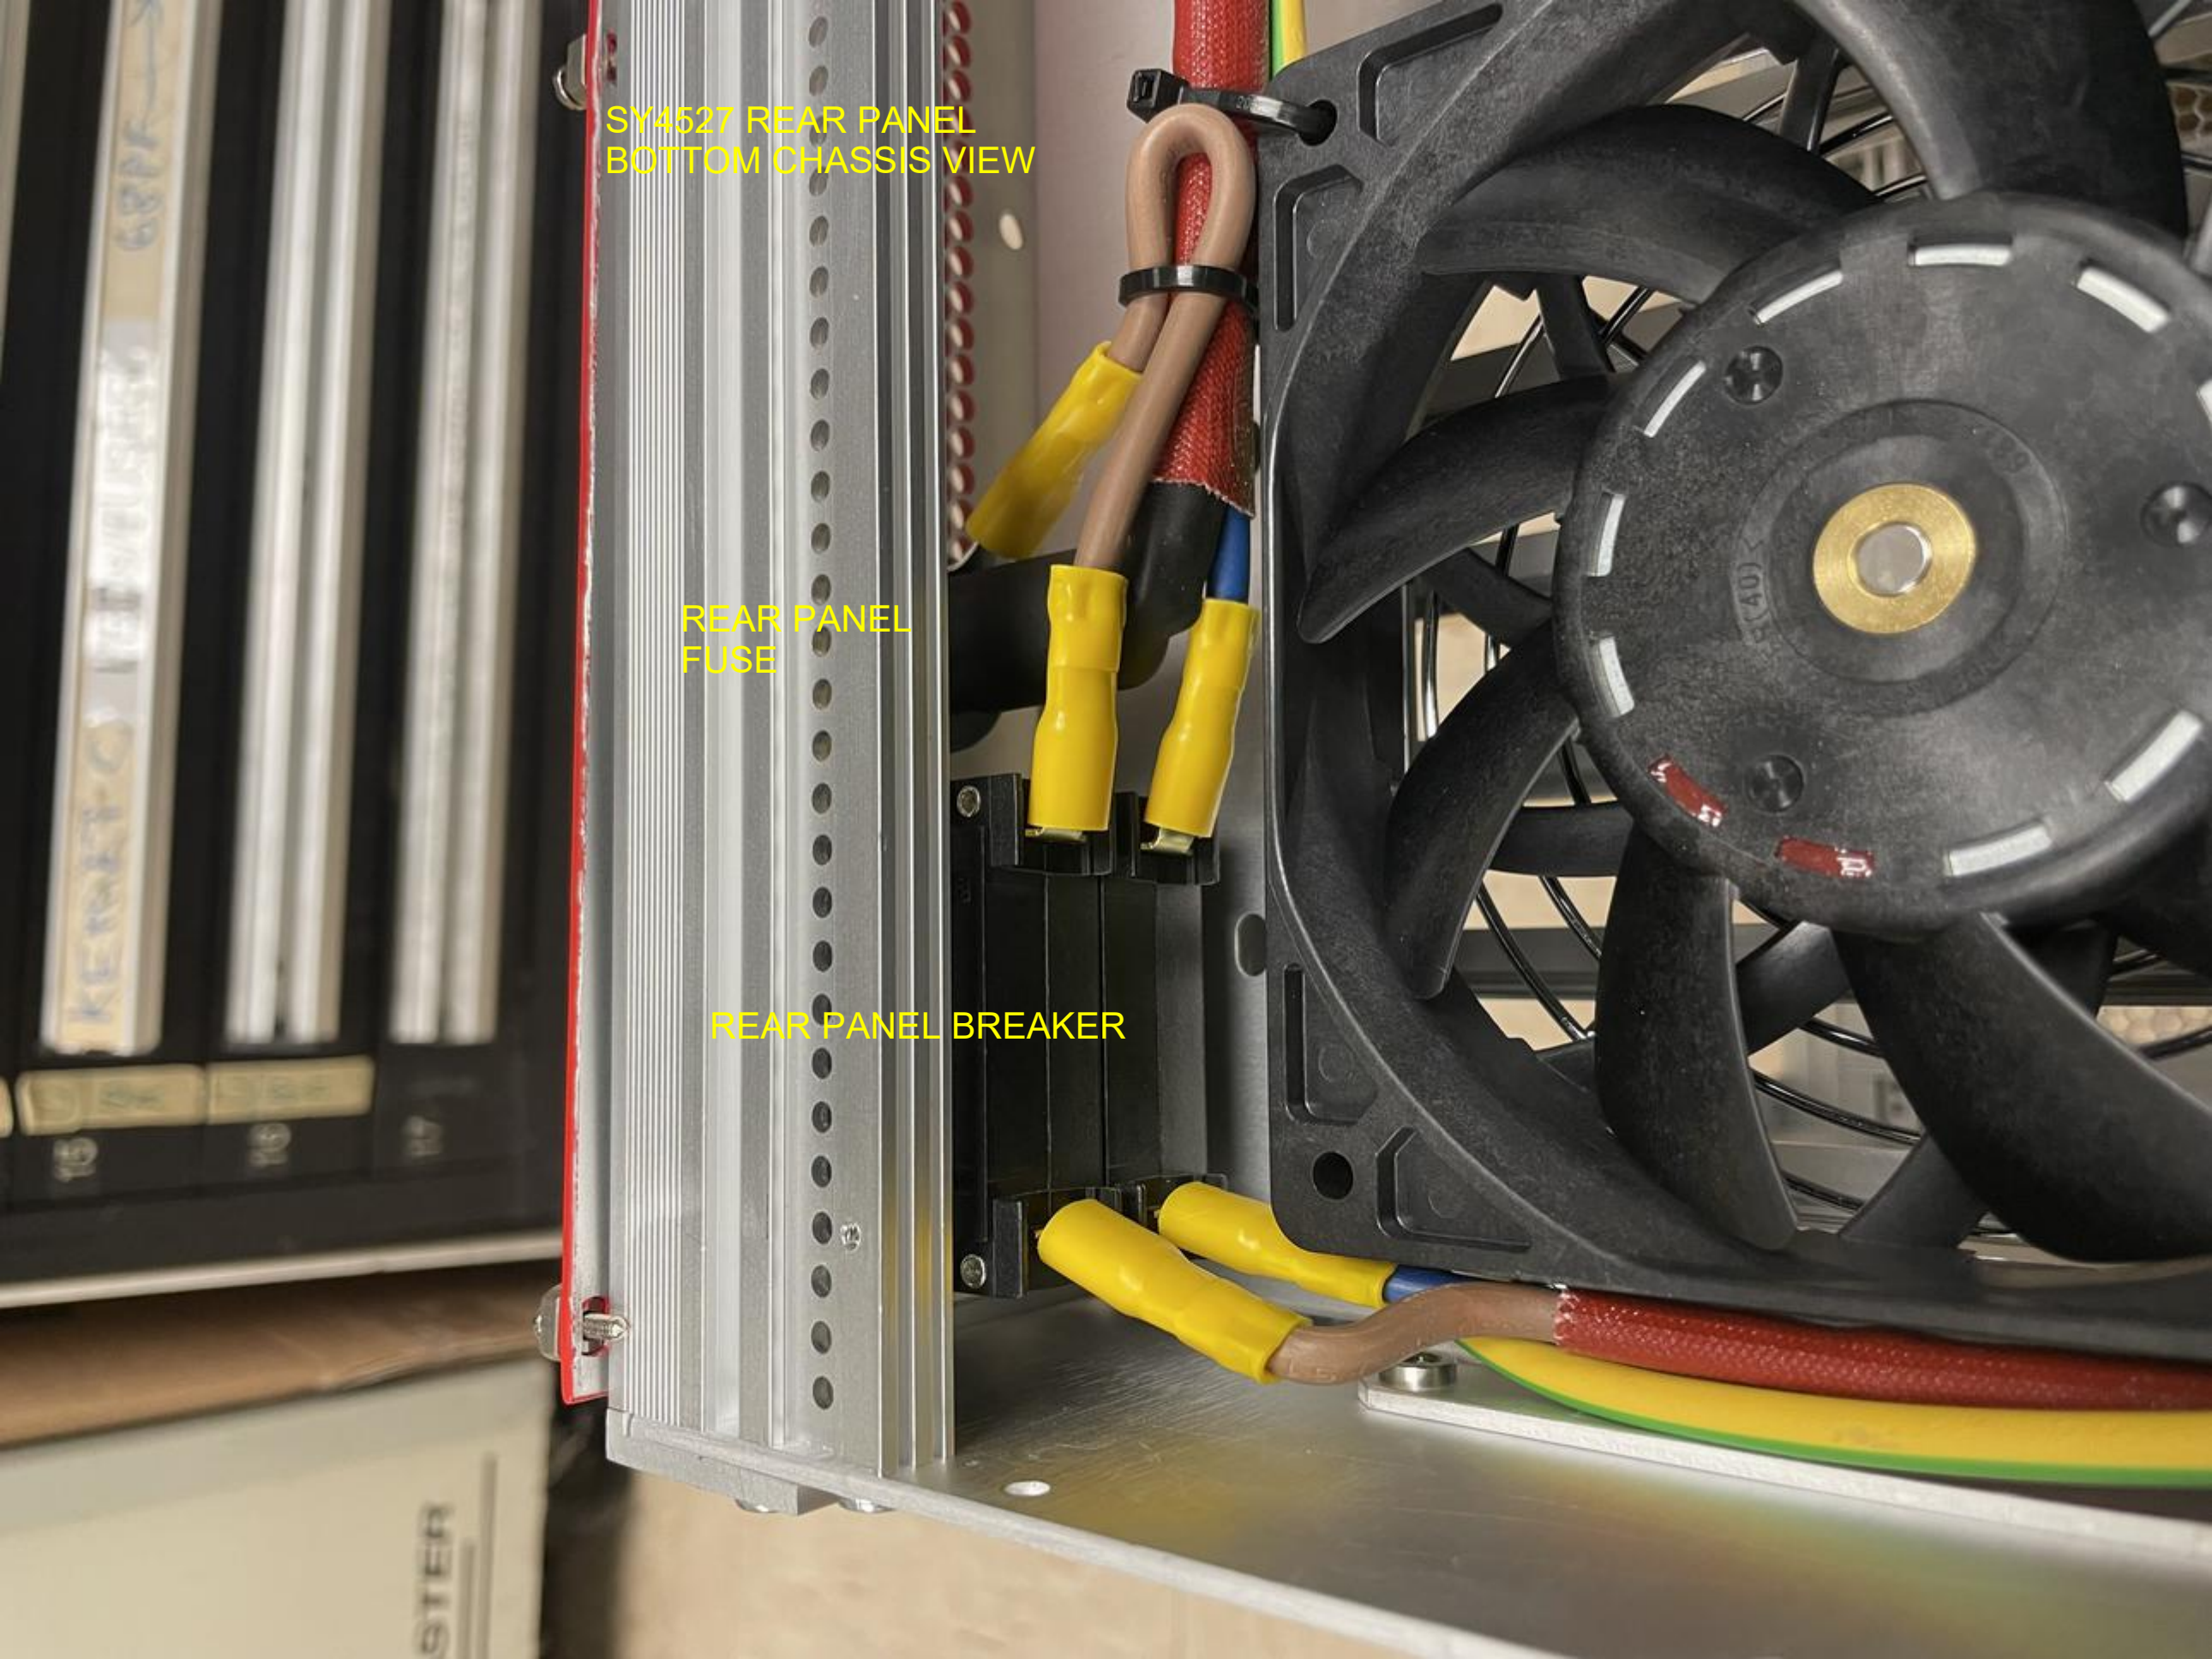
SY4527 REAR PANEL
BOTTOM CHASSIS VIEW

REAR PANEL
FUSE

REAR PANEL BREAKER
