**Notable Event Report**

Title of Event			
<b>Event Title:</b>	Breach of a Radiological Area (Contamination and Radiation Area)		
<b>Date and Time of Occurrence:</b>	July 26, 2016 ~ 10:00 am	<b>Notable Event Number:</b>	ENG-16-0726
<b>Event Location:</b>	Building 95	<b>Date Notable Event Report is Due*:</b>	August 26, 2016

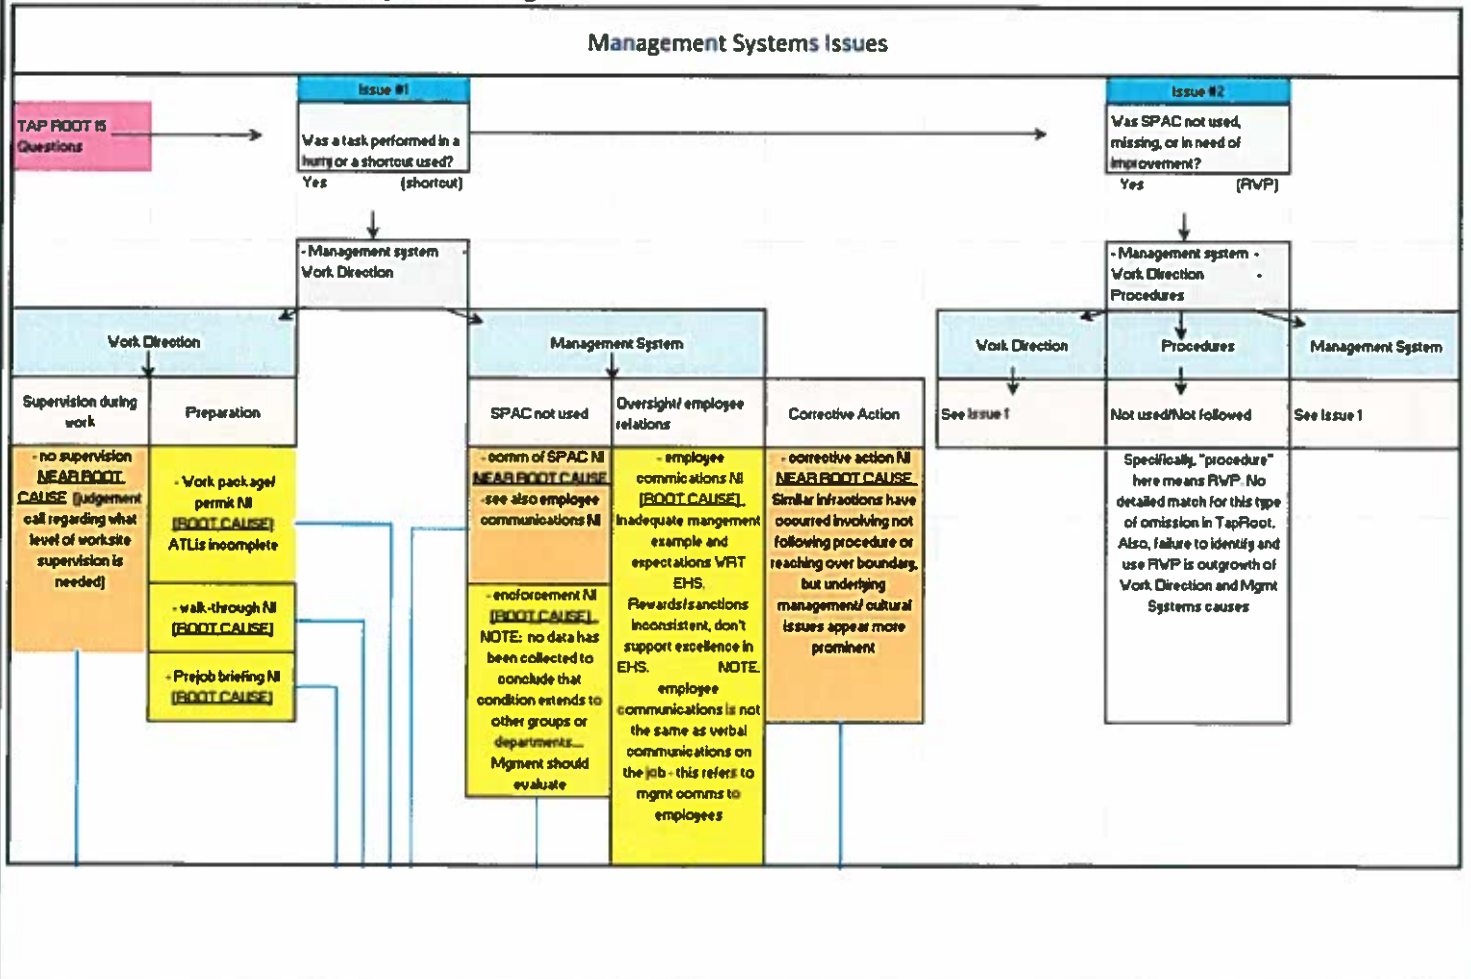
The team concluded that the *primary* root cause for this event was inadequate communication and reinforcement of expectations and inadequate supervisory involvement and oversight concerning the work planning and implementation of safety practices. These weaknesses translated into a failure of the employee to adequately plan, coordinate and communicate with the RadCon staff.

Management system causal analysis tree is shown below. Two issues were identified from the 15 taproot questions. Root and Near-root Causes shown in yellow/orange.

Recommended corrective actions are shown below. Causes from the table above are shown in the leftmost column below. Resulting corrective actions are shown in green.

Broader scope items
Correct. Action NI	Though not a root cause, investigation has identified some enhancements that can be added to training.	Conduct advanced training for the population working in SUVs. [RADCON]	Communicate boundary extent to wide audience using weekly briefs, etc. [RADCON]	Work with QA/IC to evaluate need for conducting Management Self-assessment in EE Dept to look at work preparation, execution, work observations, etc. [EES]
Employee comms NI	Affected organization (EES) hold documented briefing session to stress expectations and importance of following work standards and administrative controls. [EES]	Should define specific expectations for supervisors and job leads, including pre-job reviews, walk downs, etc.		
Enforcement NI	Does not appear to be organization-wide deficiency			
Comm of SPAC NI	See employee comms NI			
Work Page/permit NI	See employee comms NI			Though not a root cause, investigation has identified potential enhancements to work planning tools.

Walk through NI	Counsel worker on importance of identifying and complying with all EHS issues in area and proper interaction with SME/EHS reps based on nature of work. [EES]			Consider modification to ATLE to enhance review: PICD approval for some pre-identified thresholds. (like EHS review, this would show unreviewed status until RadCon reviews) Applicable to Other EHS items? If? [ATLE owner/PICD]
Prejob Briefing NI				
No Supervision	See employee comms NI

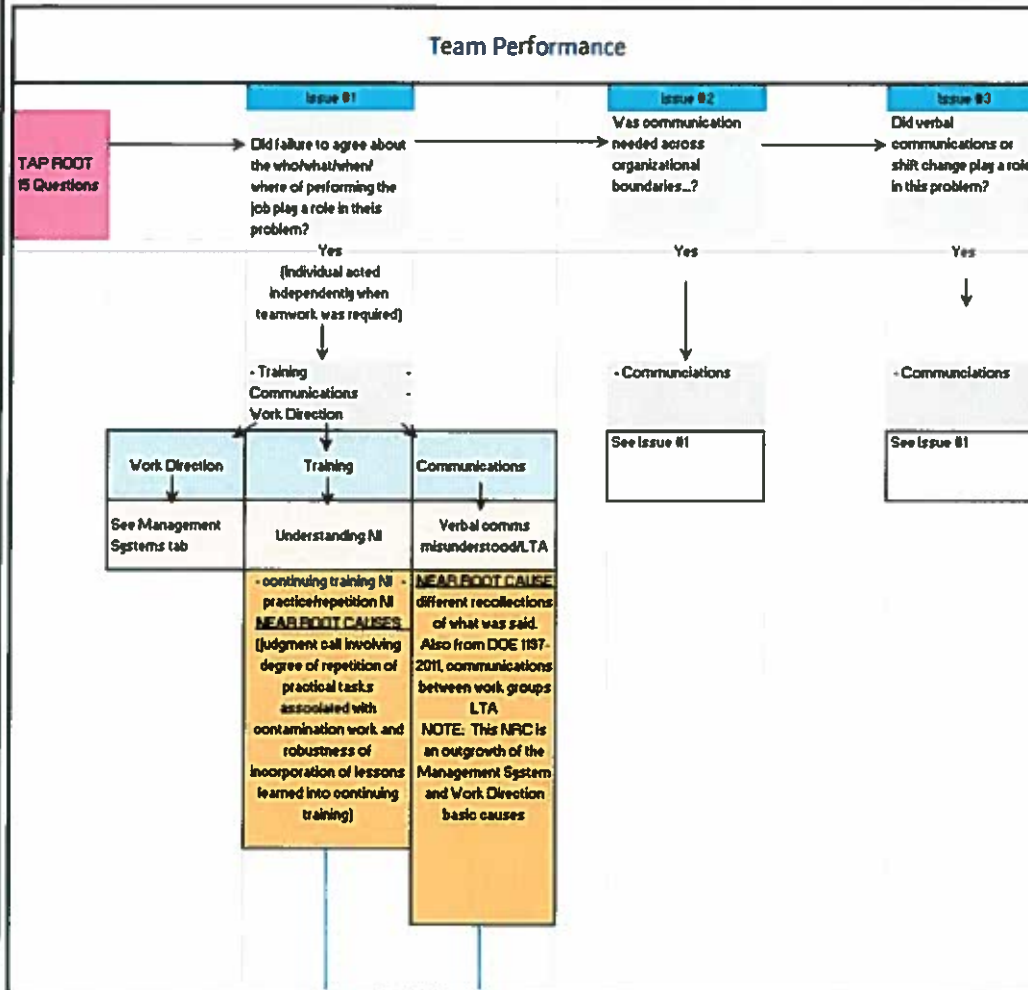
Causal analysis tree for the Team Performance issues is shown below. Three issues were identified from the 15 questions. The two near-root causes are referred back to Management Systems and Work Direction basic causes.

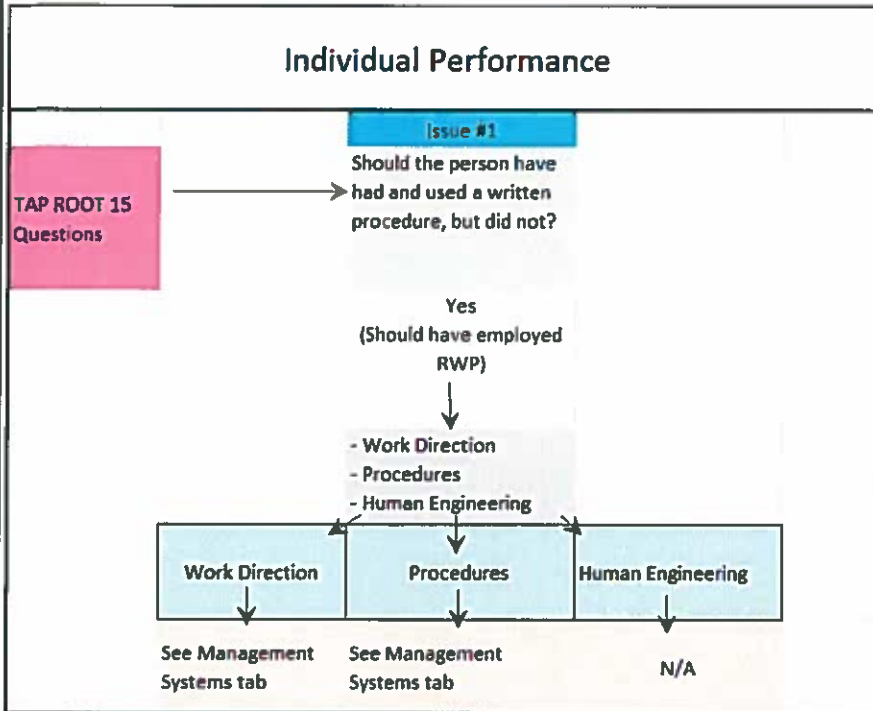
Causal analysis tree for Individual Performance is below. Causal factors all referred back to Management Systems issues.
