Notable Event Report

Title of Event			
Event Title:	Shock Incident at the ARC1 Box Power Supply in the LERF		
Date and Time of Occurrence:	07/26/2016 at approximately 11:00 am	Notable Event Number:	ACC-16-0726
Event Location:	LERF /Building 18	Date Notable Event Report is Due*:	08/25/2016

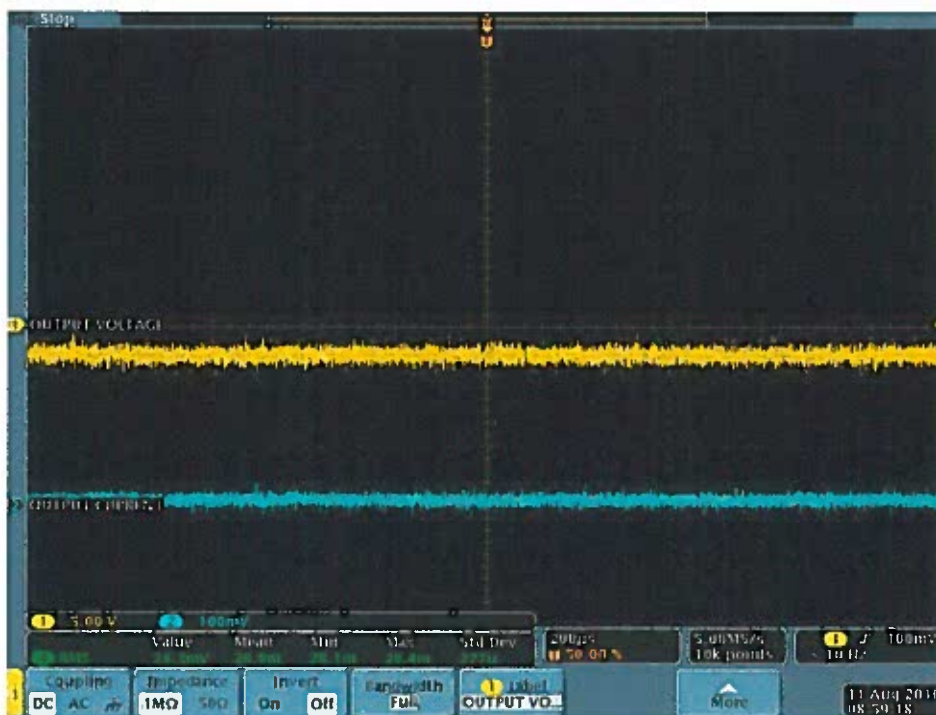
Figure 1. Voltage at BPS terminals with leads O.C. and non-oscillating trim card

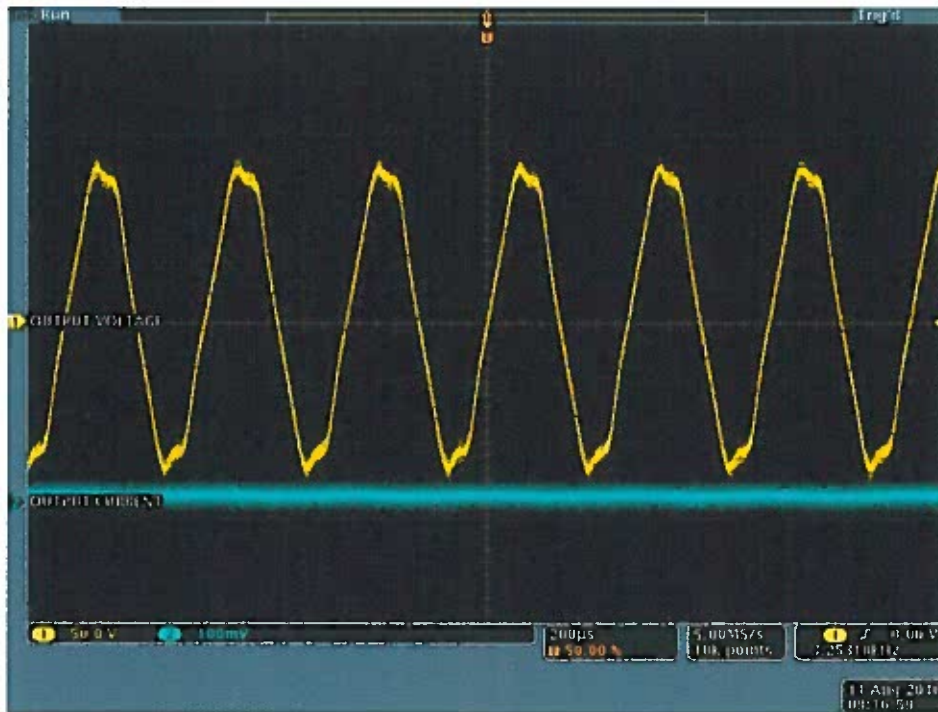
Figure 2: Voltage at positive BPS terminal to Gnd, with leads O.C. and oscillating trim card

Note: The voltage is about 125 Volts peak, corresponding to $\sim 87V_{rms}$ that was measured using a handheld Fluke DVM. The frequency of oscillation is around 3.2 kHz

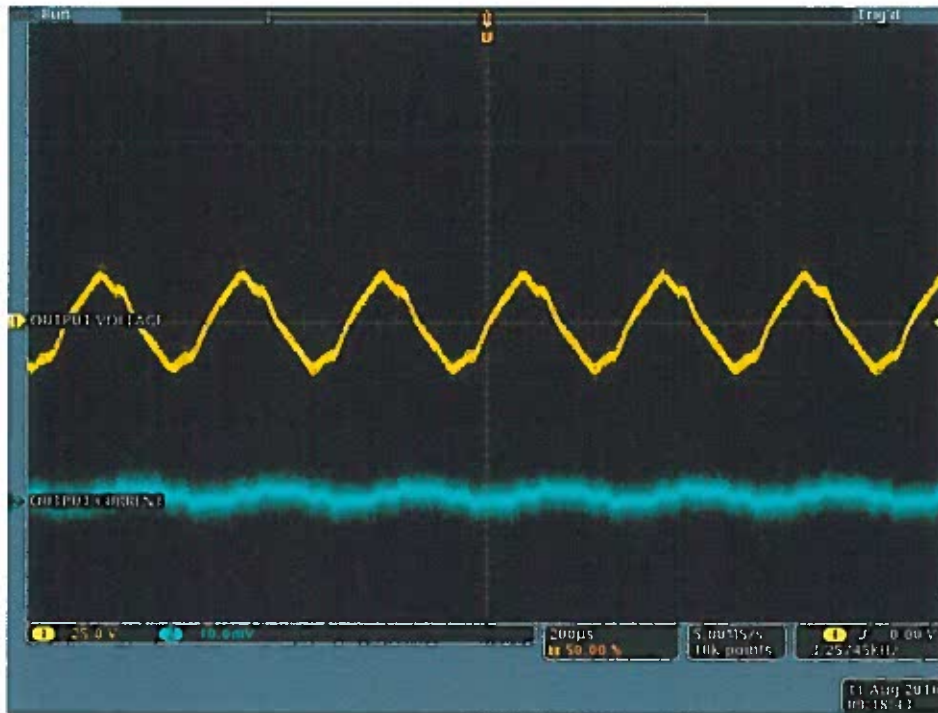
Figure 3: Voltage at negative BPS terminal to Gnd, with leads O.C. and oscillating trim card

Note: The voltage is about 24Volts peak, which is around 16 Vrms

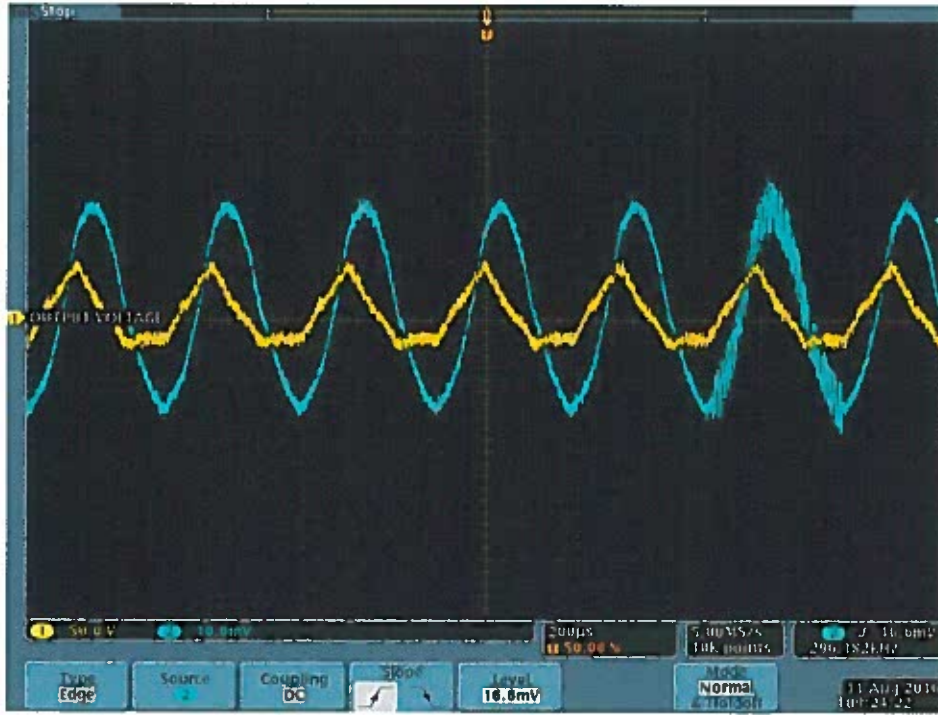
- The worst possible case shock level scenario is approximately 48 volts AC at 1.6 amps (76.8 watts) with a short circuit load (current and voltage are not in phase on the inductive load).
- The estimated shock level at the time of the event is approximately 87 volts AC (measured) and 0.88 amps (which is 76.8 watts divided by the measured 87 volts or $I=P/E$).

Figure 4. Voltage and current on BPS buss with leads S.C. This worst case scenario shows the voltage is less than 50 Volts and less than 4 Amps peak.

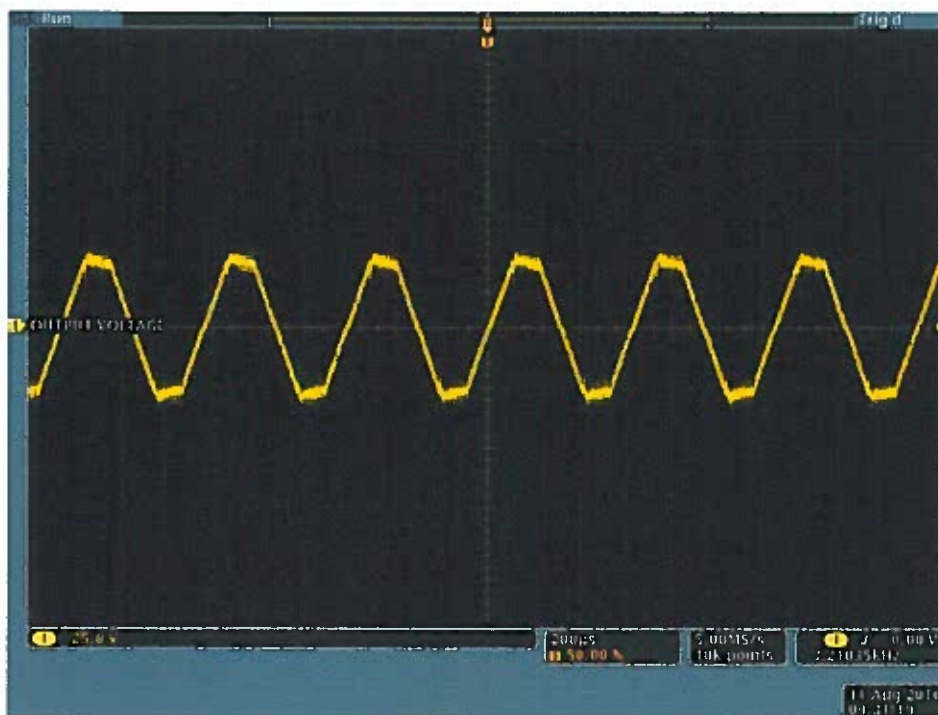
Figure 5. Trim Card output voltage when oscillating. Output current swing is about 9.5 Amps peak. This is regardless of BPS leads open or short circuited.

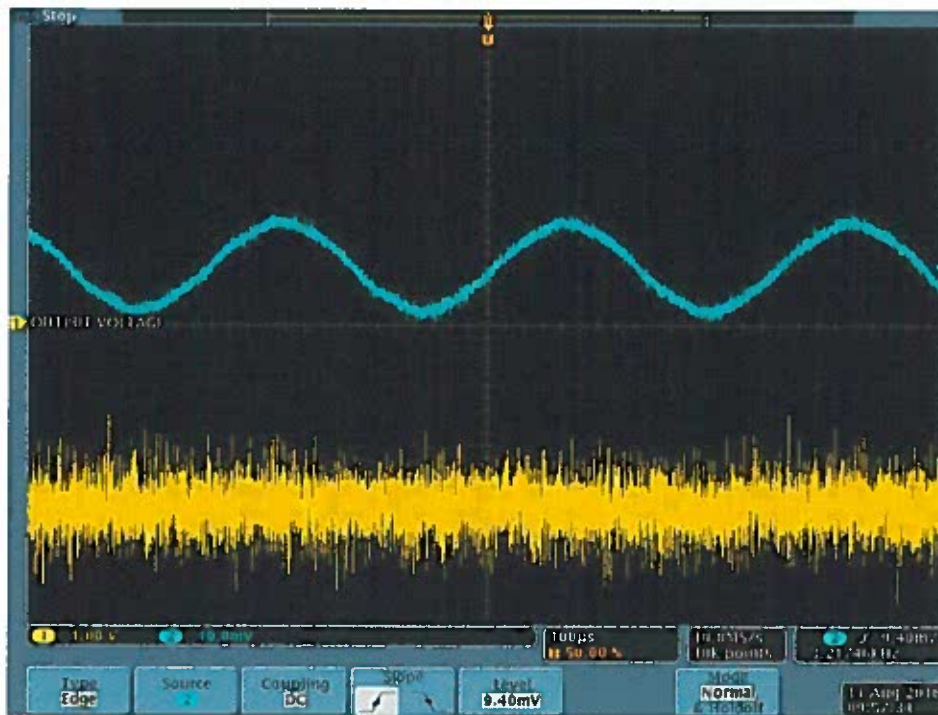
Figure 6. Voltage at BPS across leads when attached to BPS output terminal.

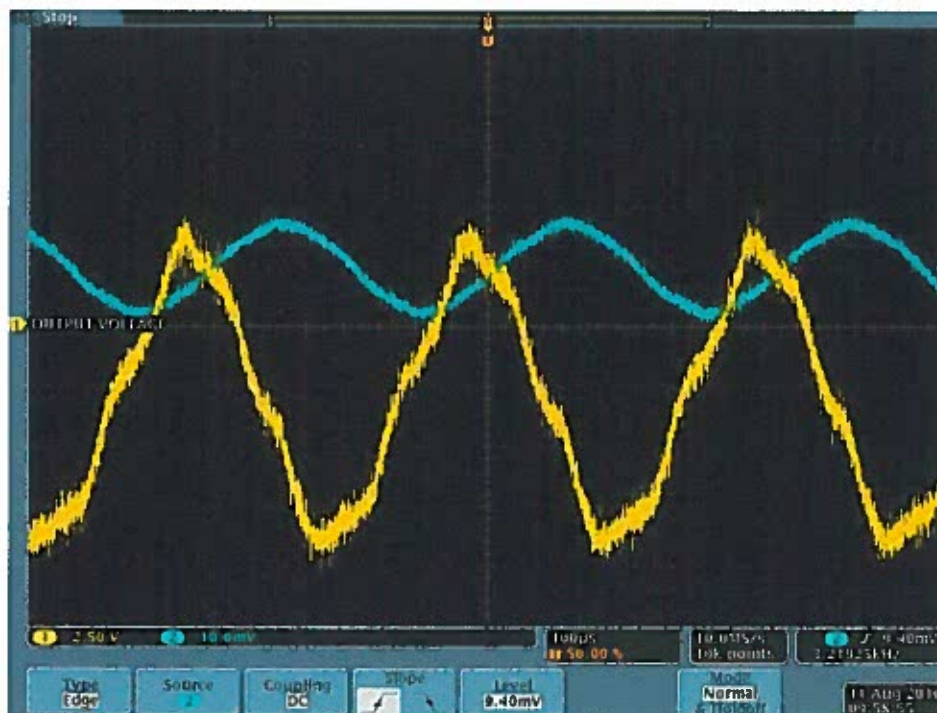
Figure 7. Voltage measured BPS positive/negative lead to ground when leads connected to power supply

Note: When attached to the power supply, the voltage measured across the leads will be zero as surmised during the initial investigation.

Note: Measured voltage from positive lead to Gnd was about 3.68Vrms. The resistance to Gnd changed from the expected 100 Ohms to 45 Ohms, which should have been a clue about the unusual circumstance.

Note: The resistance value of 45 ohms was measured during the initial stage of troubleshooting the earth leakage fault; which is significantly less than the expected 100 ohms

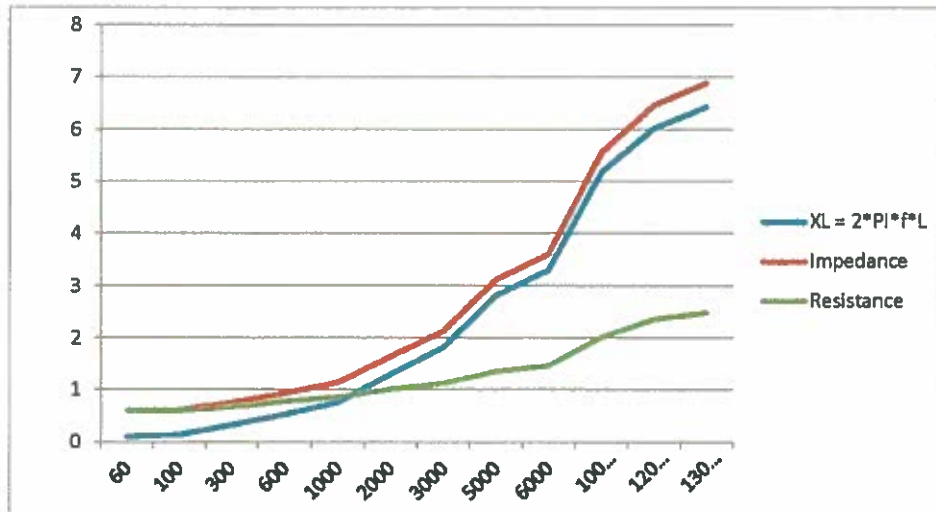
Figure 8. Impedance of Trim Cad Driven Coil, Channel 20 MGF

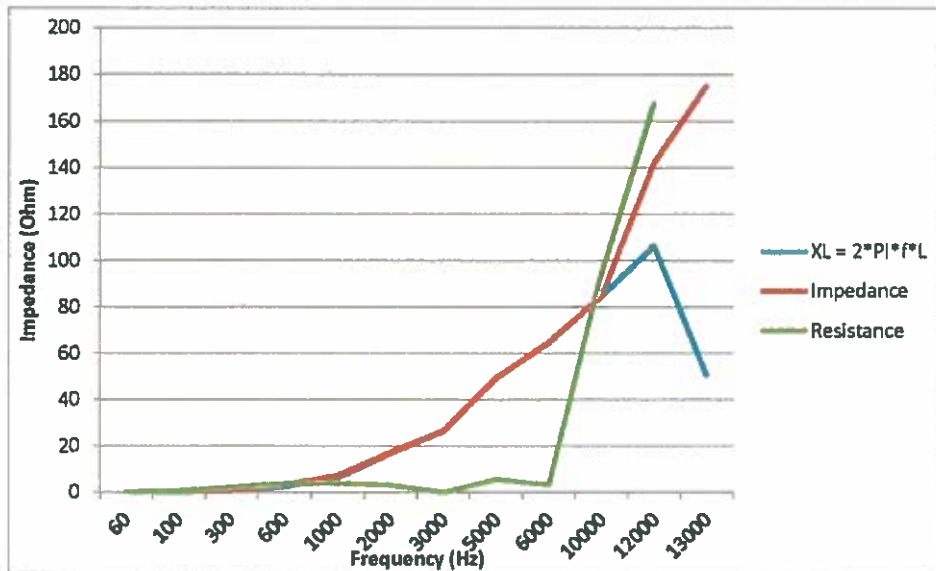
Figure 9. Impedance of LERF ARC1 string

Note: The oscillating Trim Card was found to be stable and well behaved into a nominal JLab corrector/quad in its intended configuration

Root Cause:	The problem (incident event scenario) was not anticipated and therefore analysis of the systems hazards were not performed and mitigated. The cause of the trim card going into oscillation, producing an alternating current voltage at its output, was later determined to be the load impedance falling outside of the specification for the normally configured compensation loop.
Contributing Causes: (List as many as apply.)	<p>C1 - Lack of sufficient operational/design review; review of a system as individual components and not as a whole complete operating system.</p> <p>C2 - Lack of single point ownership/responsibility when it comes to a system that involves multiple interests from different groups. Each group has their own agenda and the optimization between the power supply and the magnet load is not always considered or looked at.</p>

Engineering Division Management should evaluate the possible need and make a recommendation for rolling replacements of Trim Cards based on the Trim Card II design to areas where the Trim Card I designs are utilized. Evidence of completion: Written determination	NE-2016-13-01	12/1/2016	Andrew Kimber
