Type A Accident Investigation

Electrical Arc Injury
on October 11, 2004, at the
Stanford Linear Accelerator Center,
Menlo Park, California

November 2004

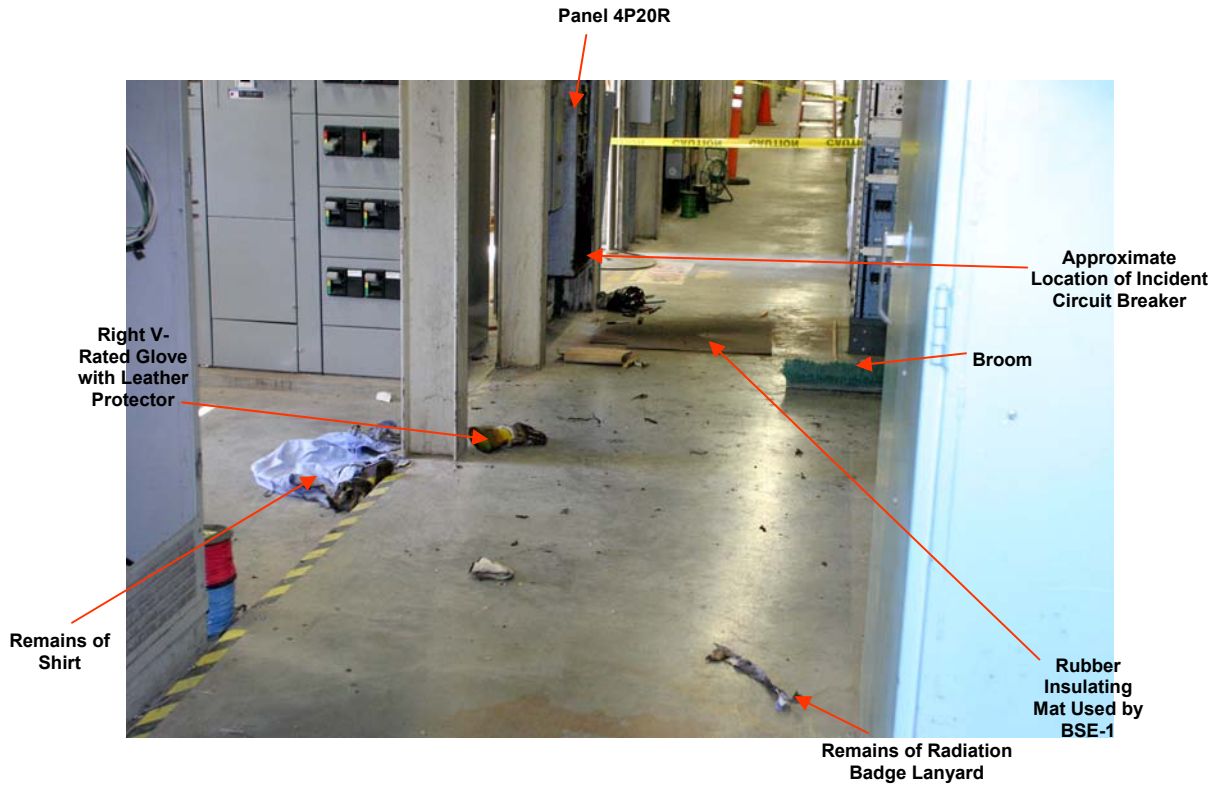
Figure 2-1. Scene immediately after the accident

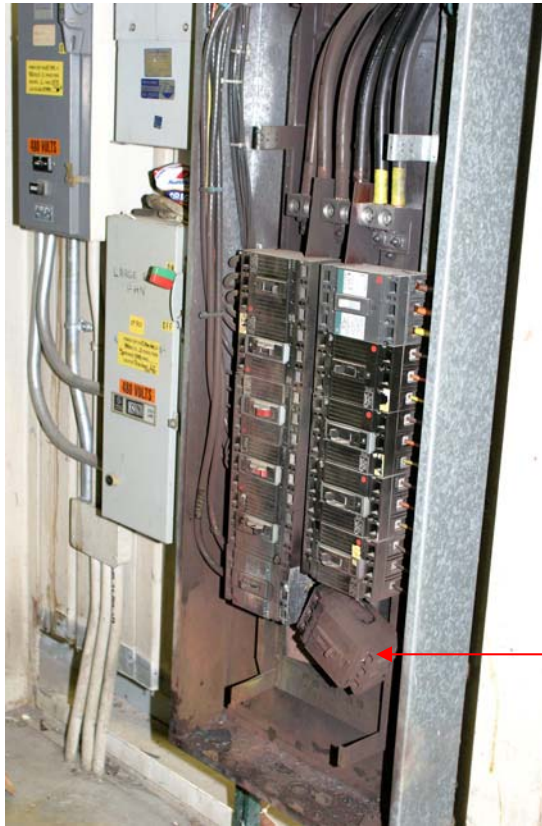
Incident Circuit
Breaker Supported
Only by Phase C
Connection

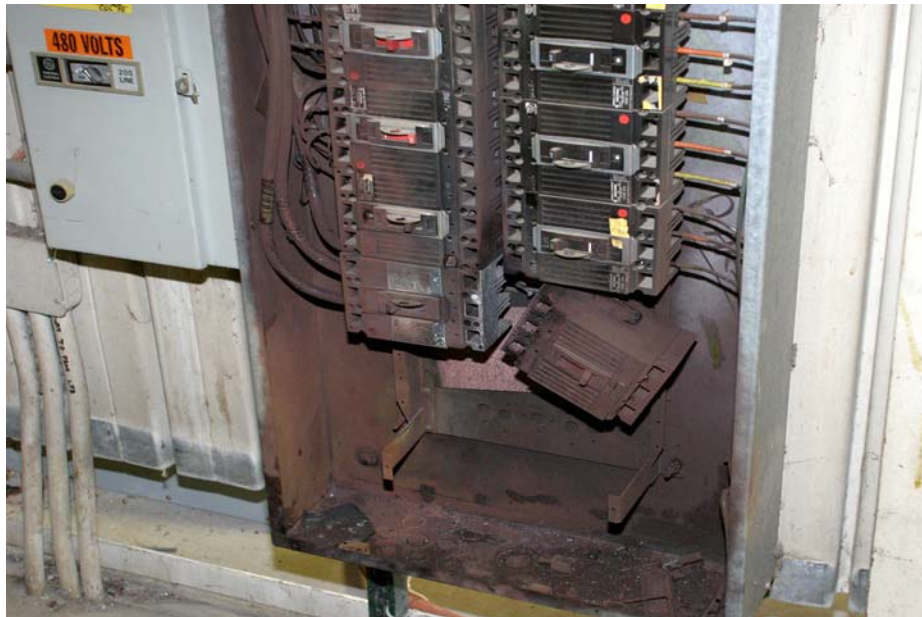
Figures 2-2a and b. Panel 4P20R after the arc flash

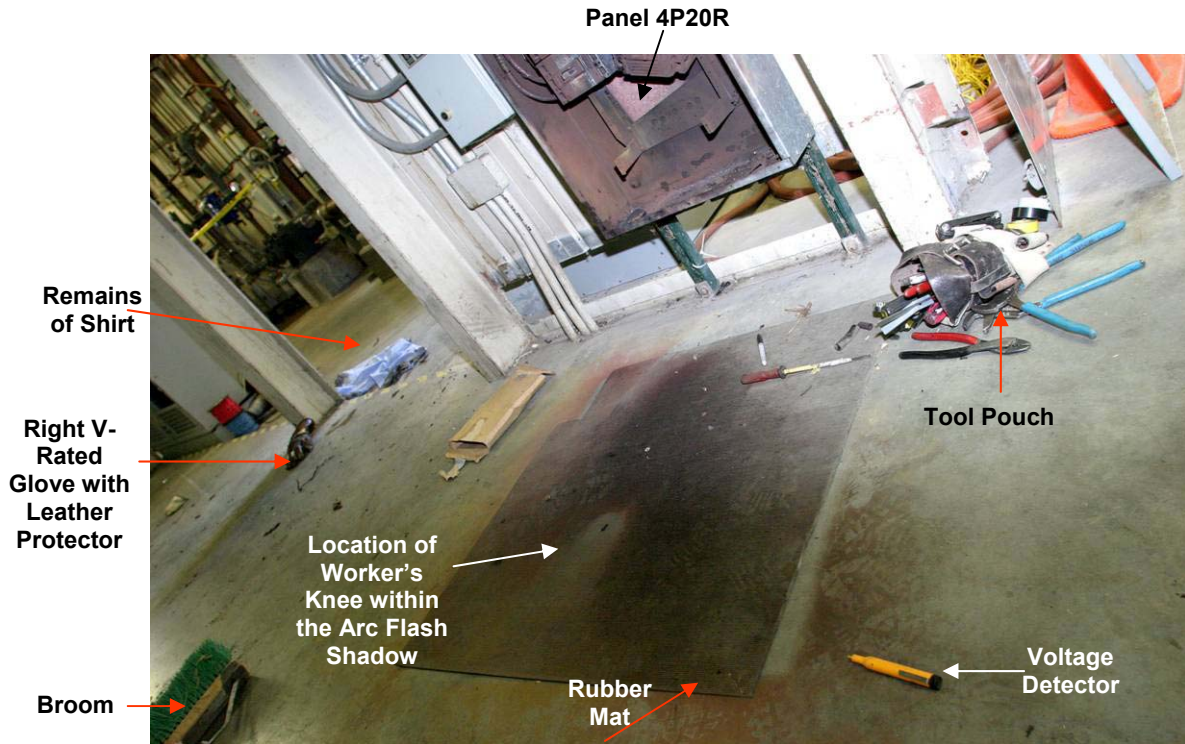
Figure 2-3. The insulating mat with the outline of BSE-1's knee in the arc flash shadow

A post-accident inspection of the rubber mat that the BSE-1 was using as an insulated work platform revealed the arc flash geometry. The arc image is roughly cone shaped, with an angular dispersion of approximately 80 degrees. There is a small clear area that shows no sign of arc damage. Because BSE-1 was kneeling at the time of the arc flash, the clear area is probably an image of BSE-1's left thigh and knee. BSL was standing behind and to the right of BSE-1. BSL received little incident energy but sufficient arc blast pressure to knock him off his feet.

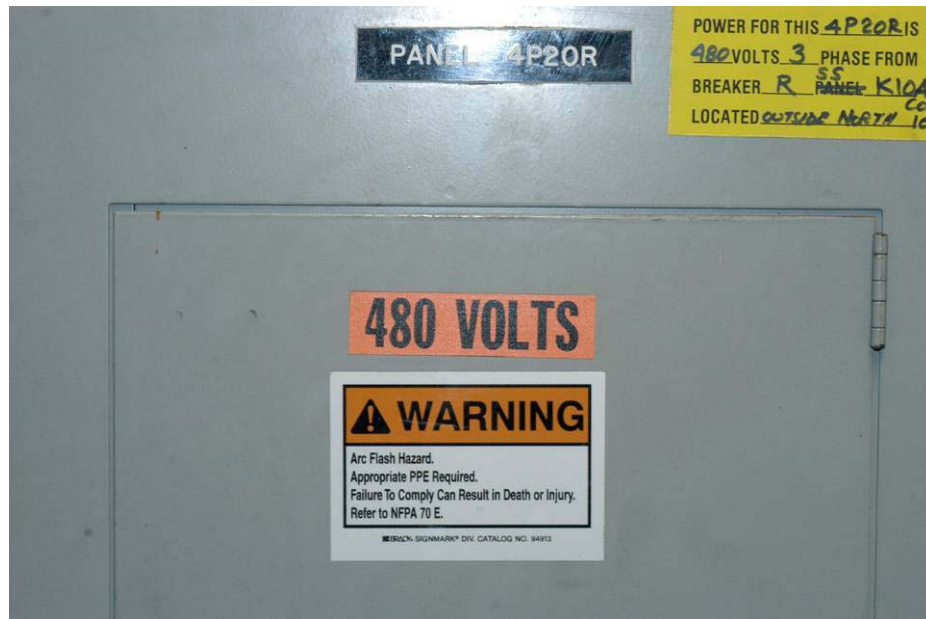
Figure 2-4. Warning label on Panel 4P20R

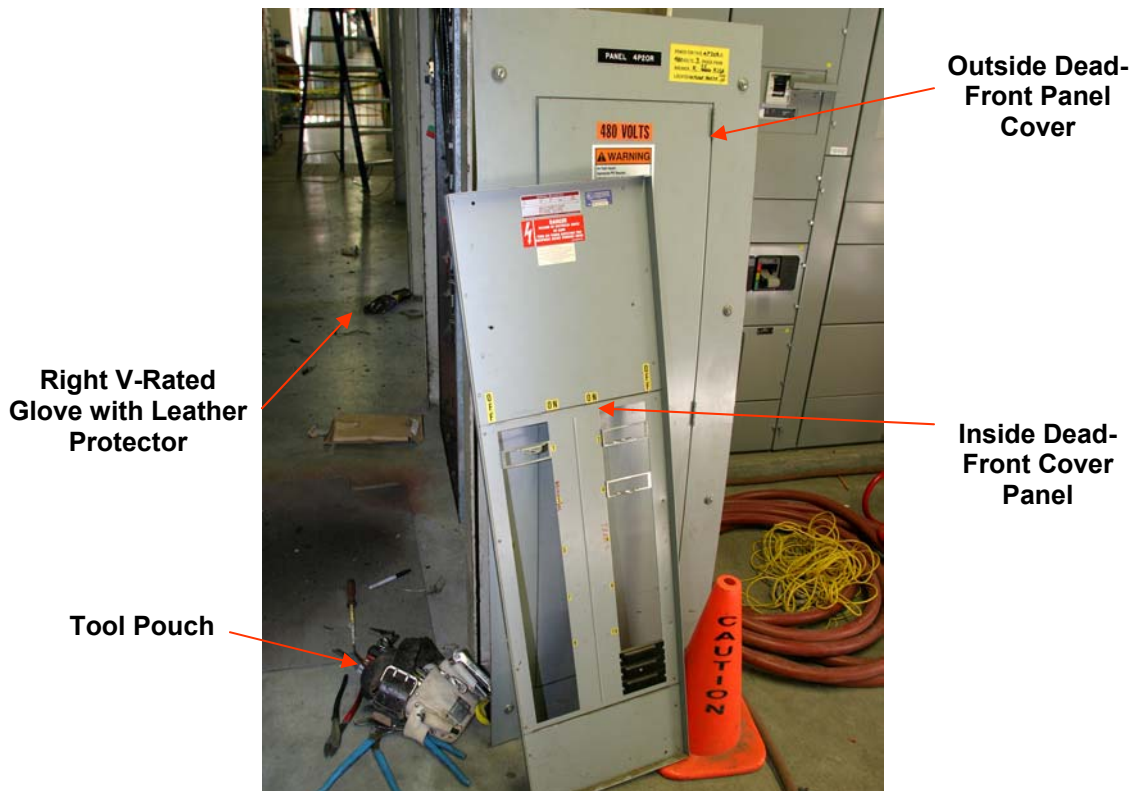
Figure 2-5. Both panel covers for the energized 480V panel

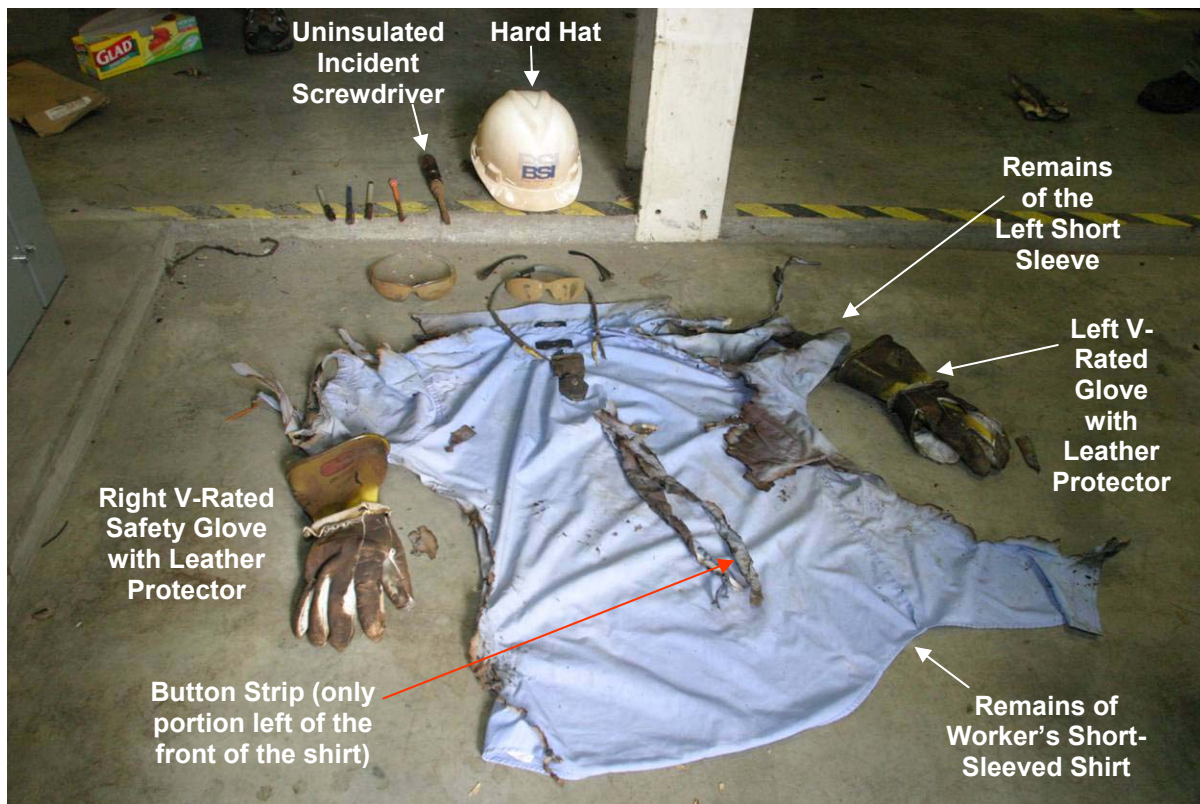
Figure 2-6. BSE-1's burned shirt and his flash-damaged PPE and tools

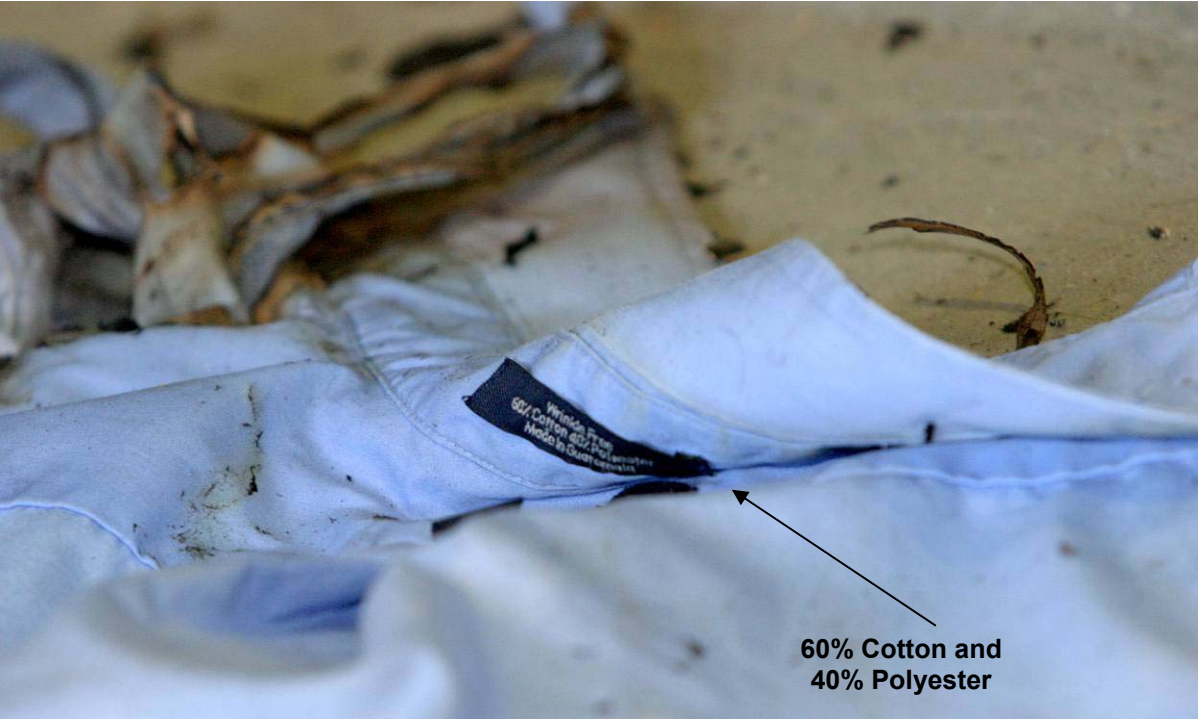
Figure 2-7. Closeup of BSE-1's burned cotton/polyester shirt

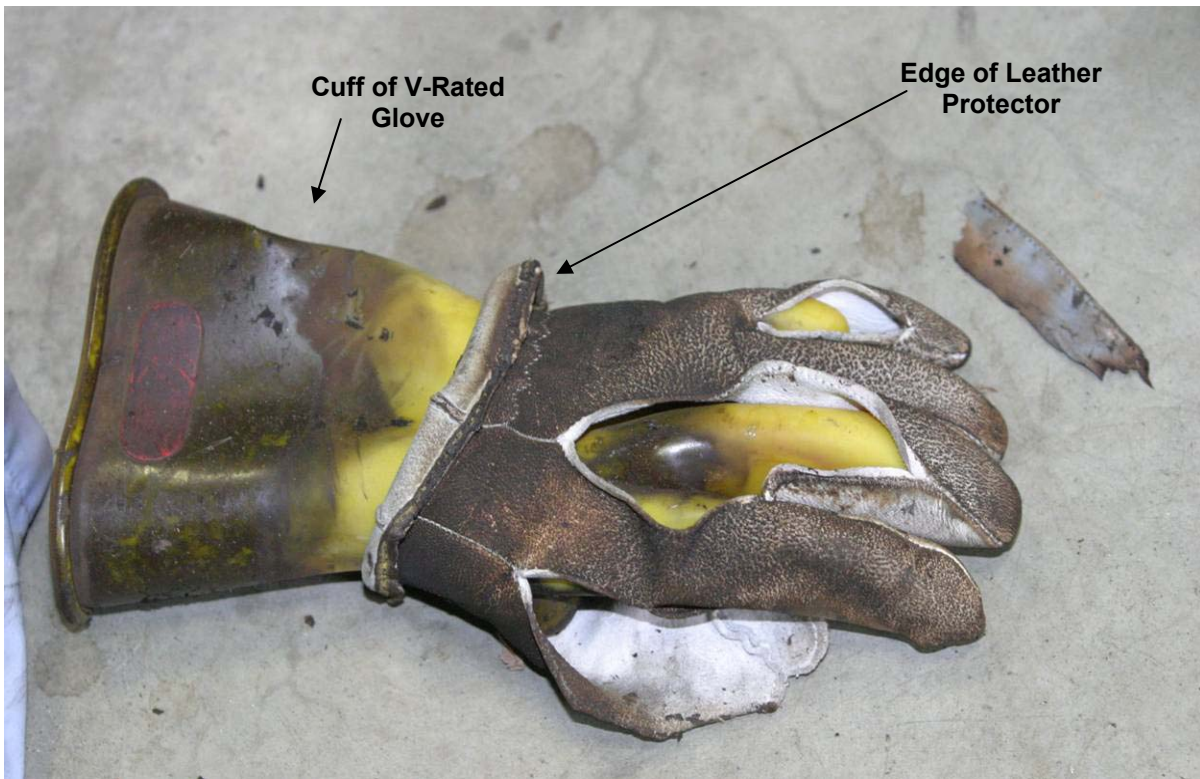
Figure 2-8. Closeup of one of BSE-1's burned gloves

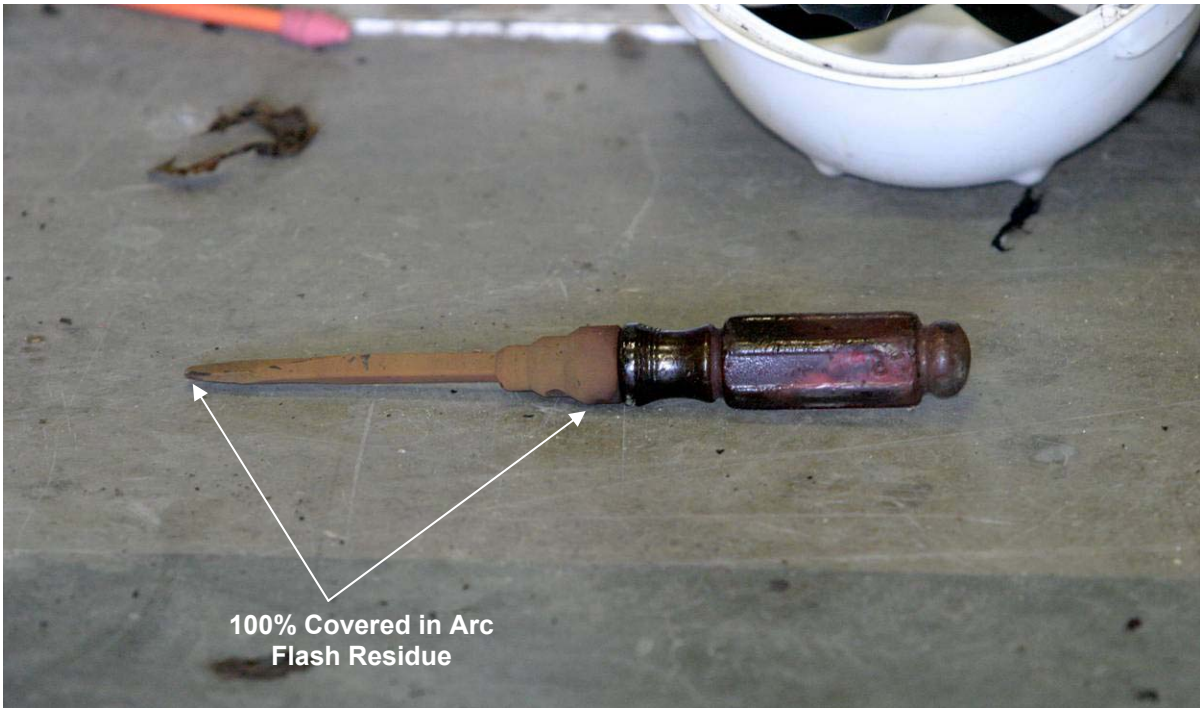
Figure 2-9. Closeup of the screwdriver the Board believes BSE-1 was using when the arc flash occurred

misaligned. The Board believes that BSE-1 was pushing with the screwdriver harder than would normally be required in order to engage the threads on the bus link when the arc flash occurred.

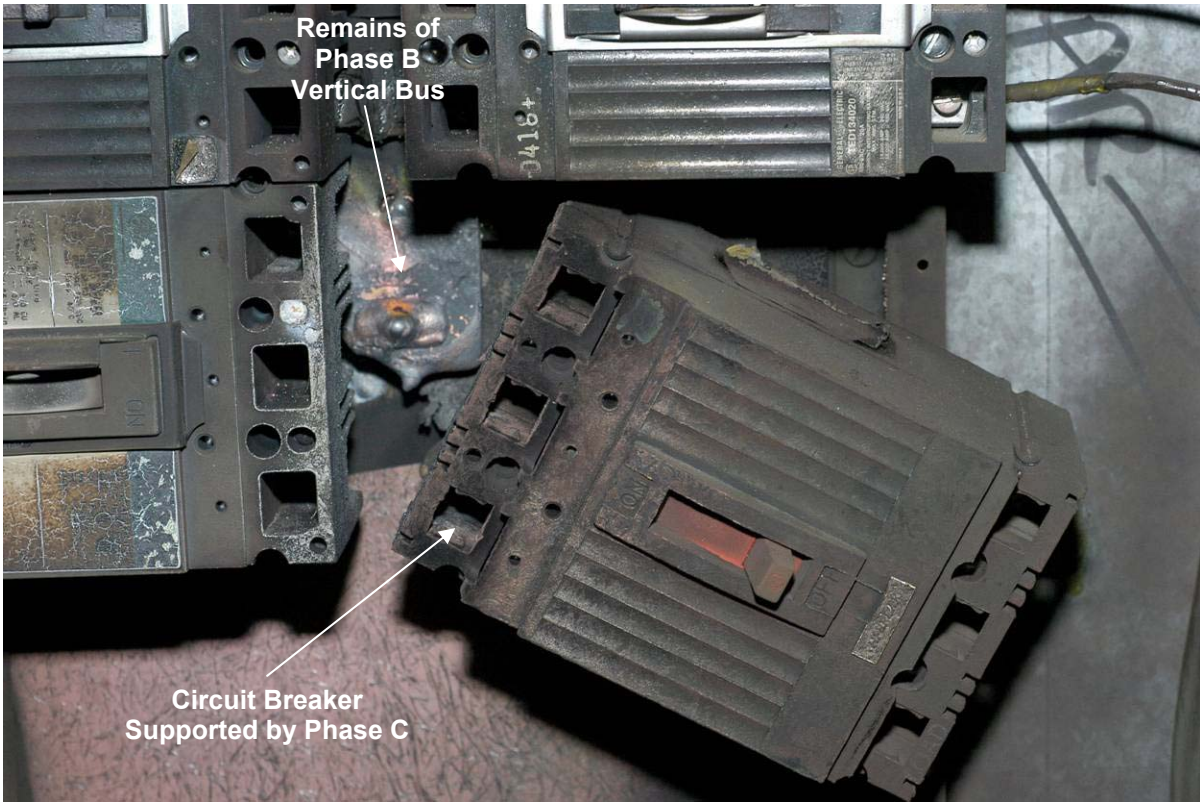
Figure 2-10. Closeup 1 of the damaged circuit breaker panel

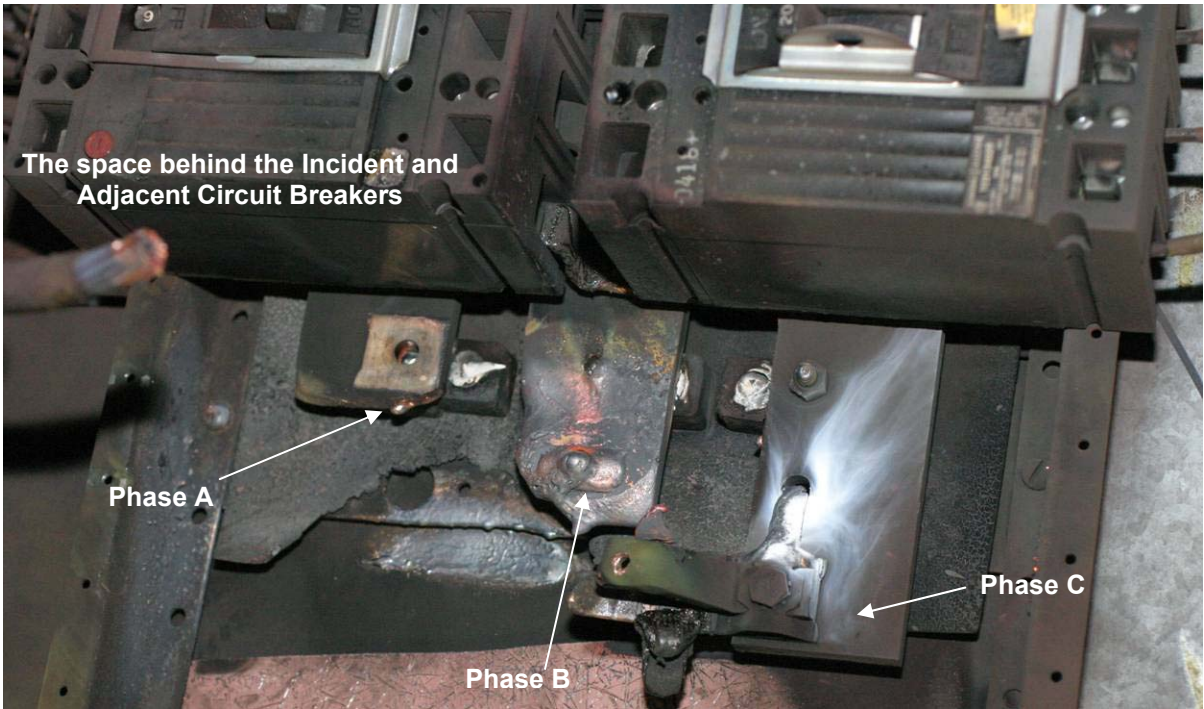
Figure 2-11. Closeup 2 of the damaged circuit breaker panel after removal of incident and adjacent circuit breakers

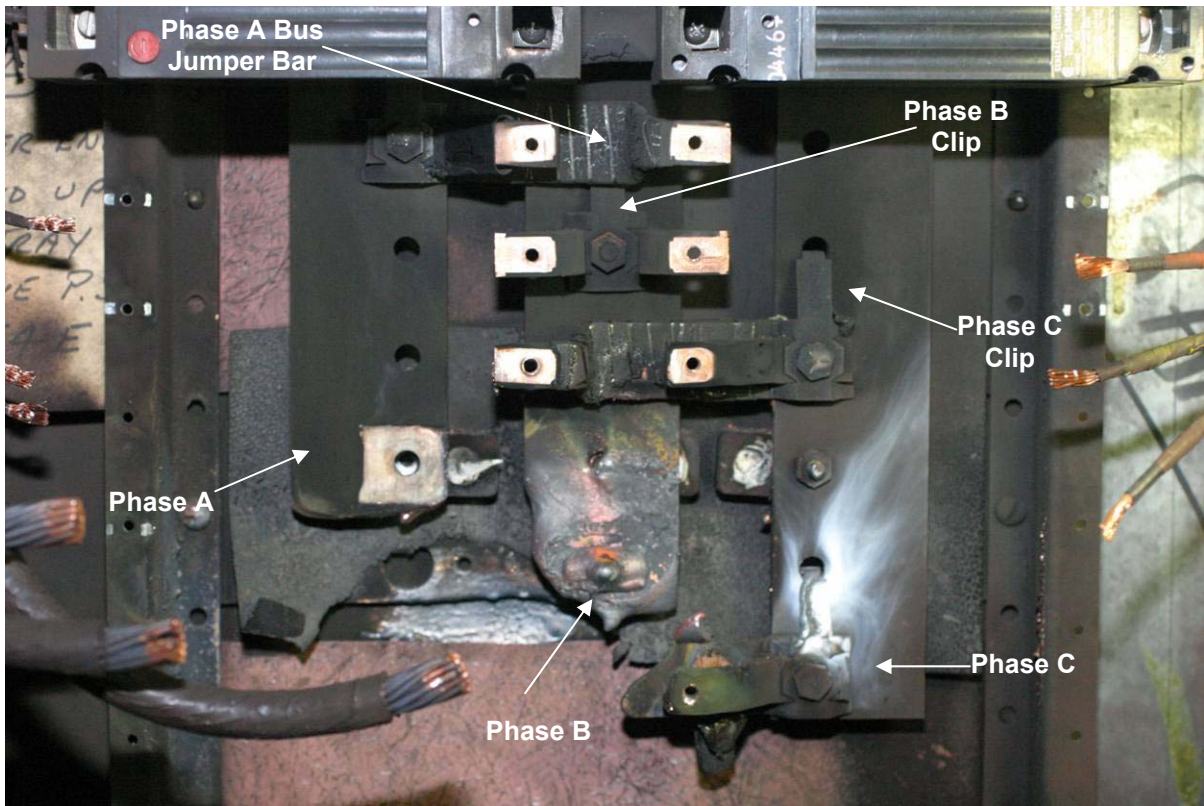
Figure 2-12. Circuit breaker panel after removal of the incident circuit breaker, adjacent circuit breakers, and the two circuit breakers above

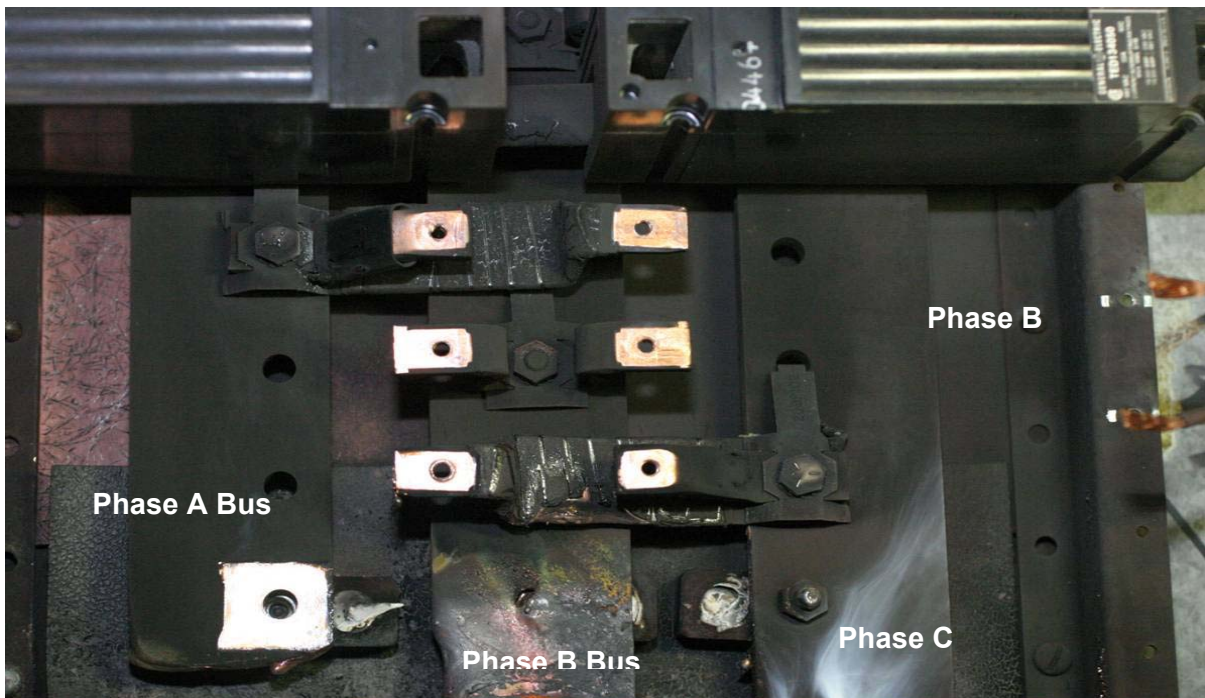
There are several possible reasons to explain why BSE-1 had trouble getting the screw to hold: damaged threads at the tip of the screw; damaged threads in the threaded hole on the bus link; the bus jumper bar may have been slightly misaligned; or the circuit breaker may have been slightly

Figure 3-1. Circuit breaker panel after removal of the incident circuit breaker and the three surrounding circuit breakers

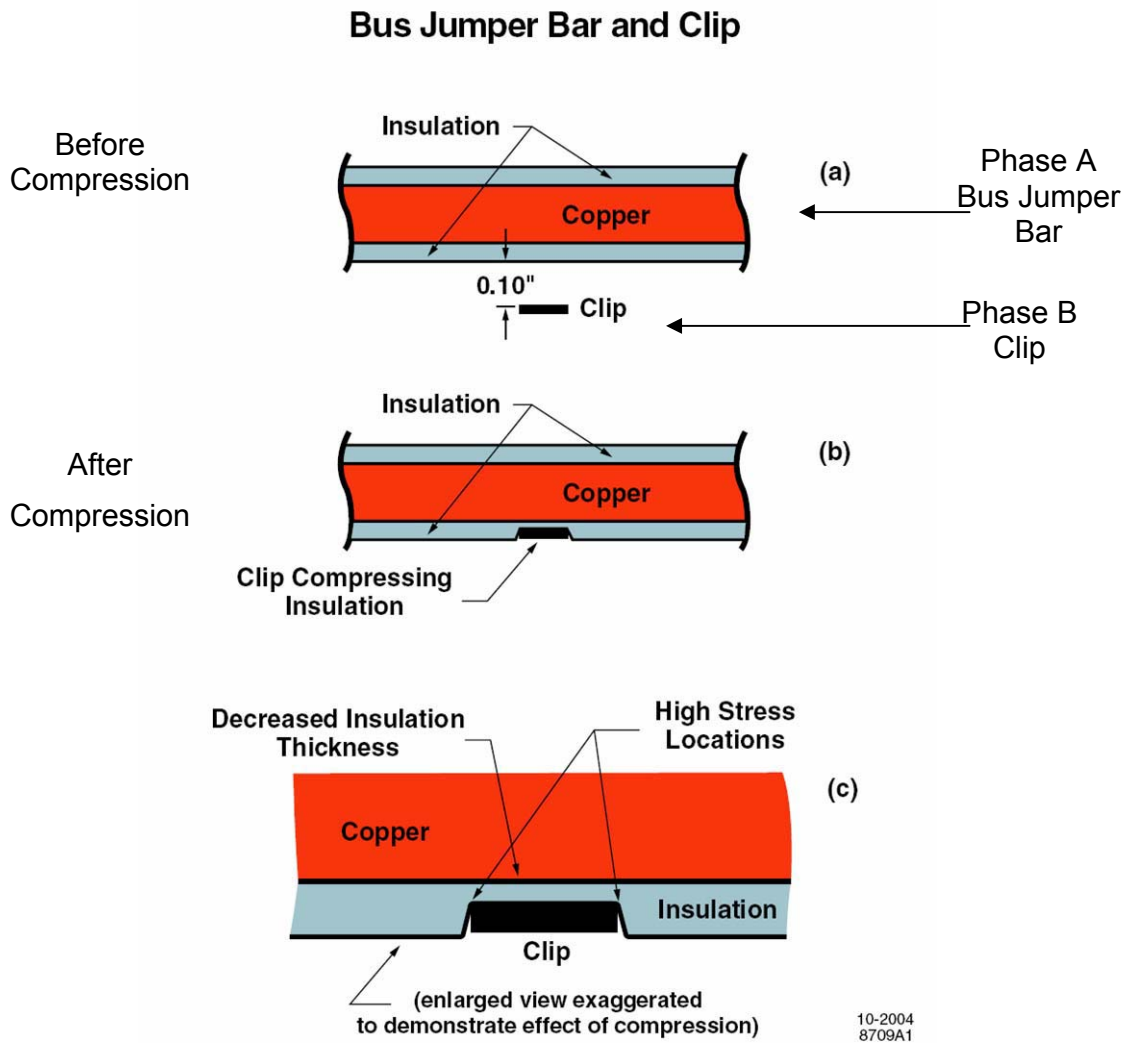
When the phase A screw failed to engage the bus jumper bar and BSE-1 applied additional force to engage it, the phase A bus jumper bar (which is supported at the bus for phase A in a cantilever fashion) deflected toward the phase B stabilizing clip. This additional force caused the stabilizing clip to contact the phase A bus jumper bar and compressed the rubber insulation.

Compressing the insulation with the clip increased the electric field stress in the insulation in two ways. First, it decreased the distance over which the electric field was distributed. Second, it further increased the field intensity in the region of the sharp edges of the clip. The Board believes that the increase in electric field stress could cause a failure of the insulation and result in an arc flash. (See Figure 3-2.)

Figure 3-2. The effect of contact between the bus jumper bar and the clip (not to scale)
