## Hall B Torus' 325 K Cernox Error

June 30, 2017

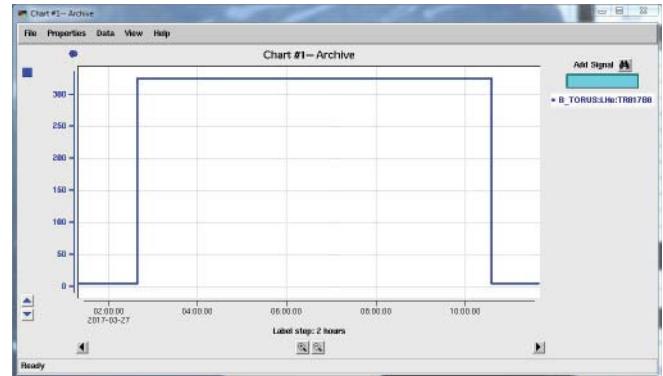
Sometimes, a Cernox temperature reading jumps to and stays at 325 K (Fig. 1), for an unknown reason. This issue has been present since the beginning of the Torus project and only occurs when the Torus is at 4 K. Many empirical solutions were tested, Table I. Since January 1, 2017, the error has occurred 22 times, Table II.

FIG. 1. MyaViewer EPICS plot showing TR817B9 jumping to 325 K and staying there until cRIO program was manually restarted.

the calculated resistance. The error was found to occur when the two voltages read during a single DAQ loop from a single Cernox were equal. This caused the calculated resistance to be  $0.0 \Omega$  and the interpolated temperature to be 325 K. See steps 2–8 in Fig. 2.

The error occurred in the version of the LV cRIO program in which the algorithm used to determine Cernox excitation currents targeted a fixed power. The program was modified so that the algorithm targets a voltage of 15 mV (“Fixed Voltage Solution”, Fig. 2). This new algorithm (deployed April 21, 2017) replicates how Cernoxes are calibrated at the manufacturer and how they are initialized when the LV cRIO starts.

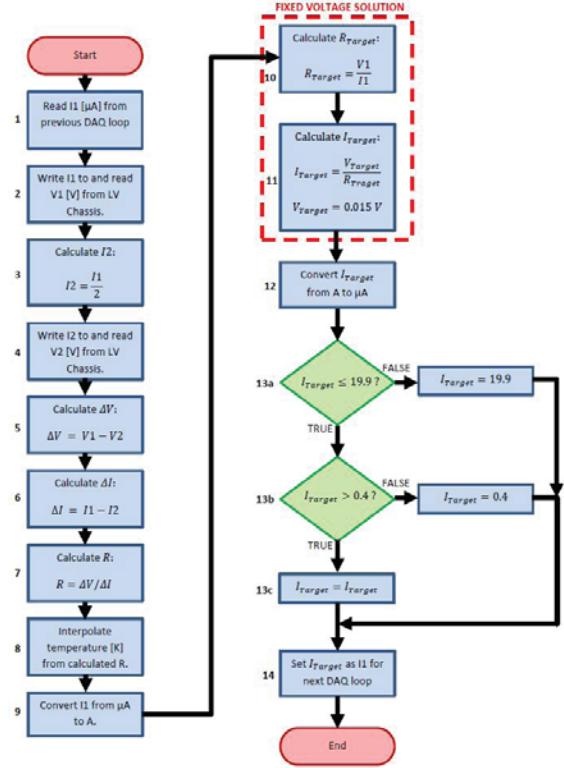
FIG. 2. Flowchart of Cernox excitations using Fixed Voltage Solution.

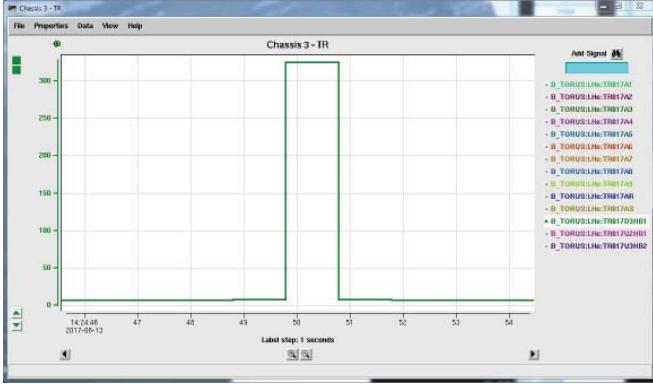
After the Fixed Voltage Solution was deployed for testing, three instances of a Cernox jumping to 325 K and resuming normal operation after a second were observed. On April 29, 2017, Cernox TR817F9 jumped to 325 K, but then resumed normal operation after a second. On May 31, 2017, LV cRIO’s program indicated TR817D3HB1 jumped to 325 K and then resumed normal operation. However, this error and recovery were not recorded in EPICS, and therefore it was not decisive that the Fixed Voltage Solution was successful. On June 13, 2017, Cernox TR817D3HB1 jumped to 325 K and resumed normal operation after a second (Fig. 3), confirming that the Fixed Voltage Solution prevents Cernoxes from getting stuck at 325 K.

Fig. 3. MyaViewer data from EPICS on June 13, 2017, showing TR817D3HB1 jumping to 325 K and returning to a normal temperature 1 s later, indicating that the Fixed Voltage Solution allows a sensor to automatically recover from jumping to 325 K.

On the basis of the results, the LabVIEW program containing the Fixed Voltage Solution has been deployed to the Torus LV cRIO as its start-up application and the program will deploy automatically any time the cRIO is restarted.
