## CONSTRUCTION CHANGE REQUEST (CCR)

1	Subcontract No: 10-C0162	Date: 08/02/2011	
2 Project Title: Technology and Engineering Development Facility Project			
3	CCR No: 25	PR No. FTCCS	
4 CCR Title: East Parking lot undercut			
5 Description: Undercut unsuitable soils and replace with stone as directed by GET Solutions in the report dated 7/20/2011			
6 Changes in Drawings/Sketches: N/A			
7 N	Changes in Specifications: /A

## DAILY REPORT

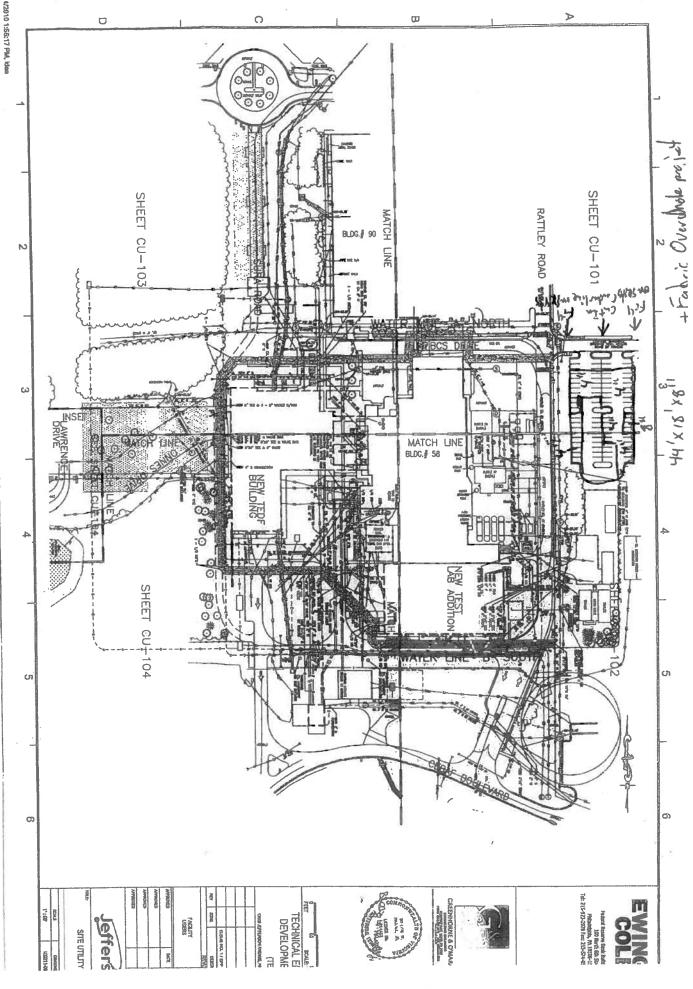
C. Tests/Observations Performed:  Proof Roll / V. 344   Observation 5  D. Problems/Non-Compliances/Failing Tests:			
D. Problems/Non-Compliances/railing less.  Soft subgracle encountered, lumping from 2" to 8"  E. Remarks or Comments:  GET Tack arrived one to as requested to perform an Inspection on the subgrade for Parking tot. A Dual Adde Duap Truck without was used to complete the Proof Roll. Under the applied wheel load the subgrade shows signs of pumping and unstable soils. Moisture and organics are present but found to be not a major problem. All Areas were marked on attached sketch will cut amounts marked. It is my recommendation to Under cut those areas shown on sketch. Then install structural till per contract thickness. Install till tubric above structural fill and accross whole parking lot. Then Fill undercuts and fill evens with thickened stone luyer to bring up to proper grade.
