## MOLLER Magnet Power Supply Factory Acceptance Test at OCEM

Below is the summary of activities performed on-site at OCEM in Italy for the magnet power supply (MPS) to be used for the downstream 3 (DS3) Torus.

Much of the testing was based on the existing factory acceptance test (FAT) document (UT-RP-0686) generated by OCEM, along with JLAB provided tests.

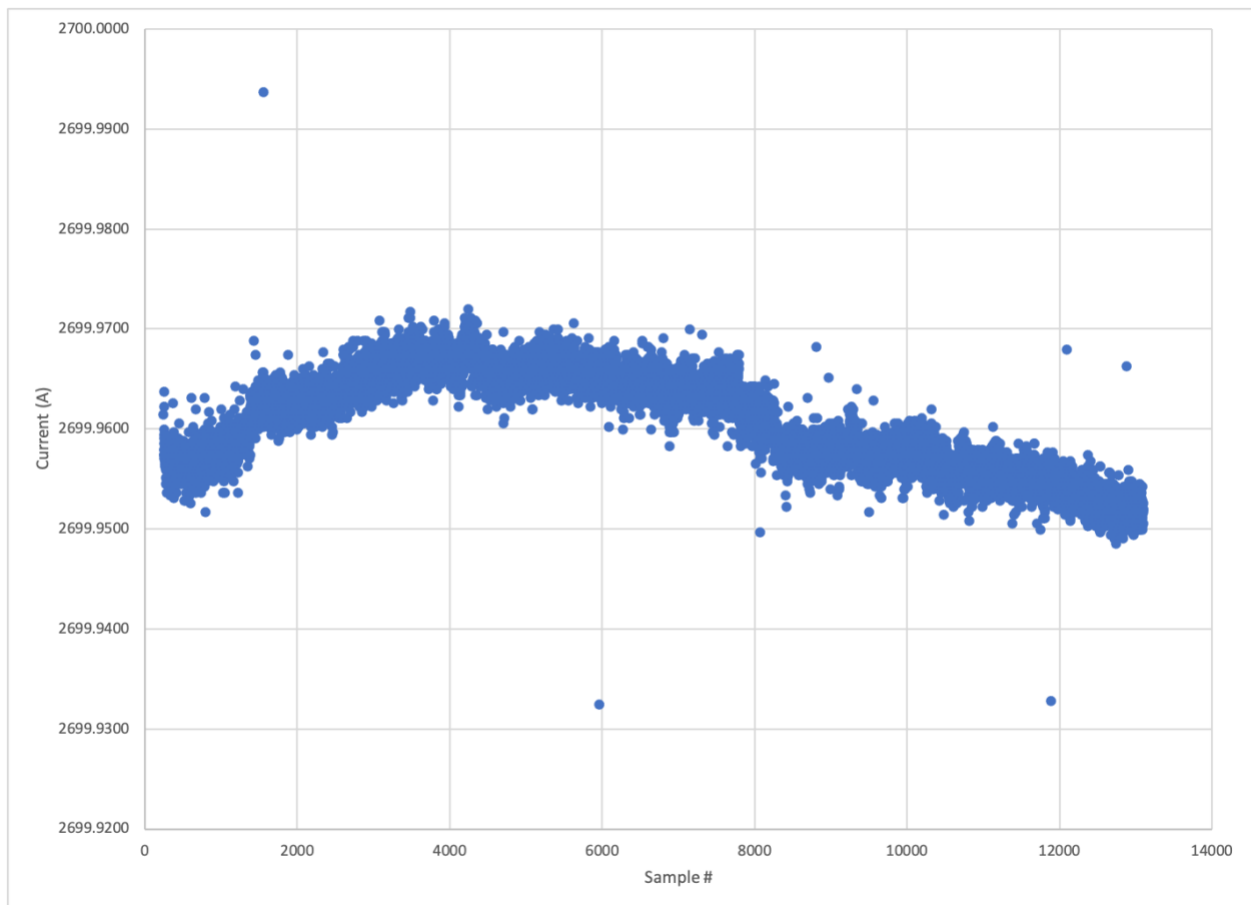
Section 8.10 of FAT – Long Term Stability – OK

- Keithly 2002 DMM set to 10 NLPC (200-ms sample), 1 sec trigger
- Ran for approximately 7 hrs when AC mains fault to OCEM tripped supply

Current (A)
<b>Min</b>	2699.9325
<b>Max</b>	2699.9937
<b>pk-pk</b>	0.0612
<b>Average</b>	2699.9607
<b><math>\sigma</math></b>	0.0048

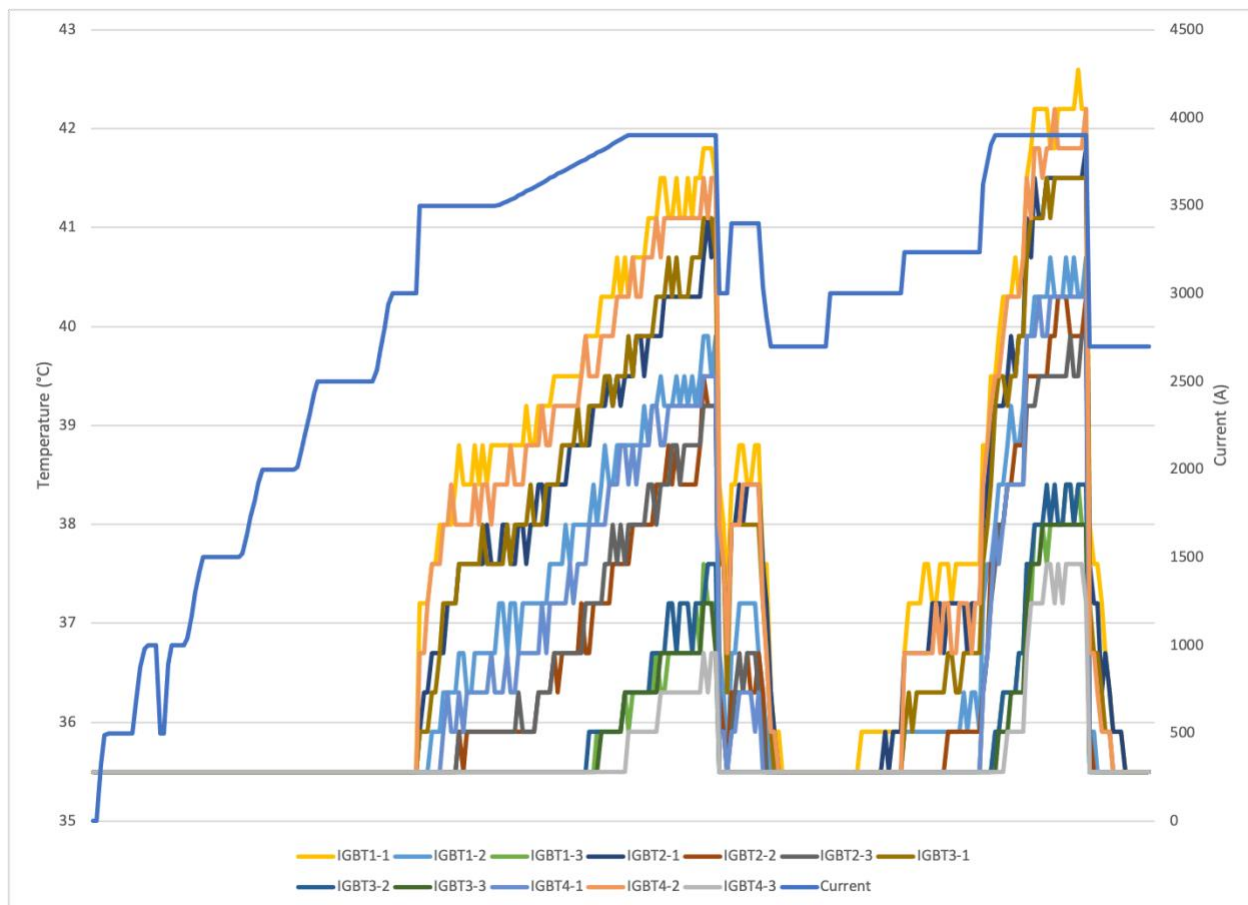
- Six cables in parallel were used to connect load – General Cavi FG17 1x240
  - Rated for 490 A each, became noticeably warm during test
- Generally speaking, the warmest IGBT temperatures were on #1 which is near the water output and the coolest were on #3, which is on the inlet
  - ~5°C difference between #1 & #3 (except for power module 2, which was 1.5°C)

- Minimum IGBT temperature is reported as 35.5°C

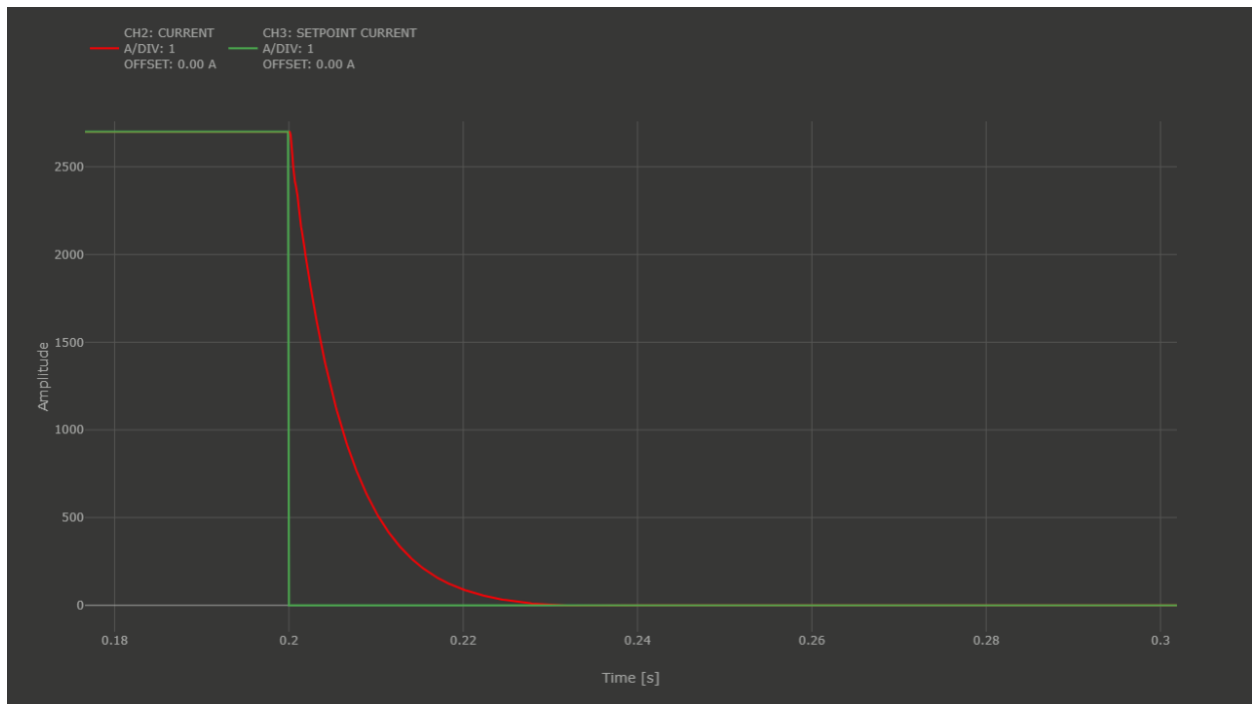
L1 Fault (no ramp to 0)

- Tested two each of L1 (E-Stop, IGBT Temperature) and L2 (overcurrent, overtemperature)
- Voltage reference to IGBT for each of the trips is attached, captured via web interface of MPS

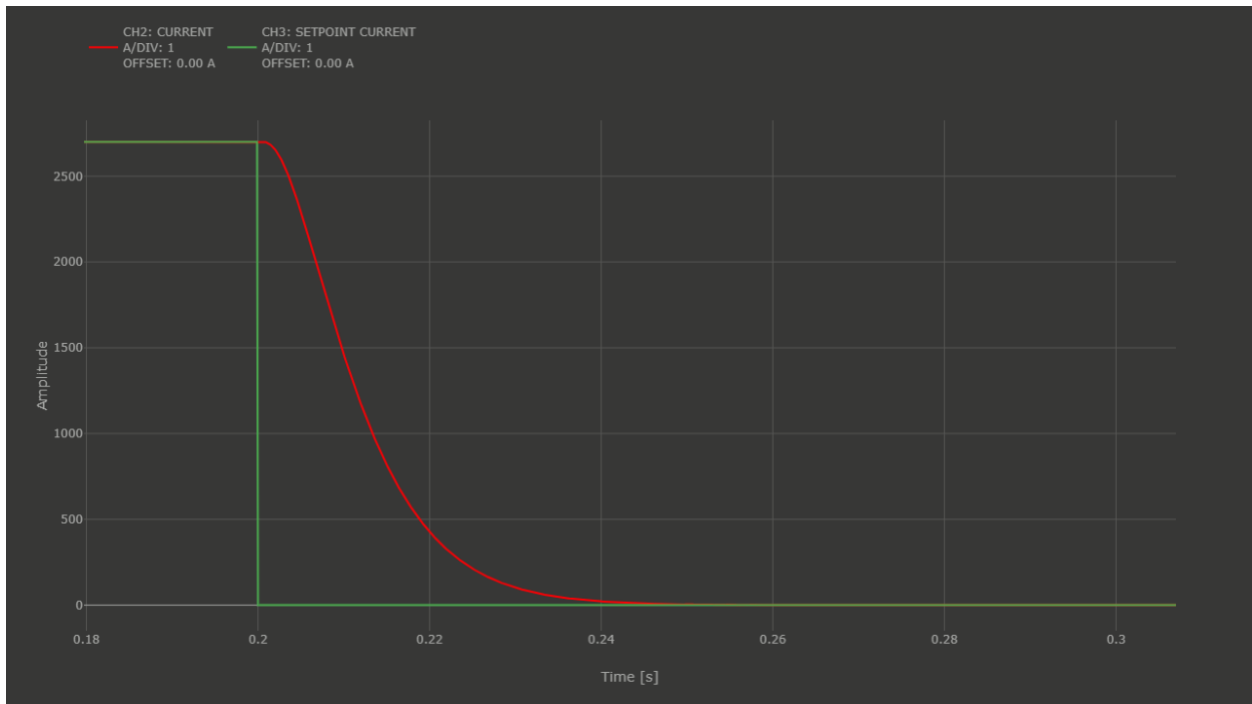
MWI set to 0 A

- Also tested issuing the MWI command (which doesn't use a ramp rate) to go to 0 A output; looks similar to an L1 fault

*JLAB should always use MWIR command to set current output, and use MWI 0 for faults*

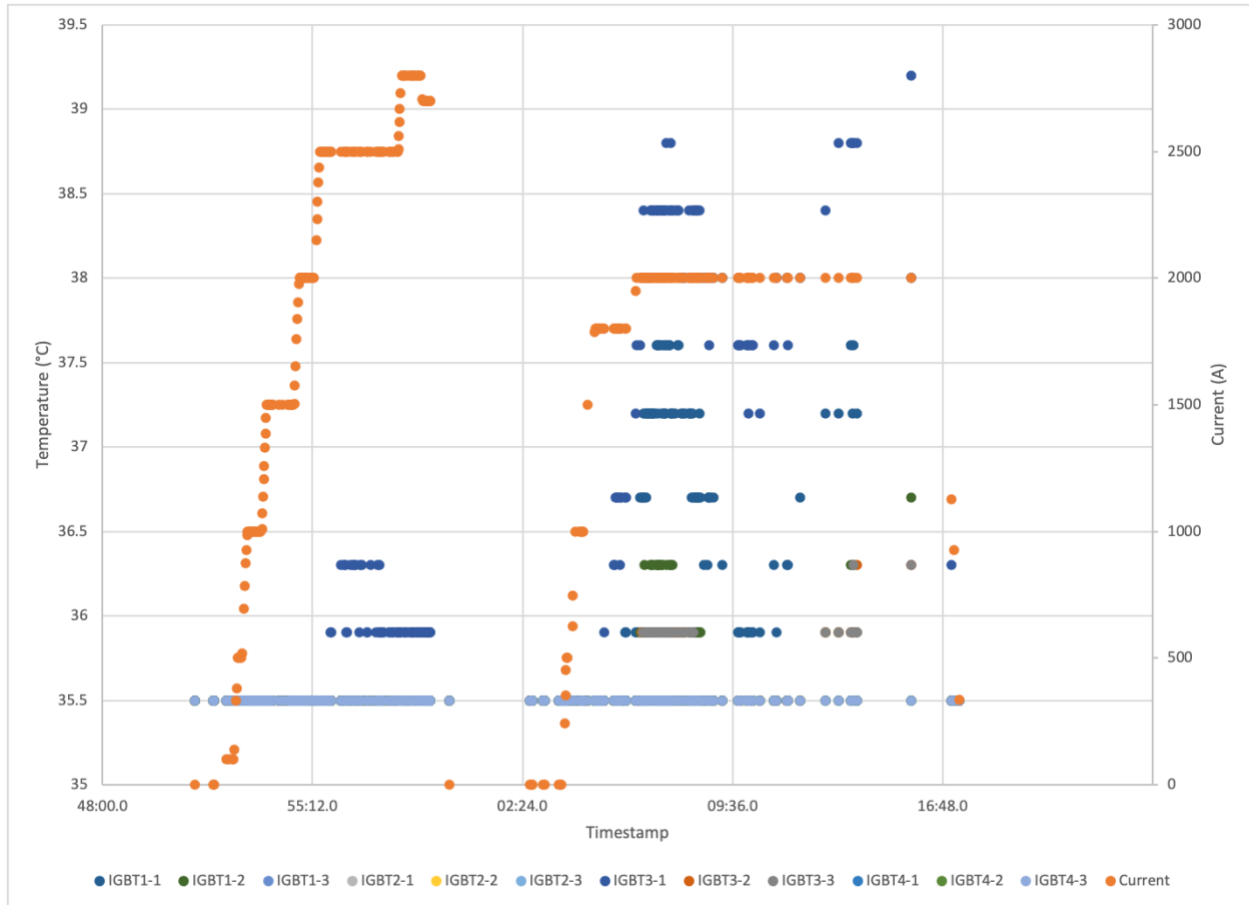
Removed PWM signal to power modules to simulate a fault

- Removed from 1 module and ran at 2800 A
- Removed from 2 modules and ran at 2000 A
- IGBT temperature difference not large enough to be used to indicate a fault

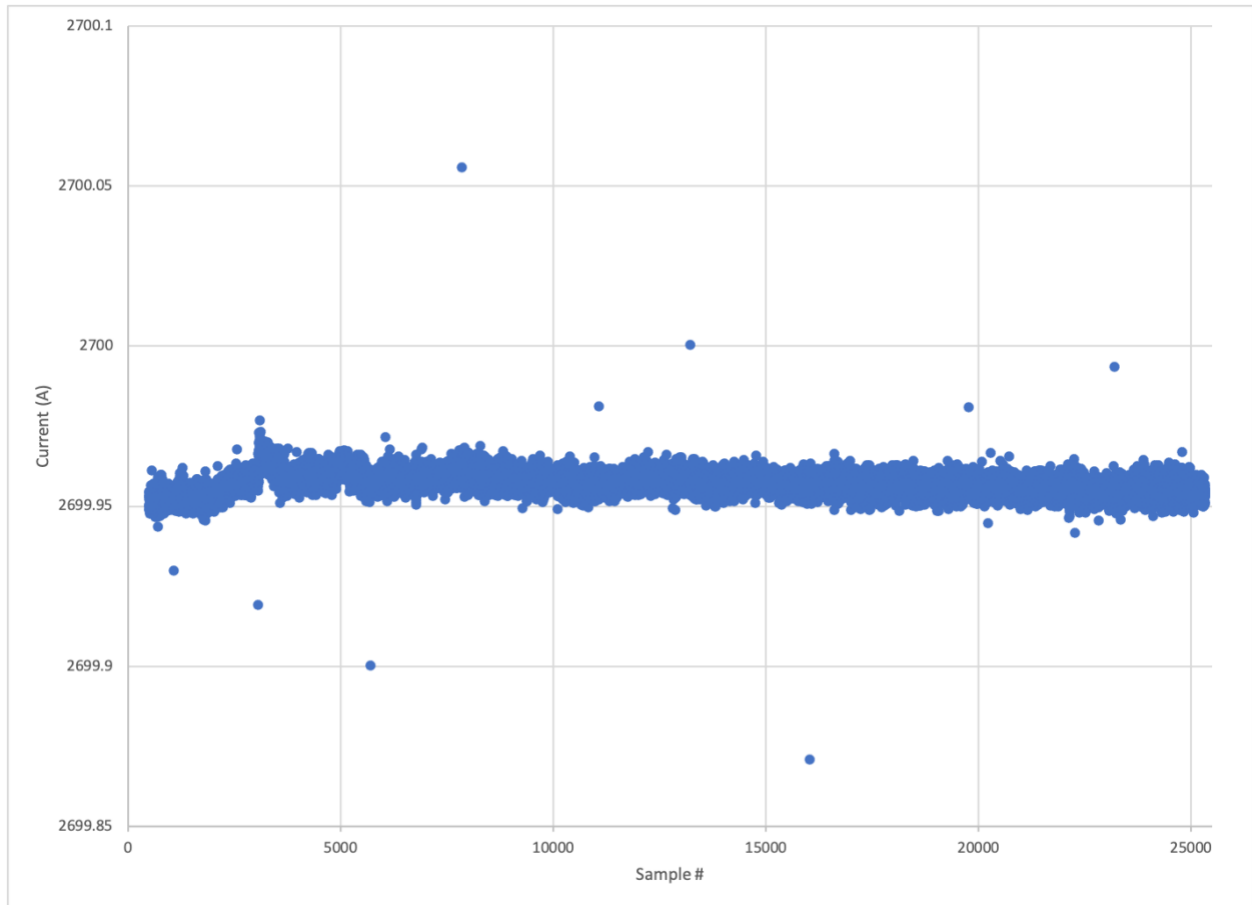
Re-ran Section 8.10 of FAT – Long Term Stability – OK

- Lowered NLPC to 5 on Keithley 2002, trigger at 500 ms
- Ran for approximately 3.5 hrs then shut down due to lack of safety personnel (COB)

Current (A)
<b>Min</b>	2699.8710
<b>Max</b>	2700.0558
<b>pk-pk</b>	0.1848
<b>Average</b>	2699.9570
<b><math>\sigma</math></b>	0.0033
