EIC Beamline Teststand Sensor Upgrade

Marc McMullen
2023-07

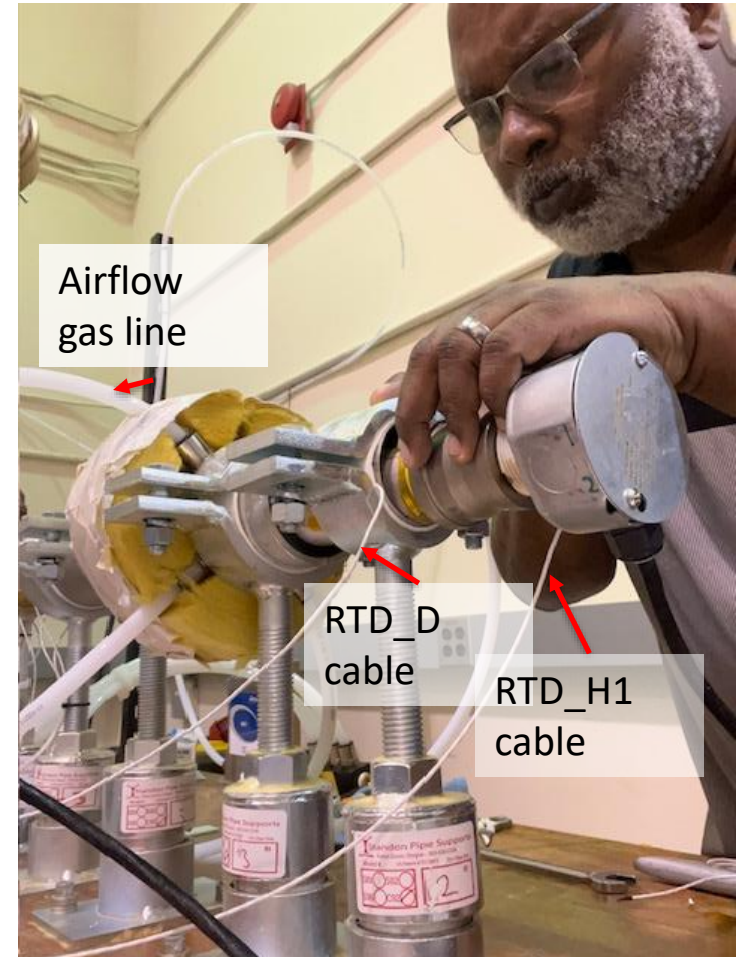
After the teststand was reassembled, I re-attached RTD_H1 to 12 o'clock as well as replaced RTD_H2 (also at 12 o'clock). I decided to add two additional RTDs on the upstream side of the heater at 3 o'clock (RTD_H1_3), and 6 o'clock (RTD_H1_6). This would give us data on the temperature profile of the pipe from bottom to top. We could then compare this to the Ansys models.

Marc McMullen is installing additional RTDs on the heater pipe at the 3 o'clock and 6 o'clock position

In conclusion, I have repaired and reinstalled sensors at the original sensor locations on the EIC beamline teststand heater pipe so that the current teststand measurements can be compared to the initial runs. I have also installed additional sensors so that a temperature profile of the heater pipe can be recorded and reviewed.
