# Detector Support Group

## Weekly Report, 2017-08-30

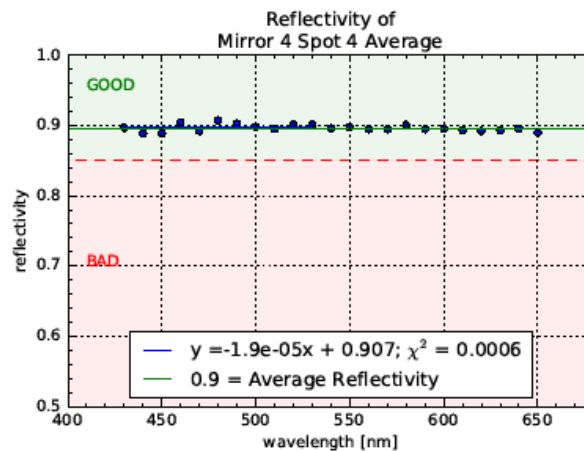
Reflectivity results from Mirror 4, spot 4 (visually good spot). Average reflectivity for spot was 90%.

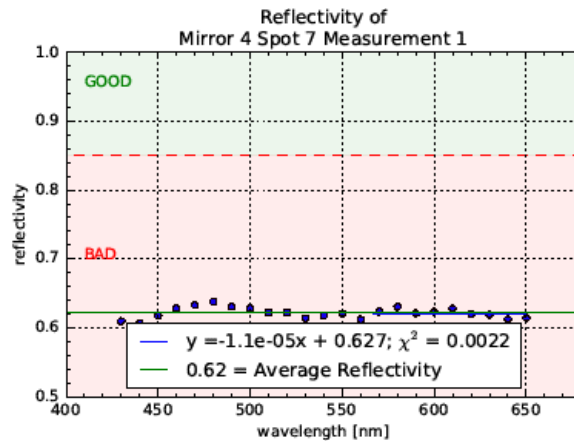
Reflectivity results for Mirror 4, spot 7 (visually bad spot). Spot corresponds to a pocket in mirror's reflective surface. Average reflectivity for spot was 62%.

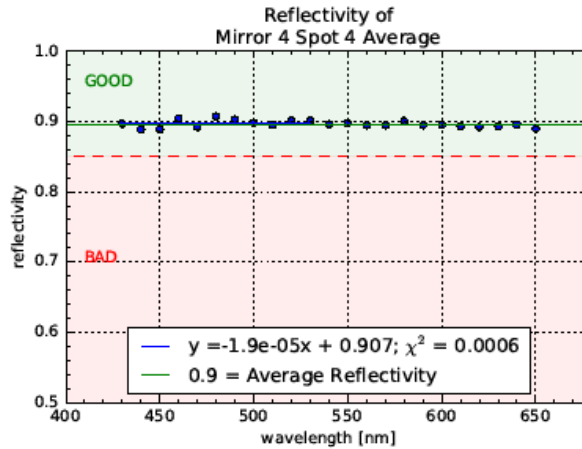
Reflectivity results from Mirror 4, spot 4 (visually good spot). Average reflectivity for spot was 90%.

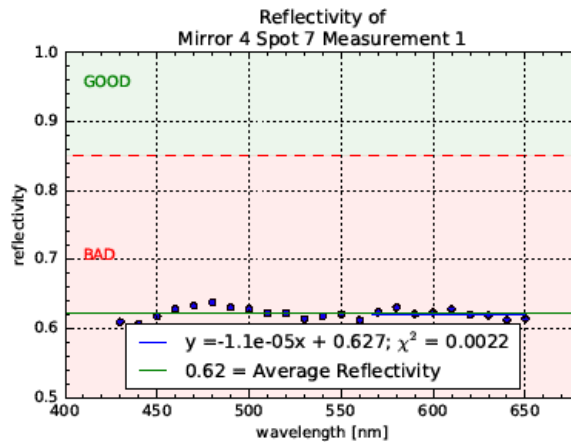
Reflectivity results for Mirror 4, spot 7 (visually bad spot). Spot corresponds to a pocket in mirror's reflective surface. Average reflectivity for spot was 62%.
