# Detector Support Group

## Weekly Report, 2018-10-03

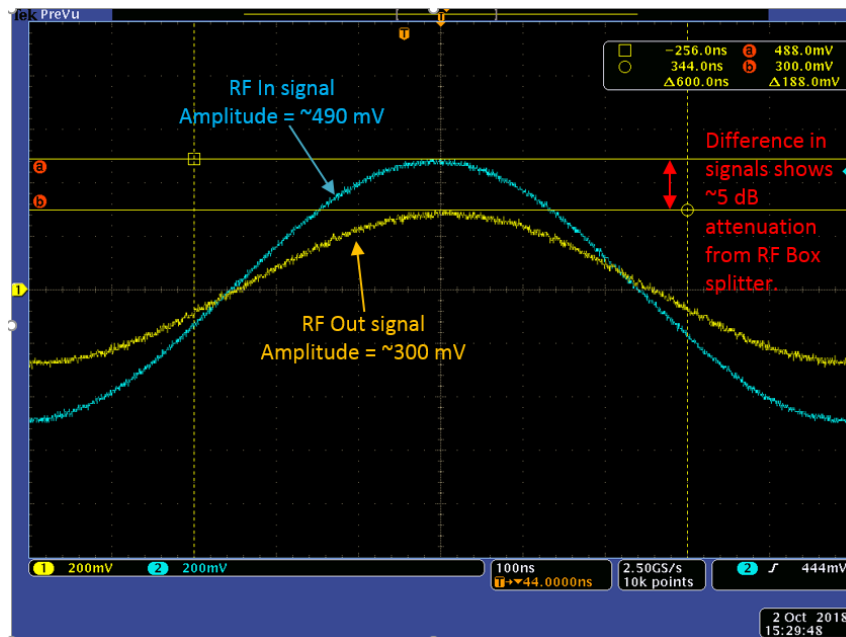
- RF Box connection to instrumentation and 50-Ohm transmission line theory discussed.
- Initially, RF Box was distorting and not attenuating signals correctly.
  - ★ Found that RF Box's splitter requires MHz frequency for input signal.
  - ★ Once frequency of signal was raised from 1 kHz to 1 MHz, RF Box operated correctly.
- Set up oscilloscope to monitor input waveform from signal generator (0.5 V amplitude, 1 MHz sine wave) and RF Box's attenuated output signal.
  - ★ Verified correct output signal is received from RF Box when attenuator is set to 0 dB.

Screenshot of oscilloscope showing input (blue waveform) and output (yellow waveform) signal when RF Box is set to 0 dB attenuation. Signals are not identical because there is ~5 dB attenuation of input signal, regardless of attenuator setting, after it passes through RF Box's signal splitter.

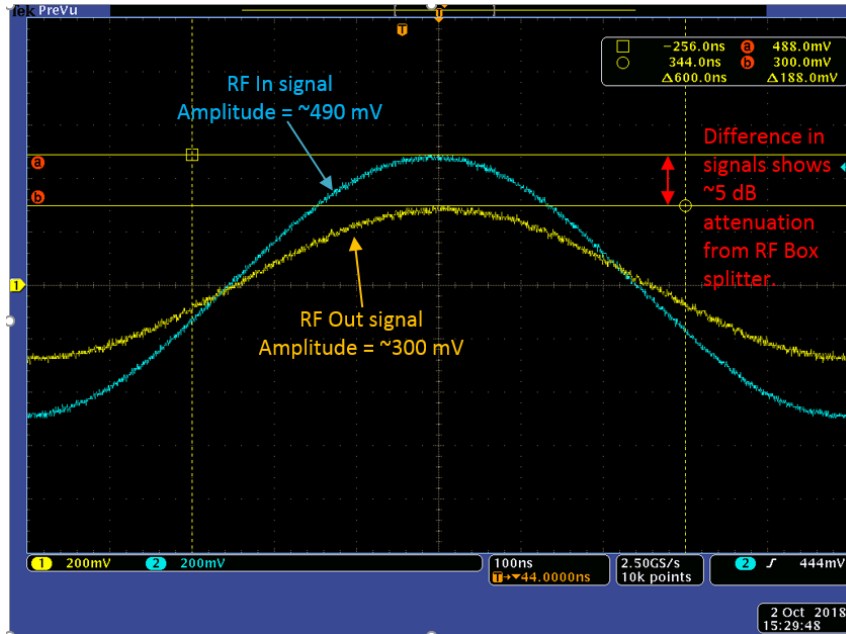
- Set up and debugged RF Box for attenuation testing.
  - \* RF box appeared not to be attenuating signals correctly.
  - \* Found that RF Box's splitter requires MHz frequency; was using kHz signal for test.

- Verified that correct output signal is received from RF Box when attenuator is set to 0 dB.
    - The RF Box's splitter causes a ~5 dB loss in signal before signal passes through attenuator.

Screenshot of oscilloscope showing input and output signal when RF Box is set to 0 dB attenuation. Signals are not identical because there is ~5 dB attenuation of input signal, regardless of attenuator setting, after it passes through RF Box's signal splitter.

- Once frequency of signal was raised to 1 MHz, RF Box operated correctly.
  - \* Set up oscilloscope to monitor input waveform from signal generator (0.5 V amplitude, 1 MHz sine wave) and RF Box's attenuated output signal.
