Detector Support Group

Weekly Report, 2017-08-23

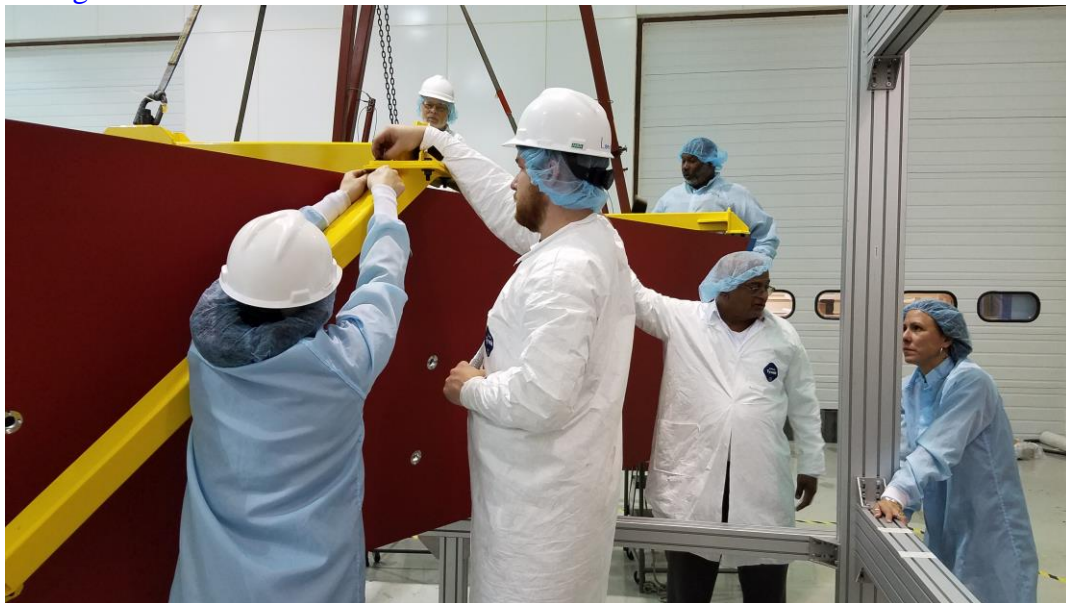
Brian Eng and Tyler Lemon installing lateral arm of stiffening tool

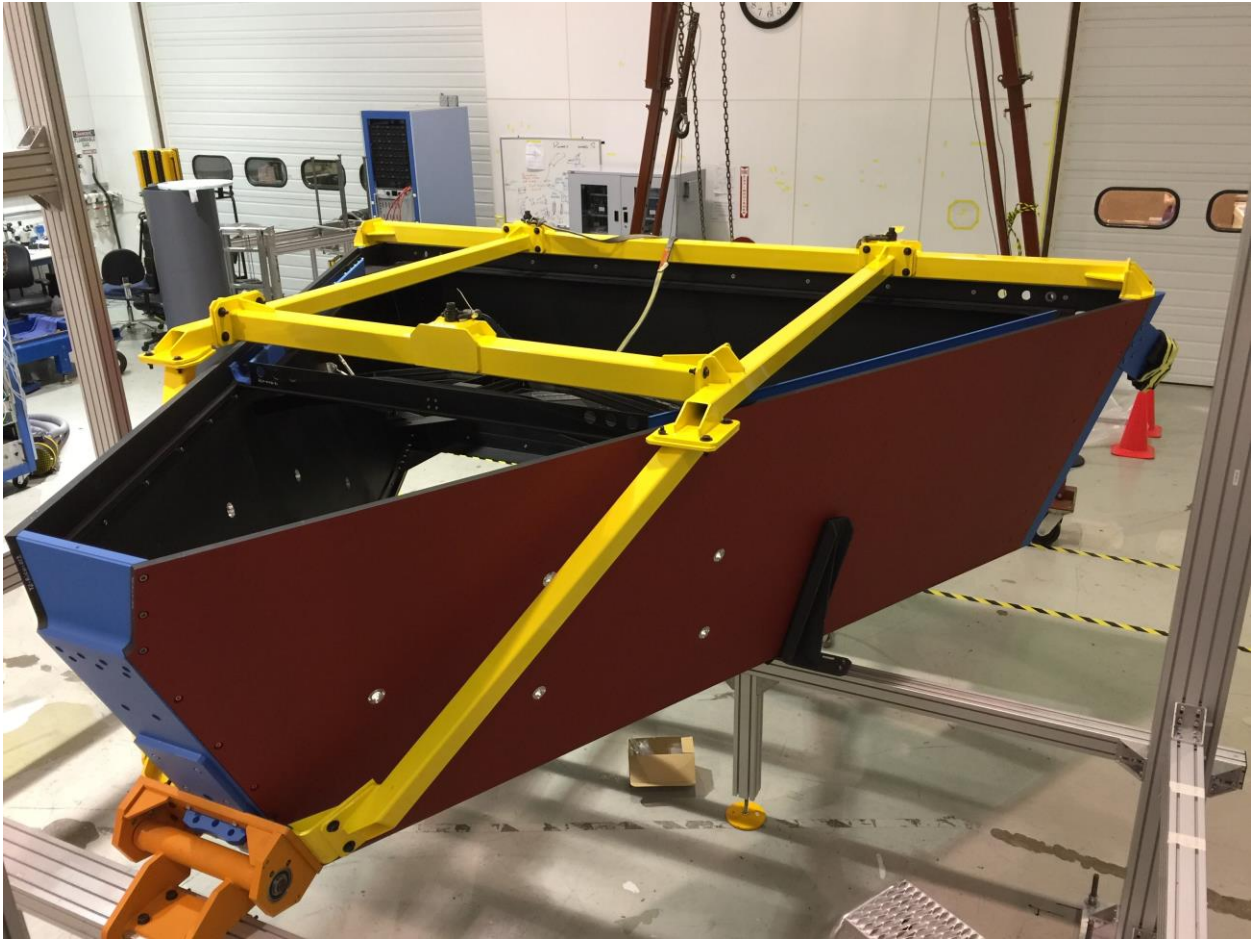
Assembled stiffening tool on RICH detector shell

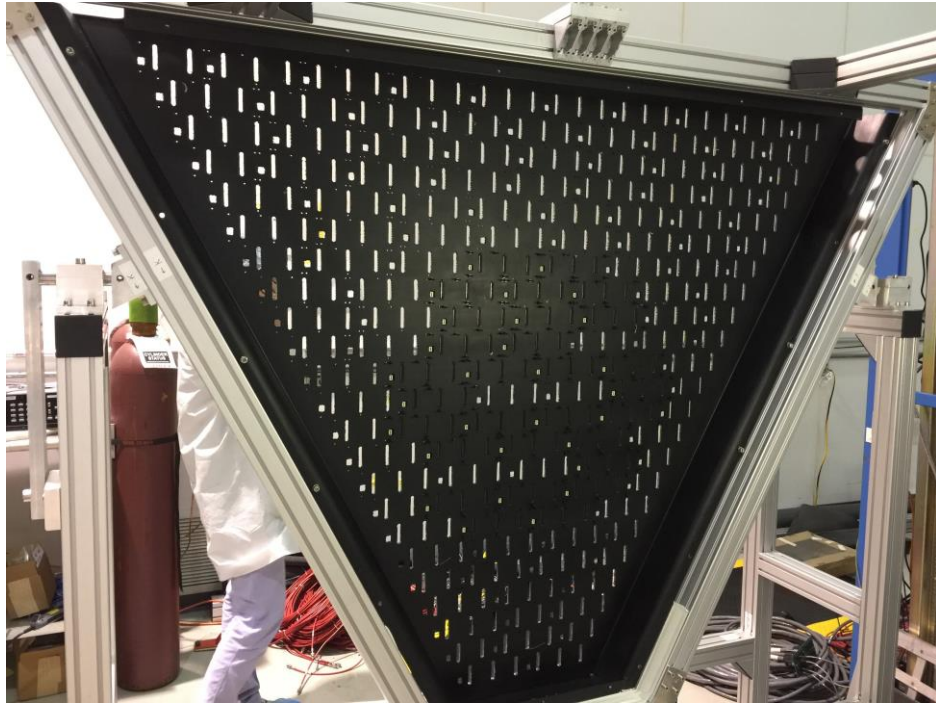
- Modifications of carbon-fiber electronic panel completed.
 - ★ Cutouts on electronic panel required enlargement to allow good connection between electronic boards.
 - ★ Dremel used to enlarge 391 cutouts.

RICH electronic panel after enlarging cutouts. Electronic boards are now able to be installed on to panel.

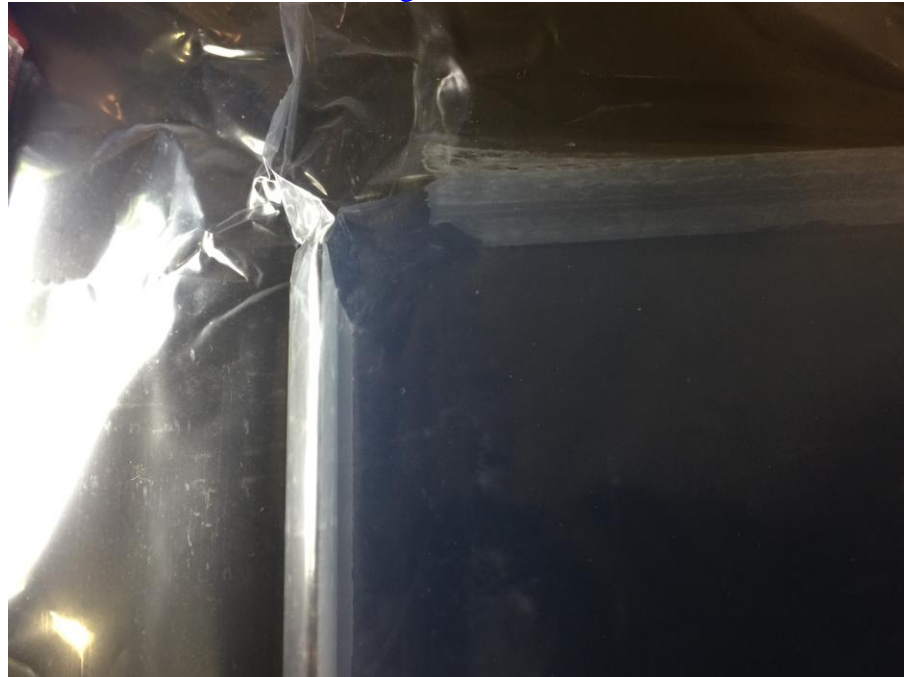
- Twenty-five 2-cm thick aerogel tiles inspected.
 - * All tiles photographed and appearance logged.
 - * All tiles had minor faults (chips on corners, small bubbles on side).
 - Minor faults like all other aerogel tiles received.

423f41 - large chip on corner
